ST VINCENT'S COLLEGE STONEWORK REPAIRS AND SEISMIC STRENGTHENING 2018

REVIEW OF ENVIRONMENTAL FACTORS

November 2018 Final Part 5 EP&A Act Environmental Impact Assessment Prepared for St Vincent's College

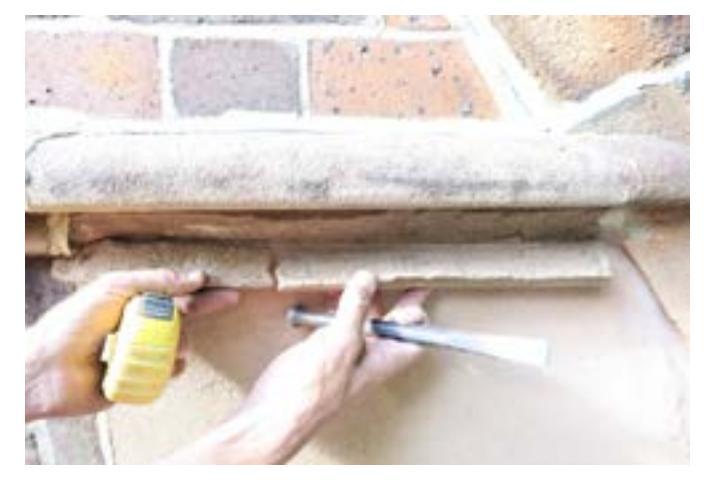
Figure 8 Evidence of defective stonework to string course

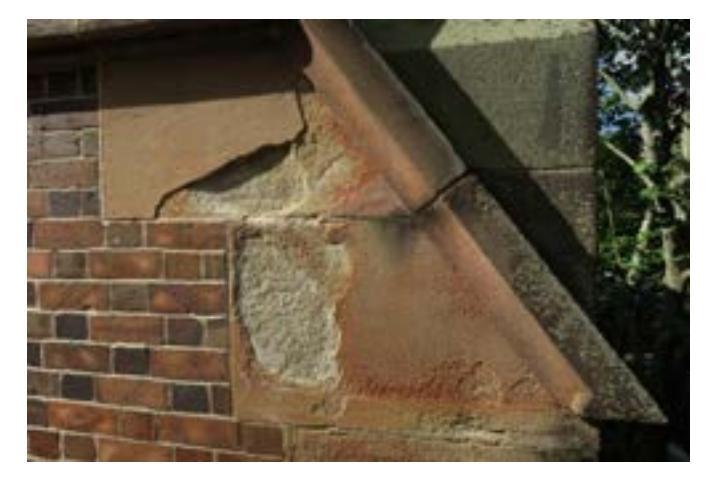
Figure 10 Previous synthetic repairs failing

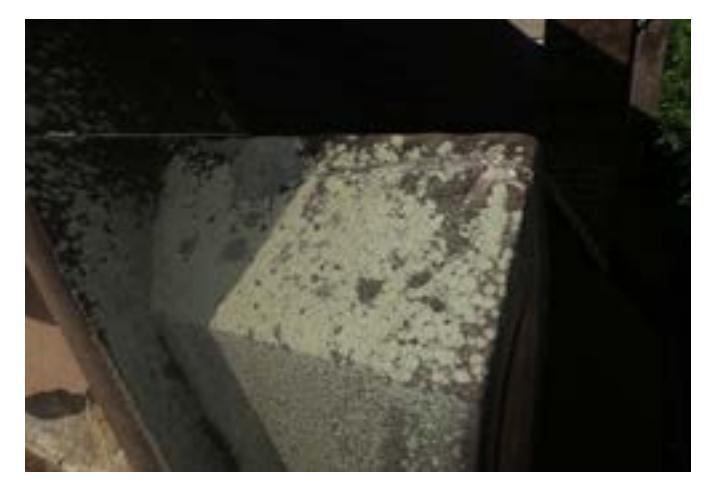
Figure 11 Biological growth and evidence of cracking to top face

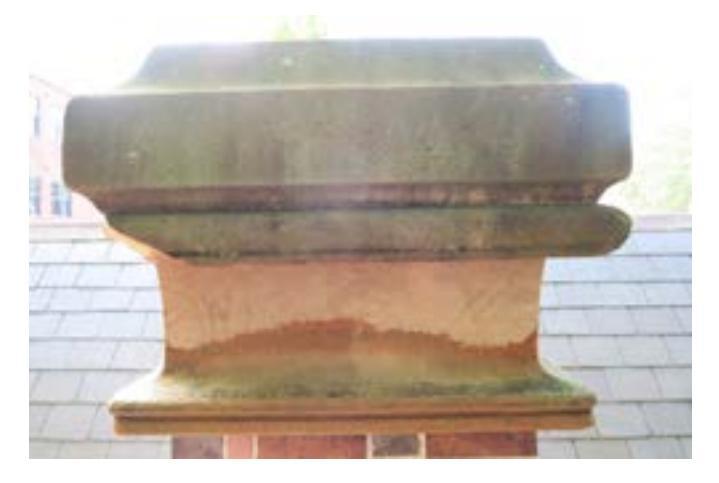
Figure 16 Chimney cap following safety audit

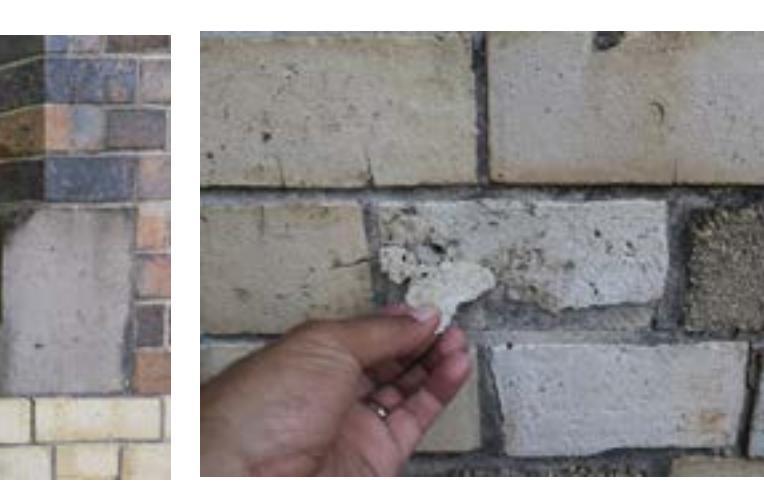
Figure 17 Typical decay to bottom edge of sill

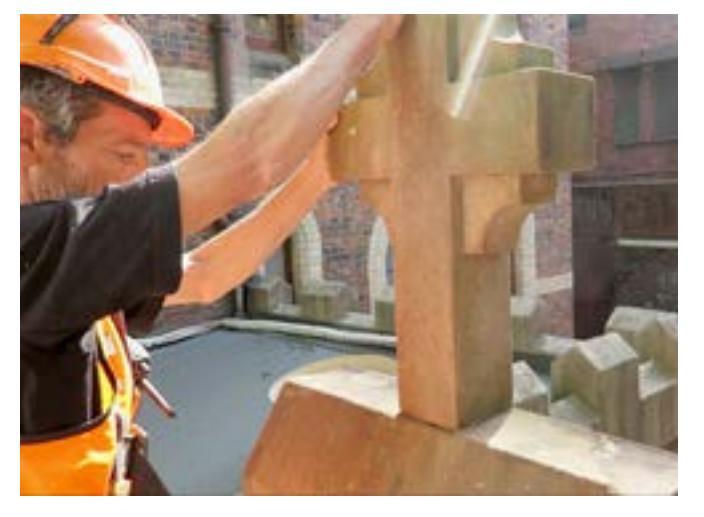
Figure 20 Removal of loose stone

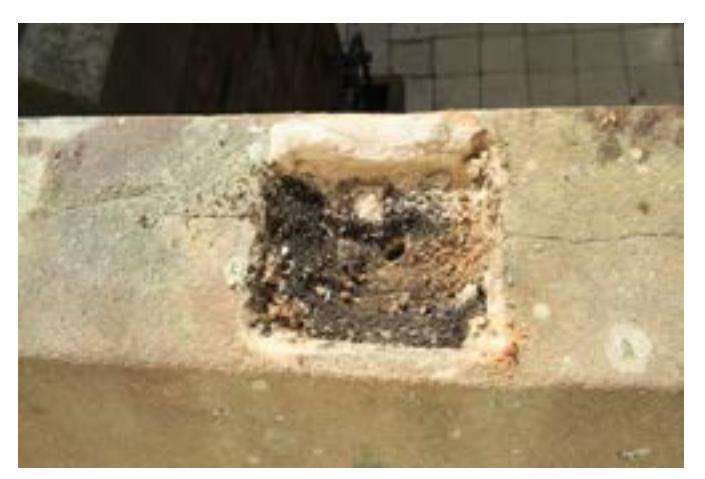
Figure 21 removal of finial above Gate 1

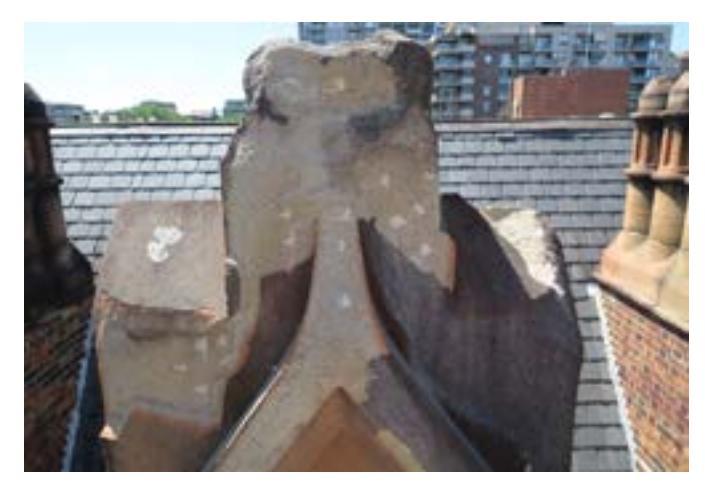
Figure 26 Removal of loose apex stone of Gable 2

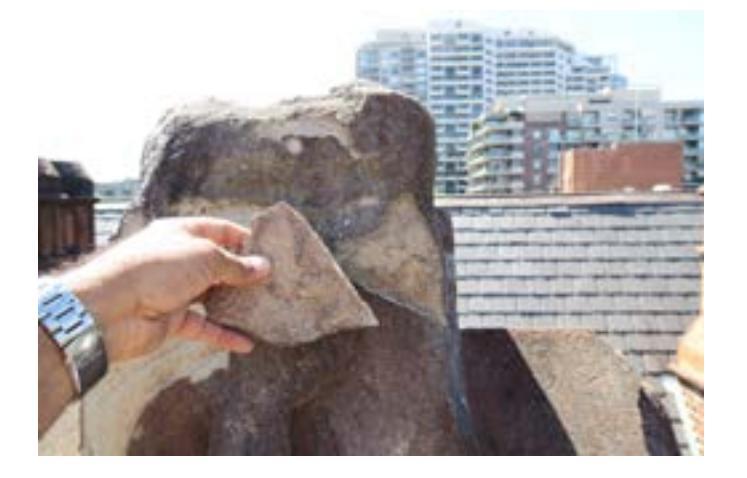
Figure 27 Removal of loose apex stone of Gable 2

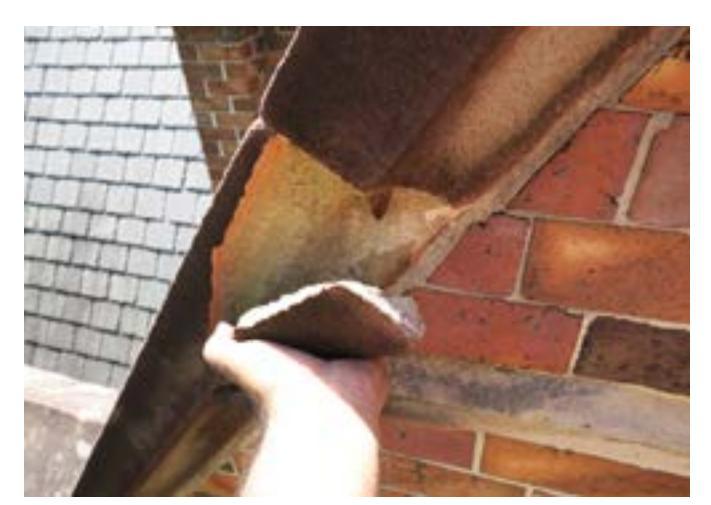
Figure 29 Typical decay to bottom edge of coping

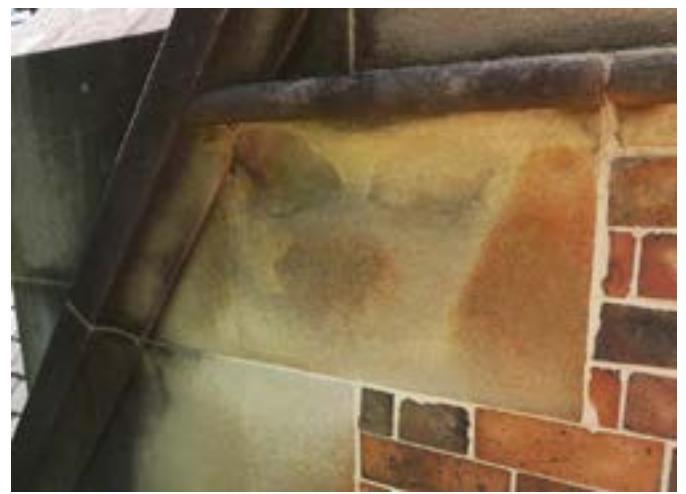
Figure 33 evidence of biological growth

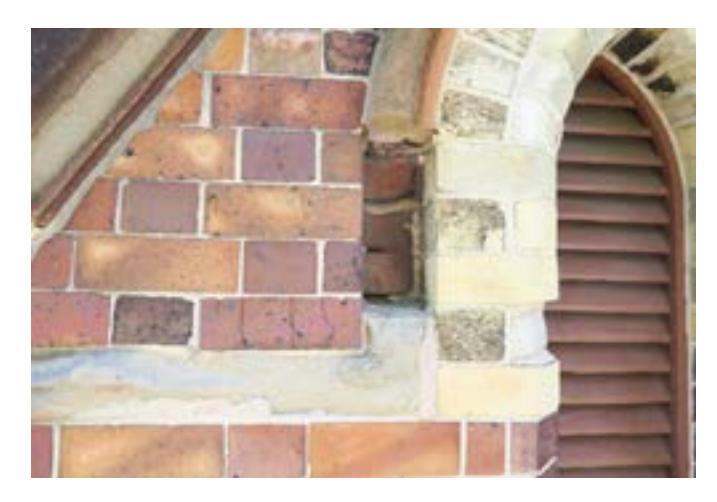
Figure 32

Evidence of missing brickwork to window reveal and missing stone window reveal

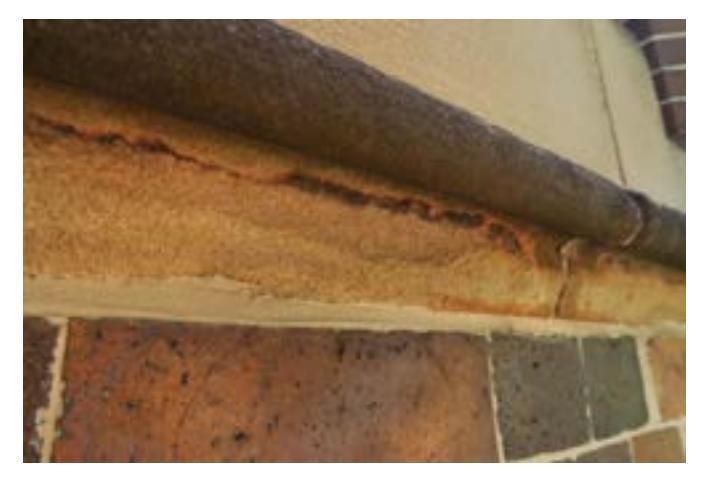
Figure 34 Previous loss to underside of string course

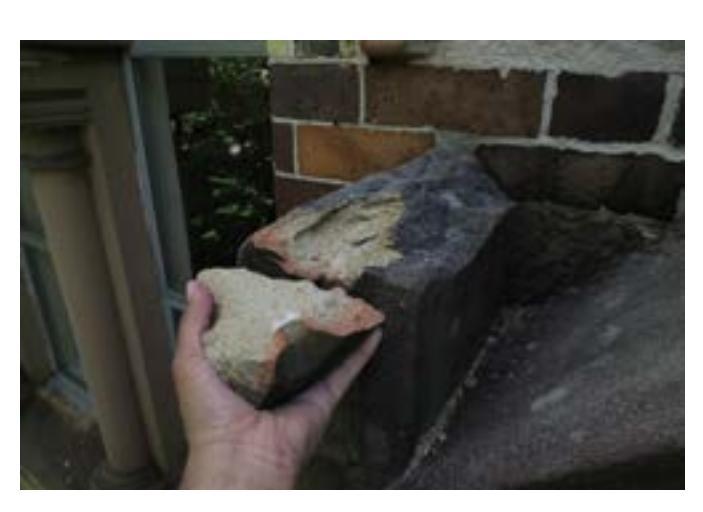
Figure 38 Removal of loose stone

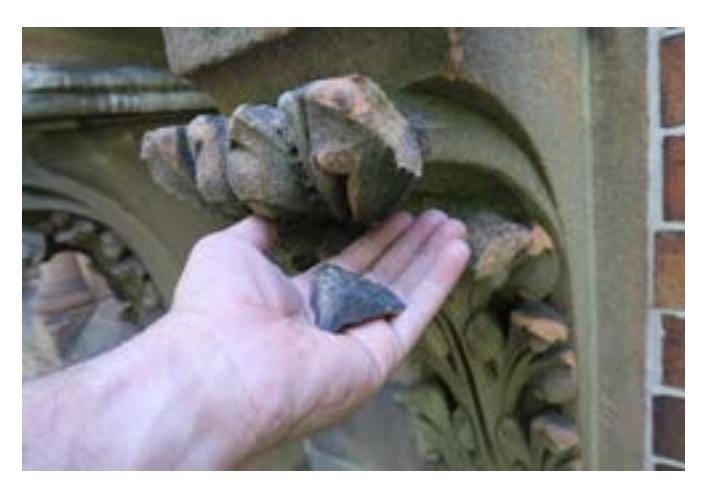
Figure 40 Removal of loose stonel

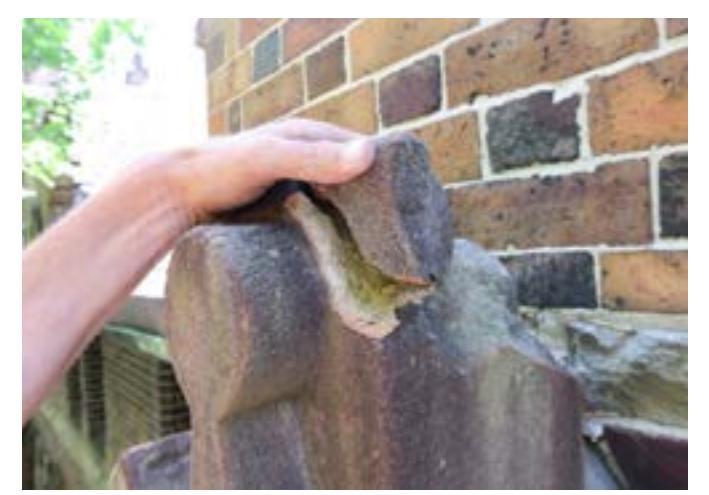
Figure 41 Removal of loose stone

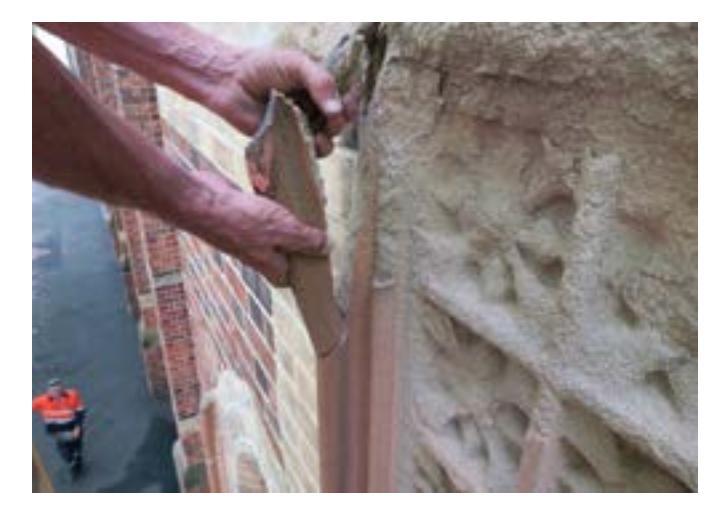
Figure 47 Removal of loose stone above doorway

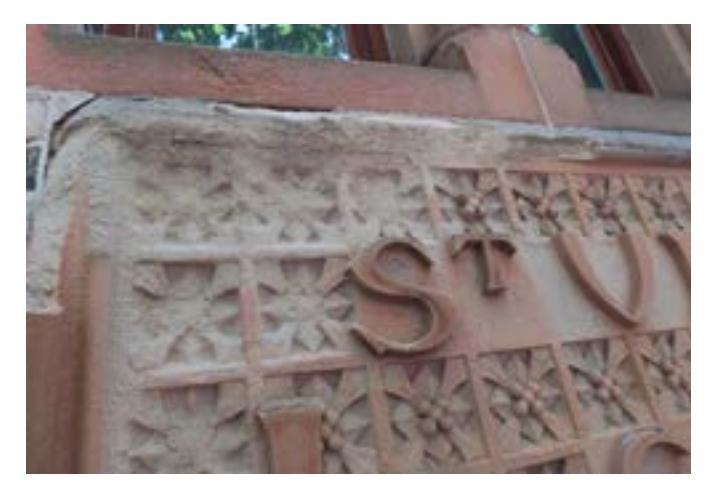
Figure 50 St Vincents lettering cracked

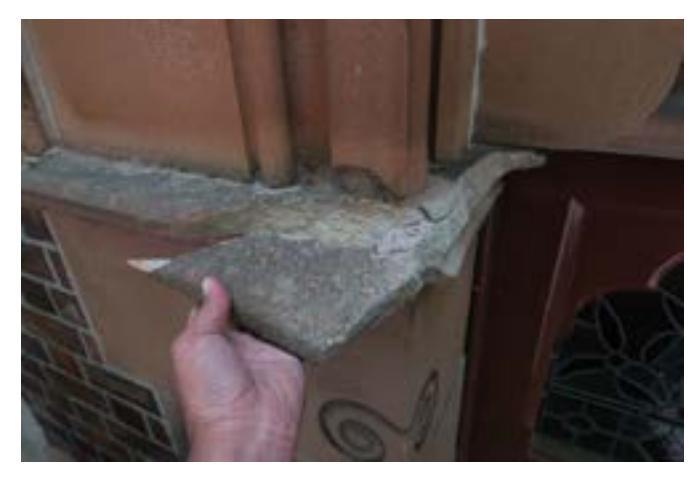
Figure 52 Removalof loose moulding

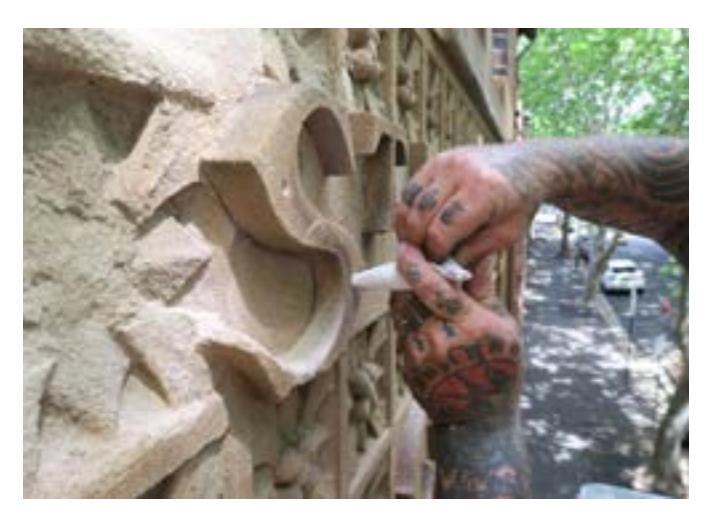
Severe decay of stonework above the main entry door on Victoria street has caused stone to become unsafe around the lettering and in exposed locations. The 'S' of St Vincent's College was temporarily pinned to save the original lettering until conservation works are to commence.

Figure 53 Temporary repairs to "S' of St Vincents on Victoria street Elevation

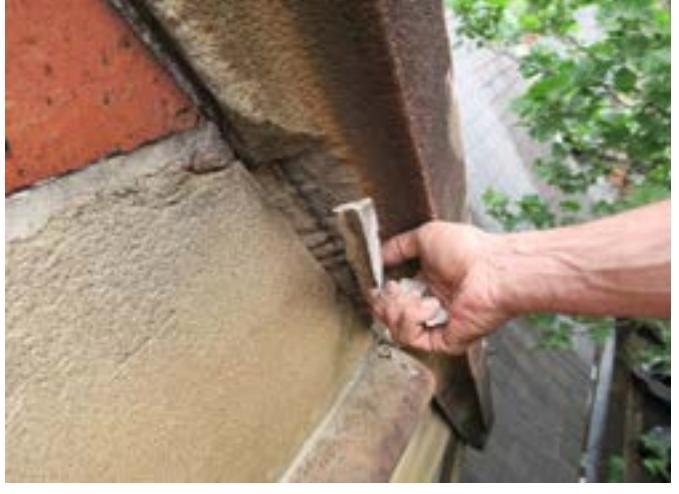
Figure 57

removal of loose stone to Gable 3 Mary Aikenhead Building

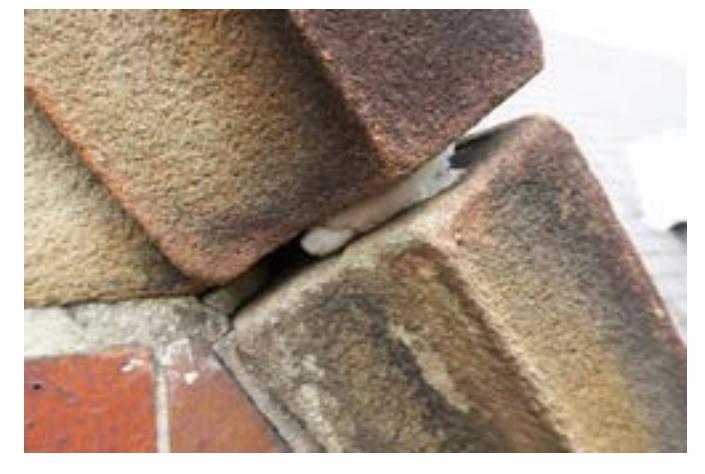
Figure 58 Open joints to Gable 3

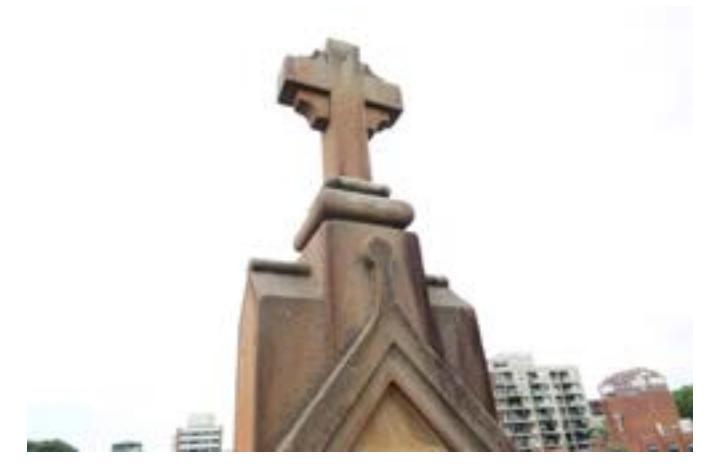
Figure 60 Condition of finial on Gable 3

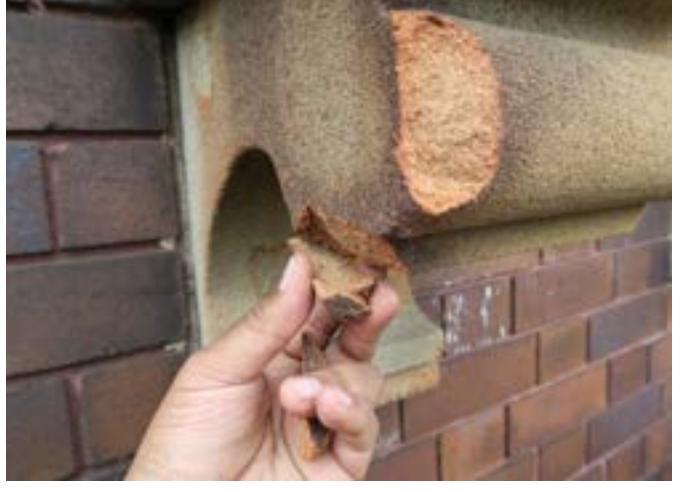
Figure 63 Loose stonework

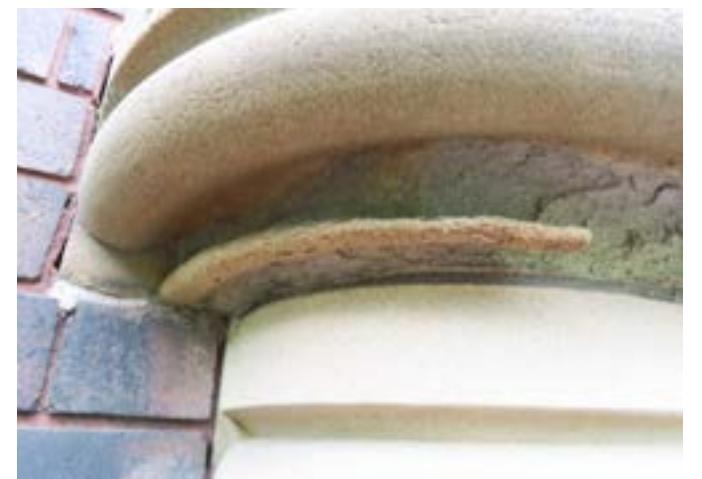
Figure 65 Typical decay to bottom edge of moulding

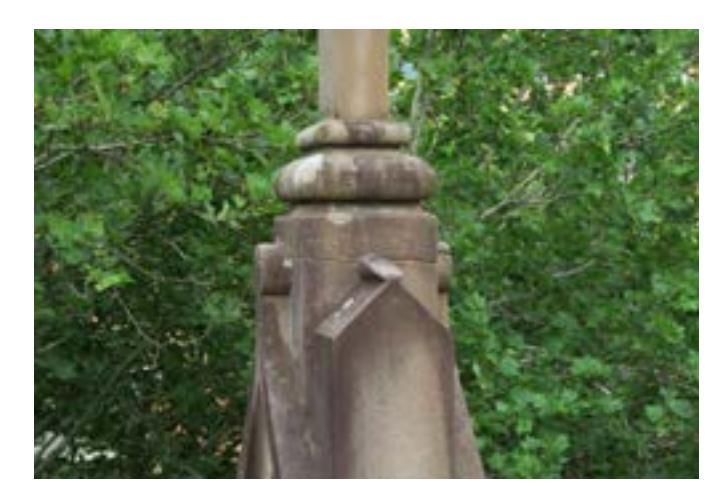
Figure 68 Crack at finial

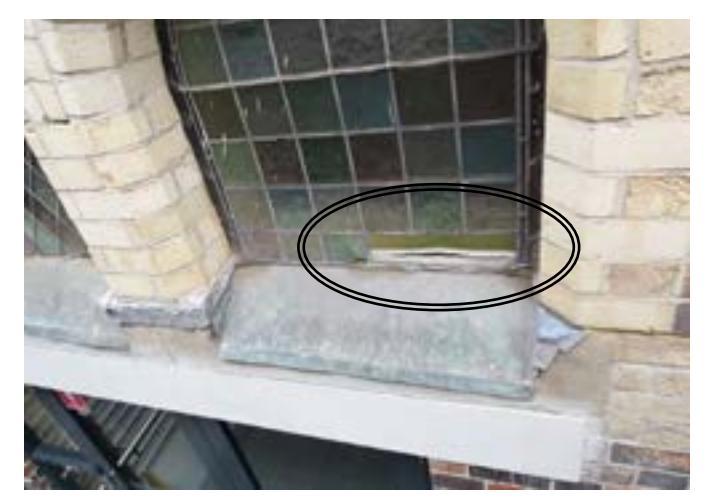
Figure 77 leadlight glass missing

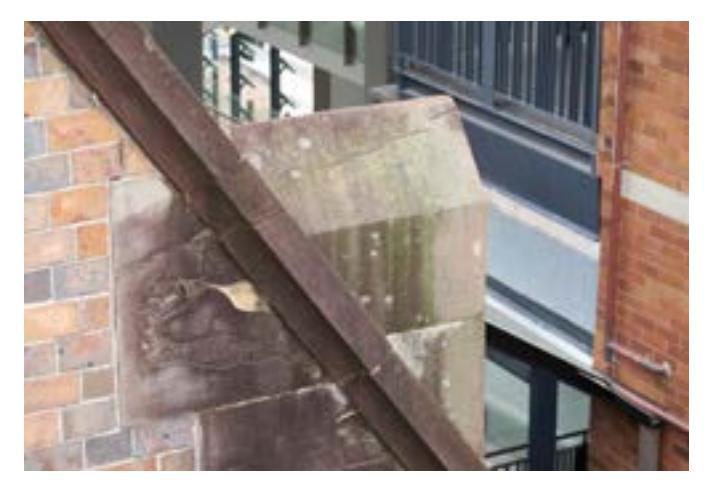
Figure 74 cracking of stone Y23 and Y24 of Gable 4

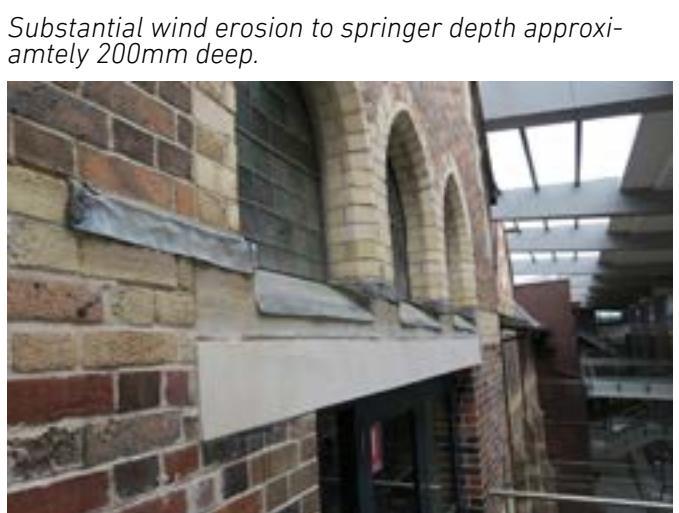
Figure 78 Detail of lead weathering

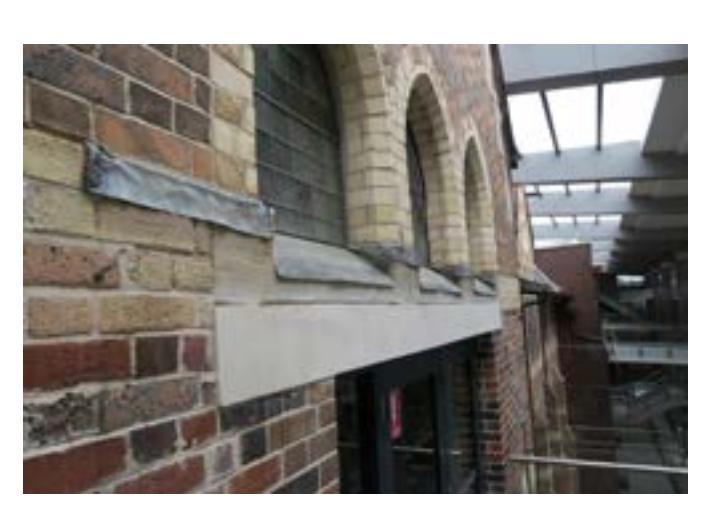
Figure 86

Lead weathering detail to be rbought up to standard and appropriately shed water from stone

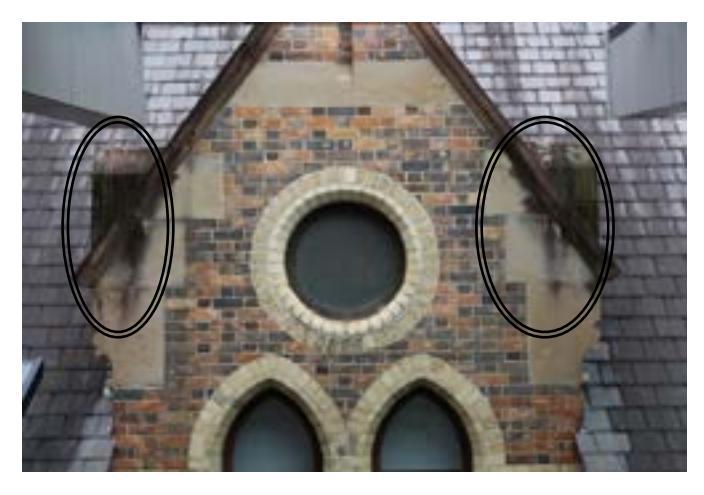
Figure 92 Evidence of water run off staining stone gables

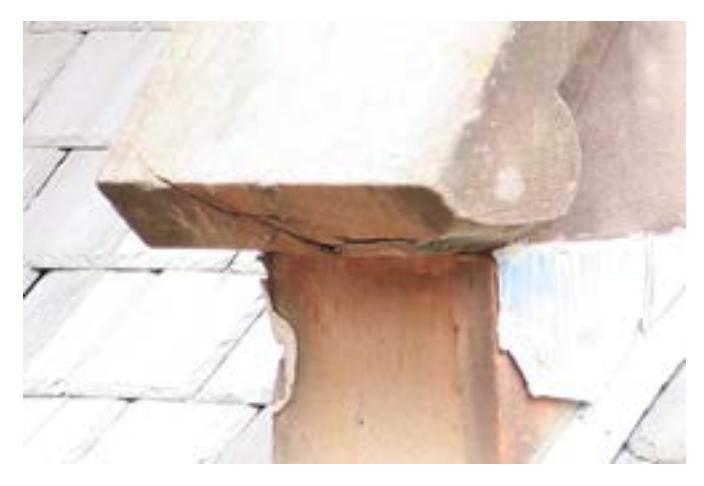
Figure 93 Previous stone repairs

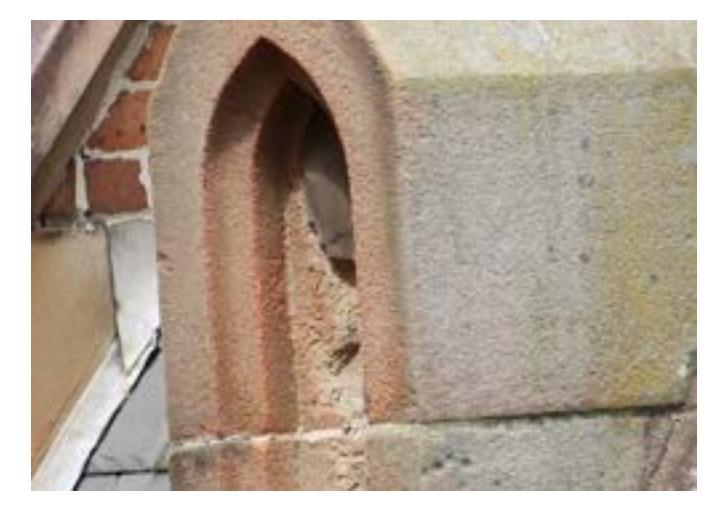
Figure 95 Typical wind erosion to springer stones

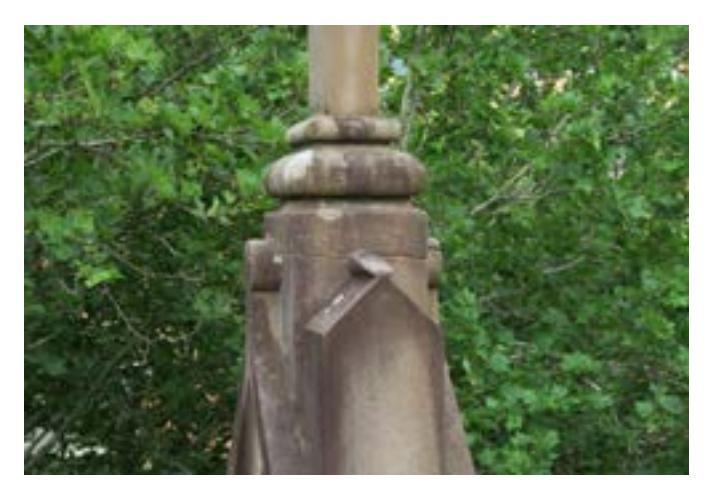
Figure 98 Evidence of cracking stonework

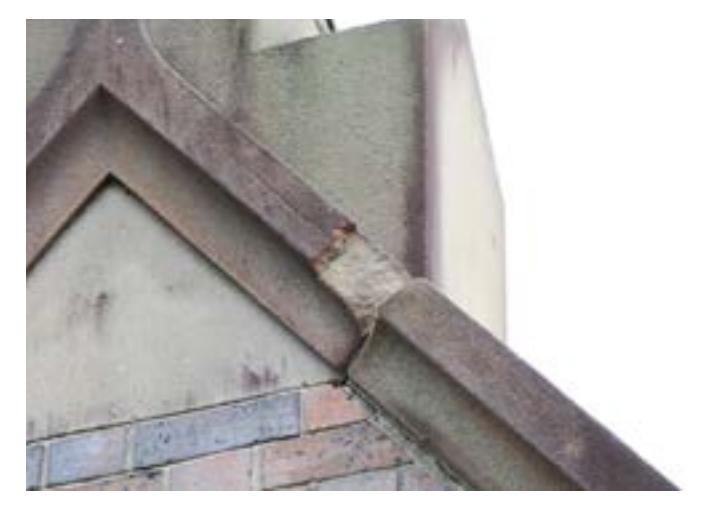
Figure 101 Typical cracking of moulding

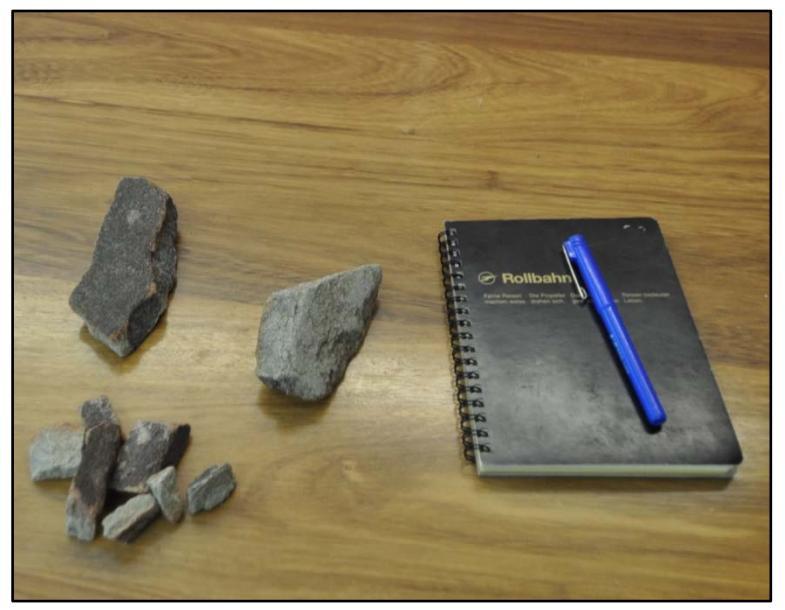
A concern regarding public liability has arisen due to falling of sandstone fragments of the Victoria Street façade especially since last winter (Figure 1).

Figure 1. Sandstone fragments found fallen from the Victoria Street façade.

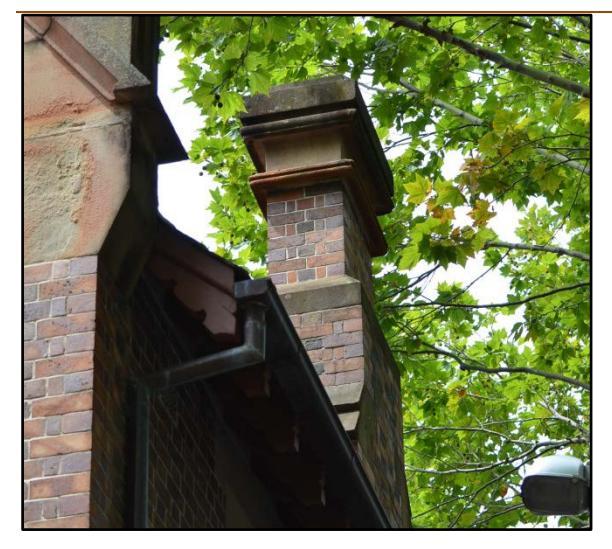
Figure 27. Chimney on the school hall's western façade (Victoria Street) (Staining, lichen growth).

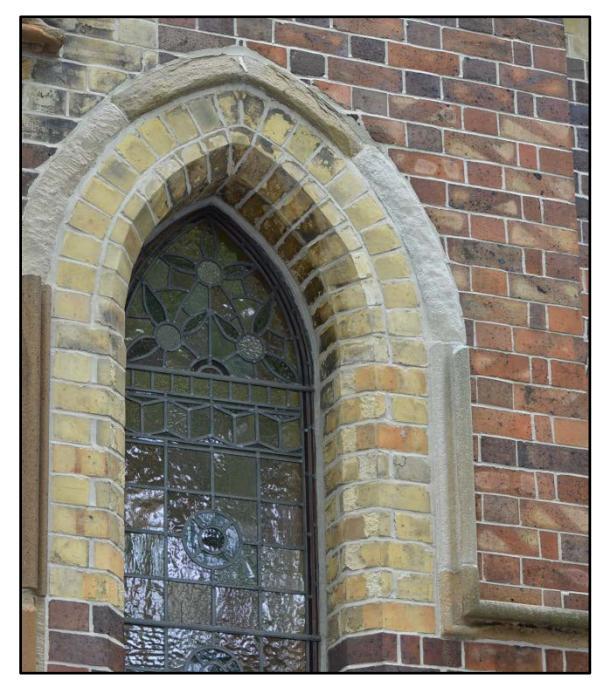
Figure 45. Label moulds around stain-glass window on the main building's central gable (western façade) (Delamination/case hardening and removal of the label mould).

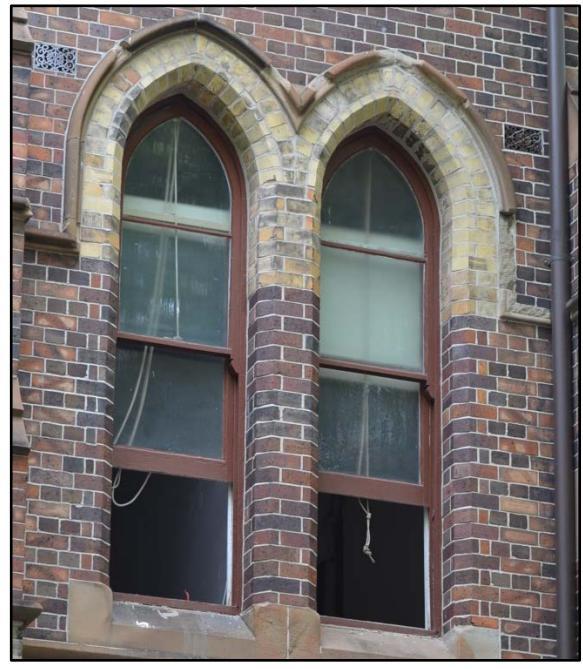
Figure 46. Label moulds around windows on the western façade of the main building (Delamination/case hardening).

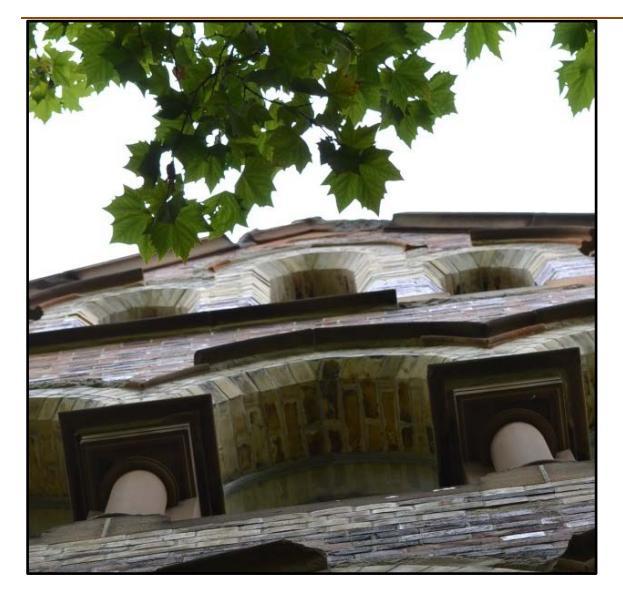
Figure 49. Label moulds around the small triple gothic windows on the main building's central gable (western façade) (Delamination/case hardening and removal of the label mould).

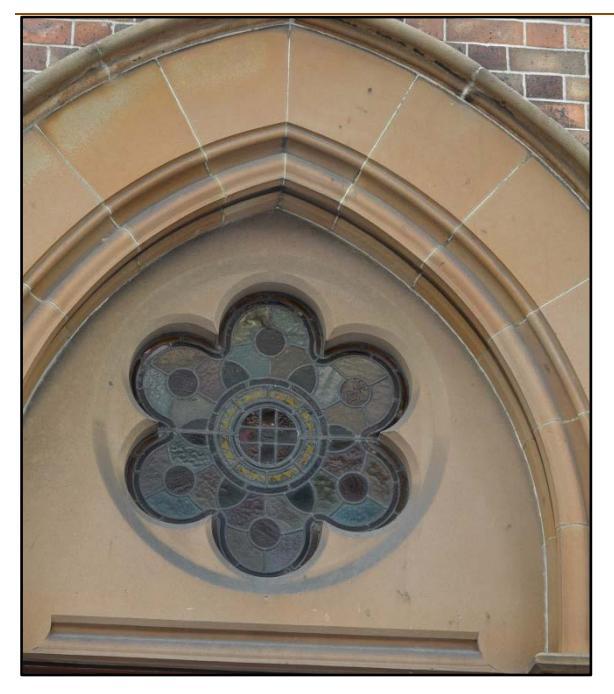
Figure 70. Detail of arch above main building central entry door (Efflorescence).

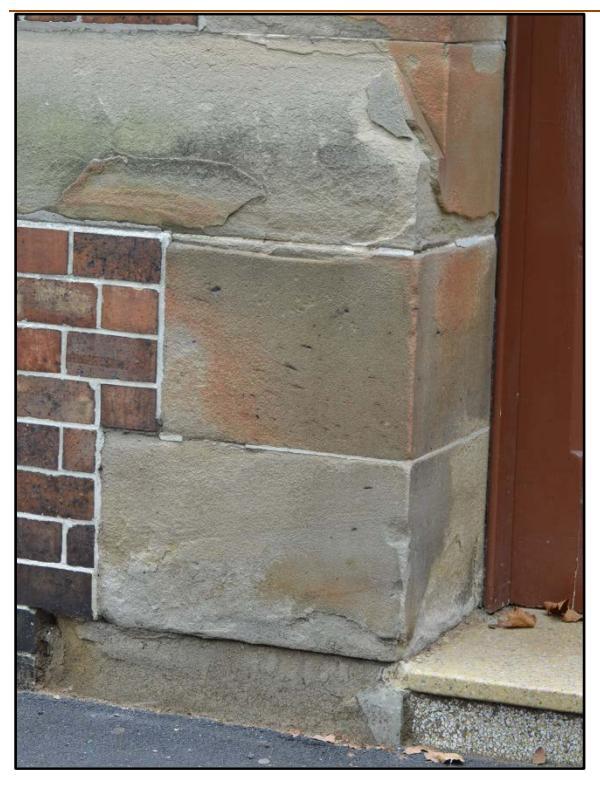
Figure 78. Door jambs of the main building's central entry (Efflorescence, delamination).

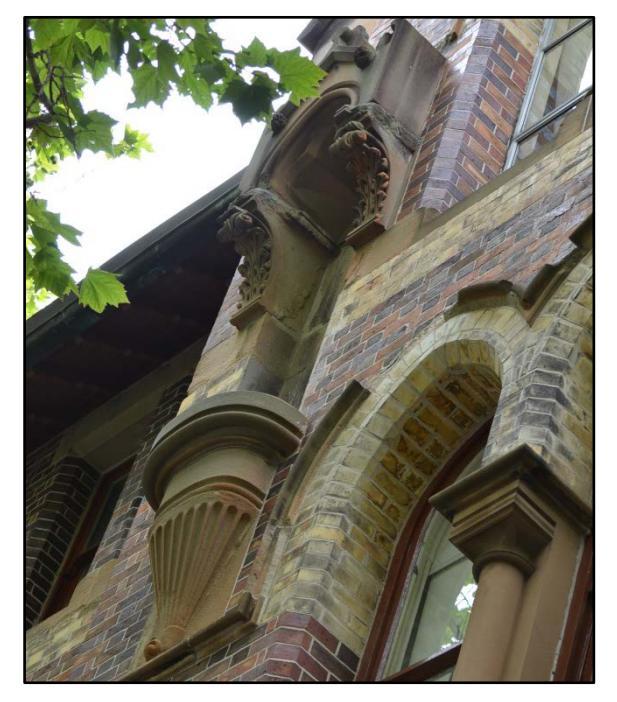
Figure 87. Most northern niche on the central gable of the main building (Staining, delamination).

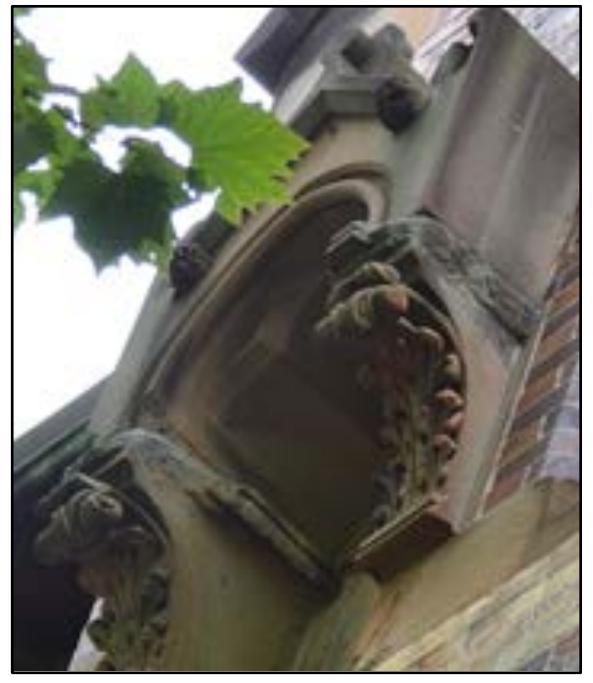
Figure 88. Detail of northern niche on the central gable of the main building (Staining, delamination on the console bracket).

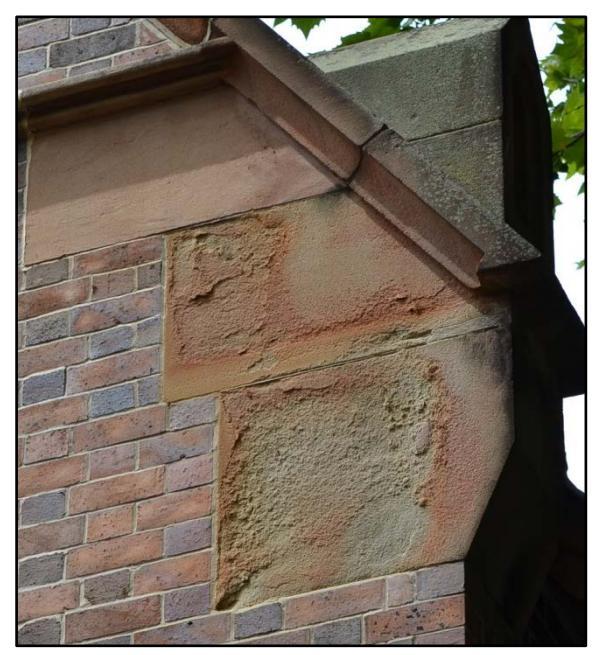
Figure 97. Quoins on the northern façade of the school hall – 1886 western gable (Efflorescence, delamination).

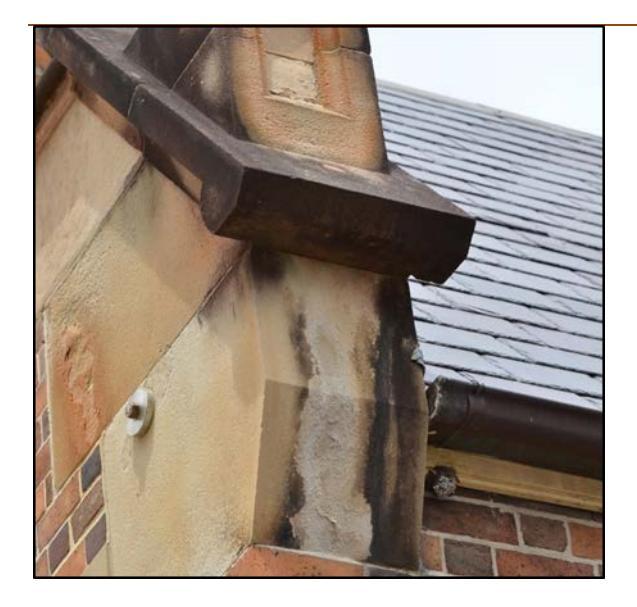
Figure 99. Quoins (under capping) on the eastern façade of the school hall (Efflorescence).
