ST VINCENT'S COLLEGE STONEWORK REPAIRS AND SEISMIC STRENGTHENING 2018

REVIEW OF ENVIRONMENTAL FACTORS

November 2018 Final Part 5 EP&A Act Environmental Impact Assessment Prepared for St Vincent's College

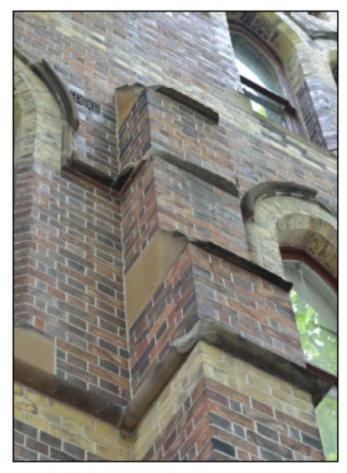
Figure 83. Saddle stones and capping on buttress on the western façade of the main building (Delamination).

Figure 84. Saddle stones and capping on buttress on the western façade of the main building (Delamination).

- Remove affected capping stones and indent with new stones to match original profiles
- 2. Repoint with appropriately specified mortar (1:2:922).
- 3. Follow up with removal of scaffold.

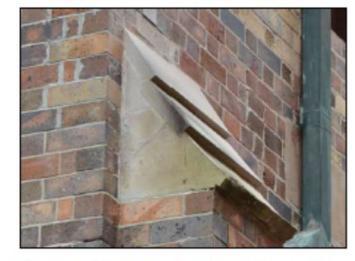
Figure 85. Saddle stones and capping on buttress on the eastern facade of the main building (Replaced in the past).

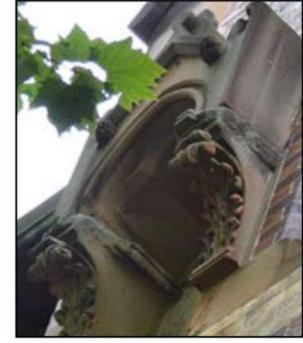
Figure 87. Most northern niche on the central gable of the main building (Staining, delamination).

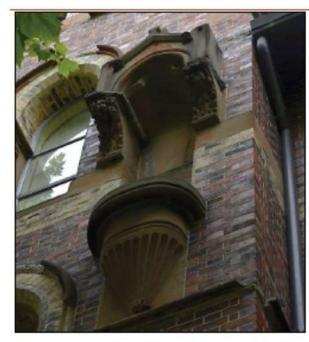
Figure 89. Most southern niche on the central gable of the main building (Staining, delamination).

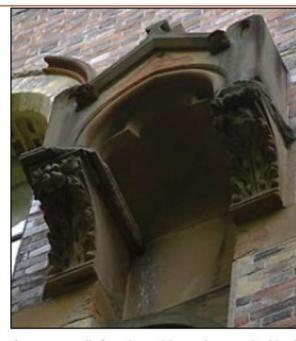
Figure 90. Detail of southern niche on the central gable of the main building (Staining, delamination).

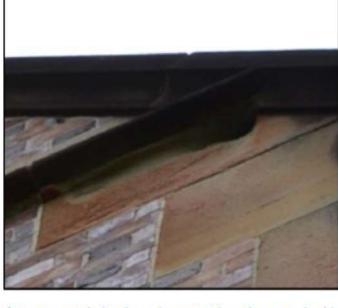
Figure 95. Quoin (under string course) on the central gable of western façade of the main building (Advanced efflorescence). This problem is mirrored on the other end of this central gable.

- 1. Remove affected quoins stones and indent with new stones to match original profiles.
- 2. Repoint with appropriately specified mortar.
- 3. Follow up with removal of scaffold.

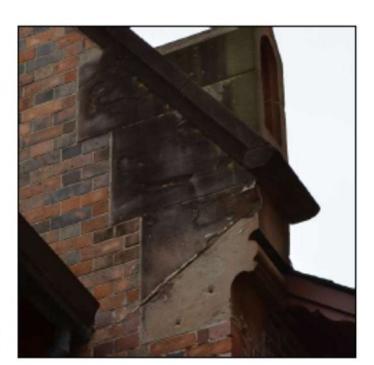
Figure 96. Quoin on the southern façade of the main building (Staining, delamination).

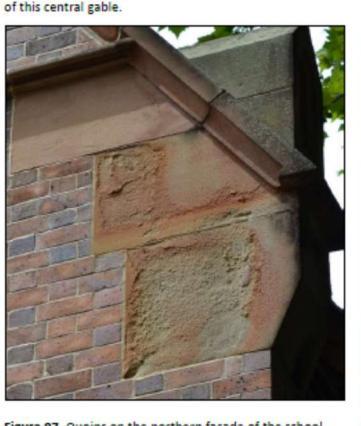
Figure 97. Quoins on the northern façade of the school hall – 1886 western gable (Efflorescence, delamination)

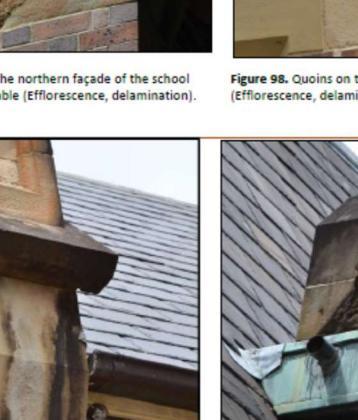
Figure 99. Quoins (under capping) on the eastern façade of the school hall (Efflorescence).

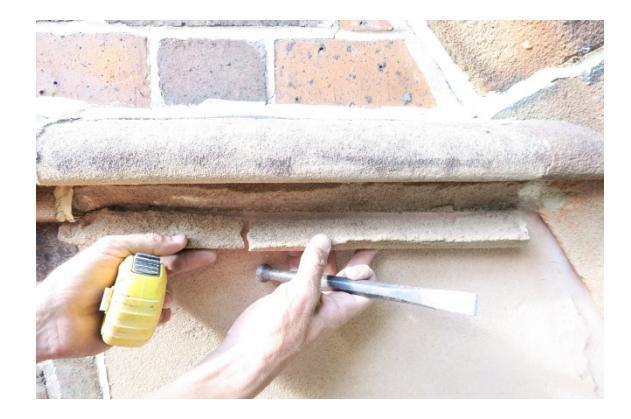
Figure 14 Evidence of defective stonework to string course (Source: VSA 01/2018)

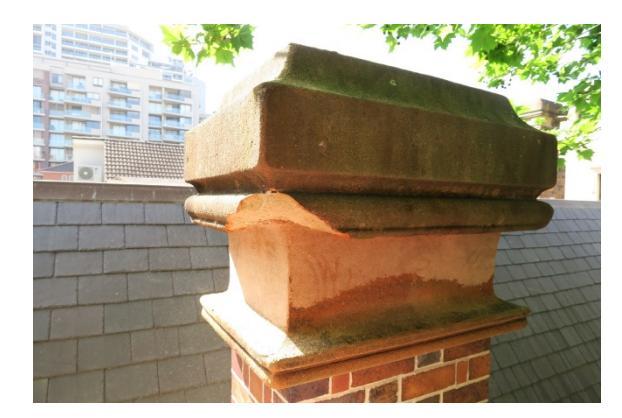
Figure 16 Chimney cap following safety audit (Source: VSA 01/2018)

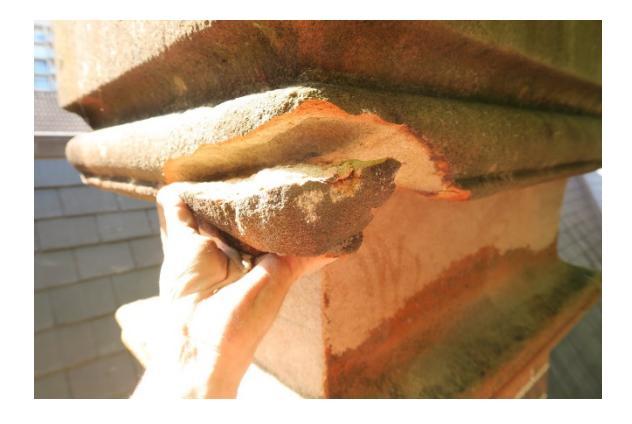
Figure 15 Removal of loose stone during safety audit of stone cap (Source: VSA 01/2018)

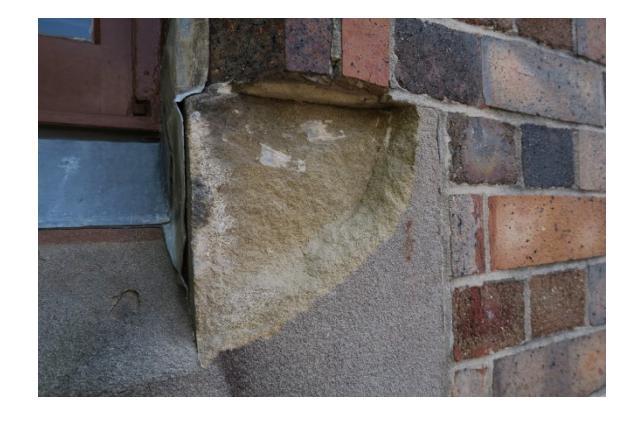
Figure 17 Removal of loose stone (Source: VSA 01/2018)

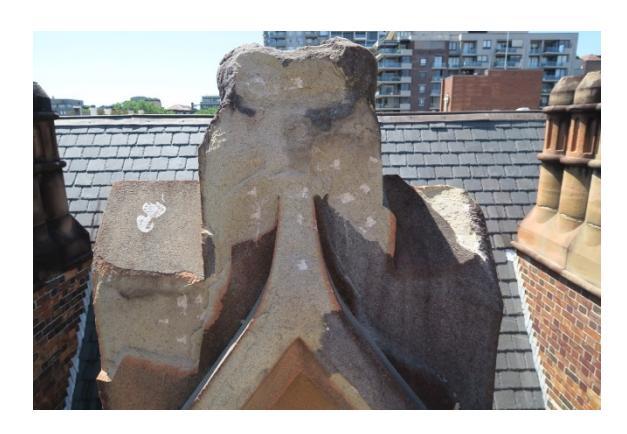
The stone elements of Gable 2 are in good condition and seismic stabilisation has been installed previously that can be seen from the street. Gate 2 has had some substantial stone deterioration and requires replacement and 100% stone repointing.

Figure 18 Removal of loose apex stone of Gable 2 (Source: VSA 01/2018)

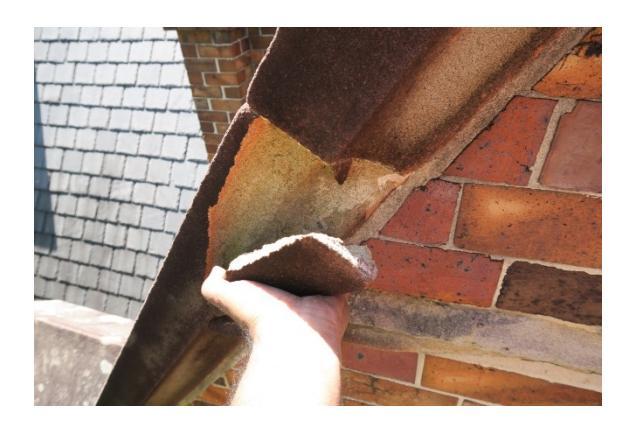
Figure 20 Typical decay to bottom edge of coping (Source: VSA 01/2018)

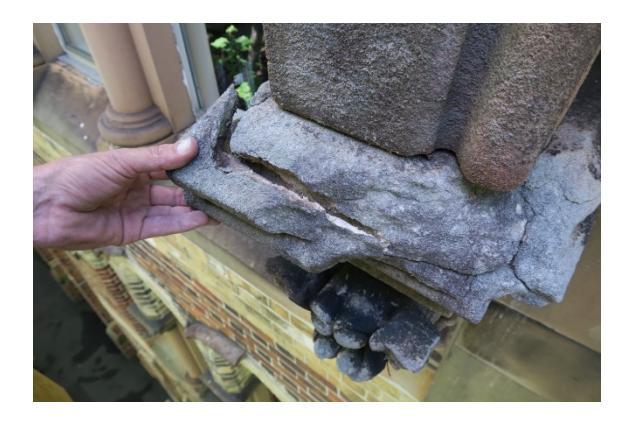
Figure 22 Failing mould detail and drip (Source: VSA 01/2018)

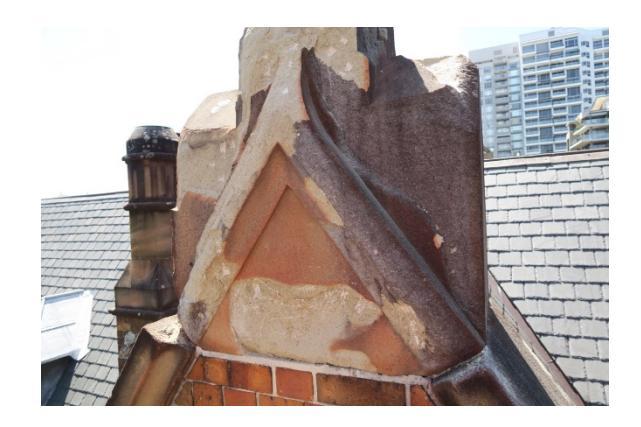
Figure 19 Cracking of Gable 2 Apex stone (Source: VSA 01/2018)

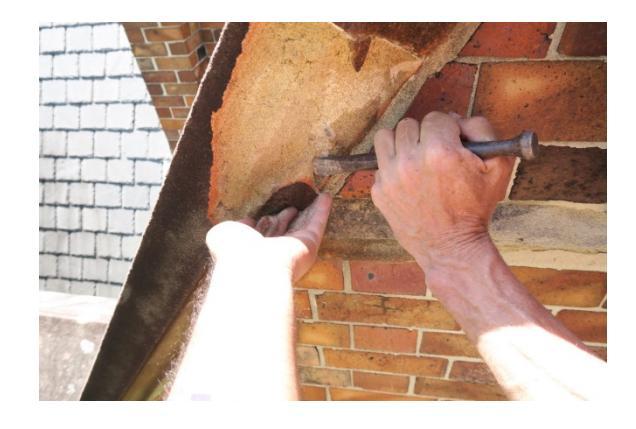
Figure 21 Removal of loose stone (Source: VSA 01/2018)

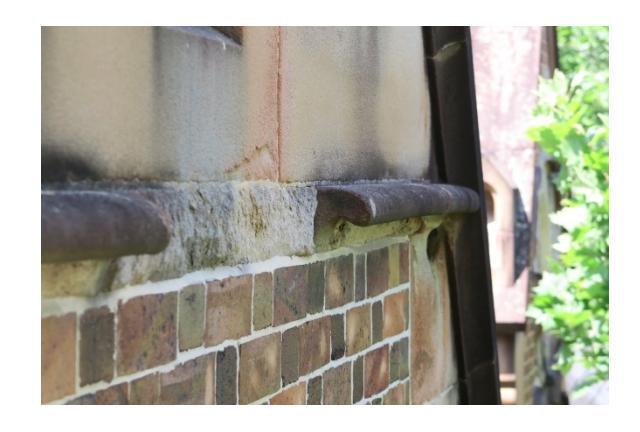
Figure 23 Typical loss of string course (Source: VSA 01/2018)

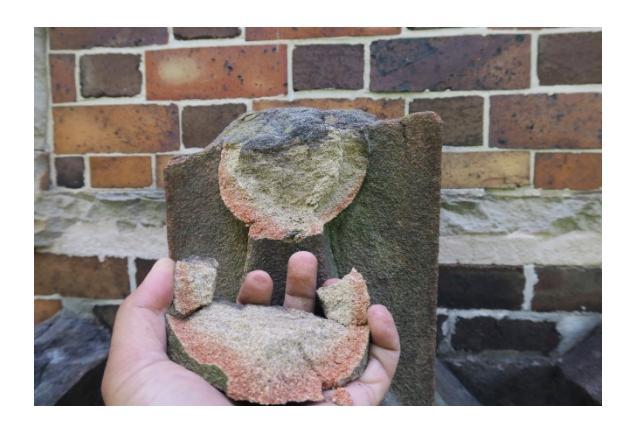
Figure 24 Removal of loose stone (Source: VSA 01/2018)

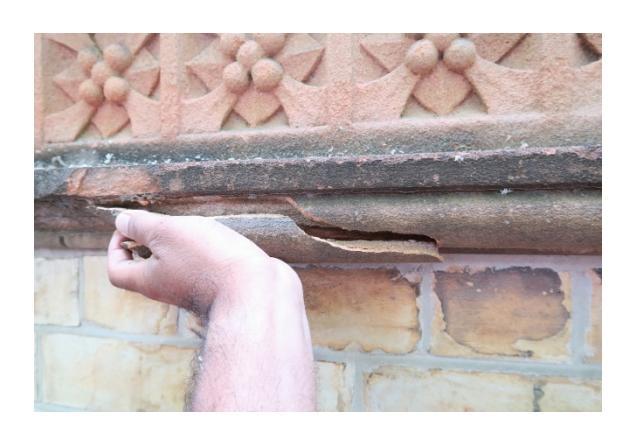
Figure 25 Removal of loose stone (Source: VSA 01/2018)

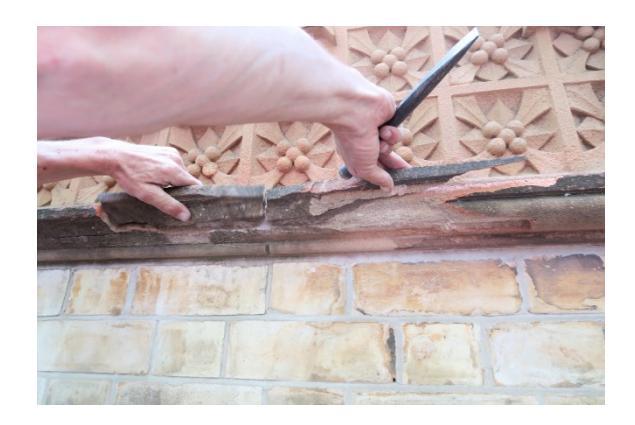
Figure 26 Removal of string course (Source: VSA 01/2018)

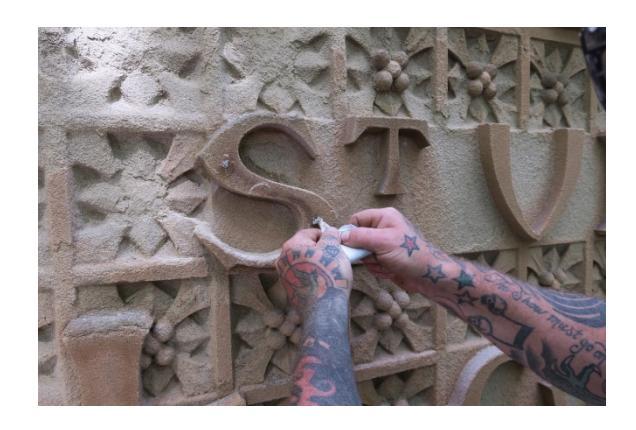
Figure 29 Temporary repairs to "S' of St Vincent's on Victoria street Elevation (Source: VSA 01/2018)

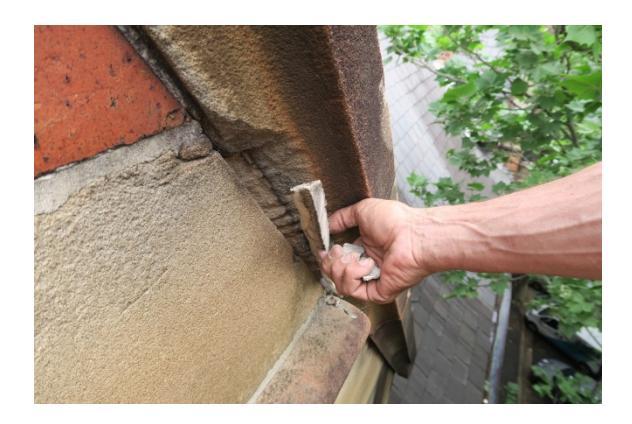
Figure 30 Removal of loose stone to Gable 3 Main School Building (Source: VSA 01/2018)

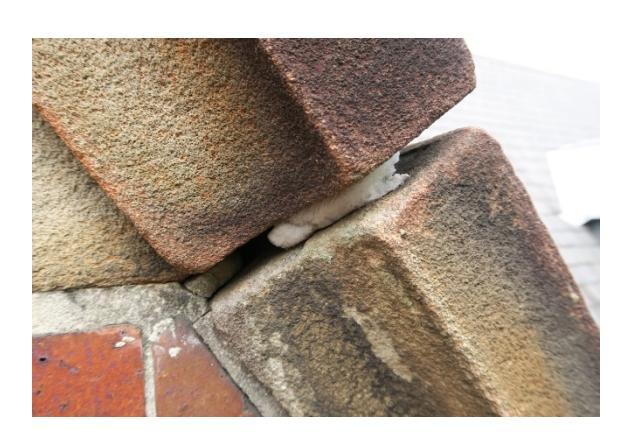
Figure 31 Open joints to Gable 3 (Source: VSA 01/2018)

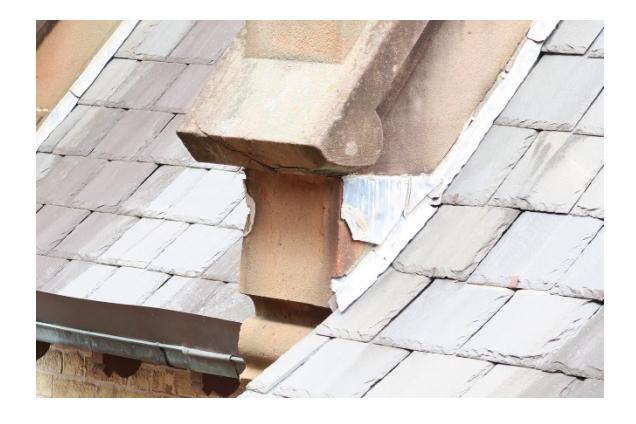
Figure 32 Decay, staining and deteriorated mould (Source: VSA 01/2018)

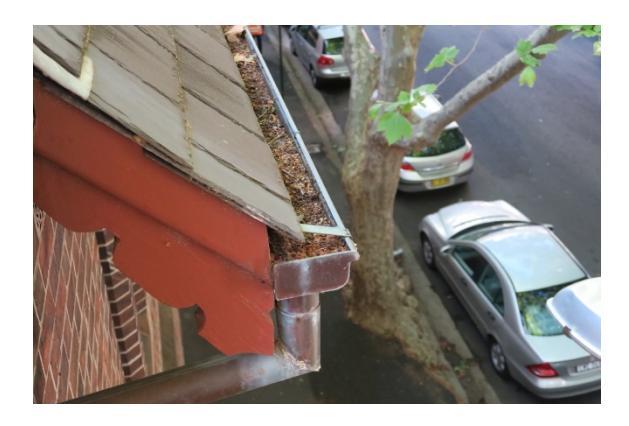
Figure 36 Victoria street elevation gutters filled with leaves (Source: VSA 01/2018)

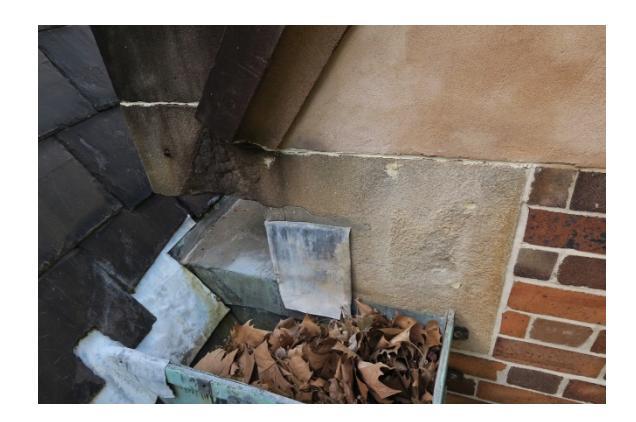
Figure 37 Rainwater head filled with leaves on Victoria street (Source: VSA 01/2018)

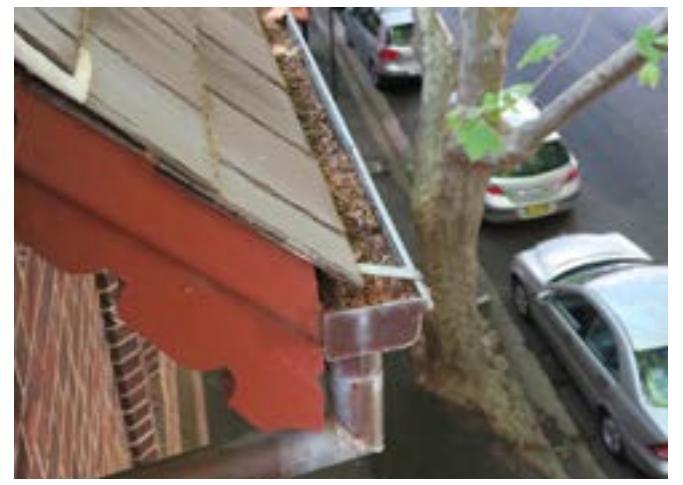
Figure 1 Victoria street elevation gutters filled with leaves

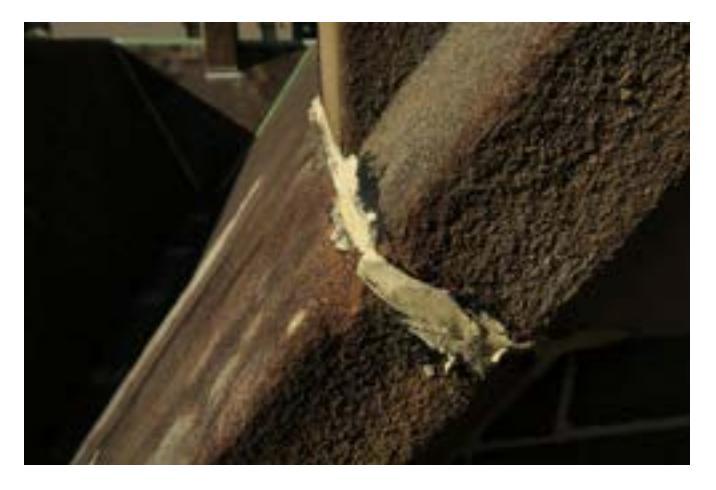
Figure 3

Example of crude elastomeric repointing to gable coping

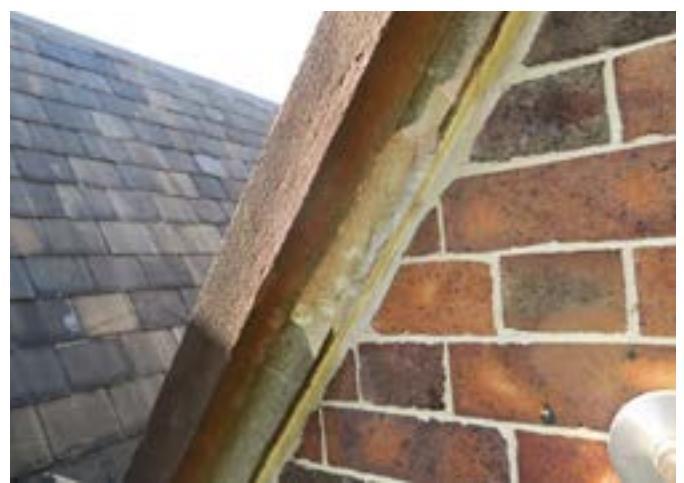
Figure 5 Typical decay to bottom edge of coping

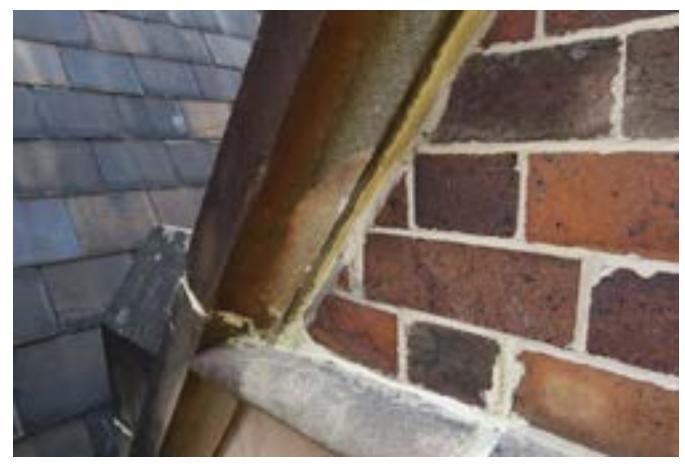
Figure 6 Decay and staining at gable coping

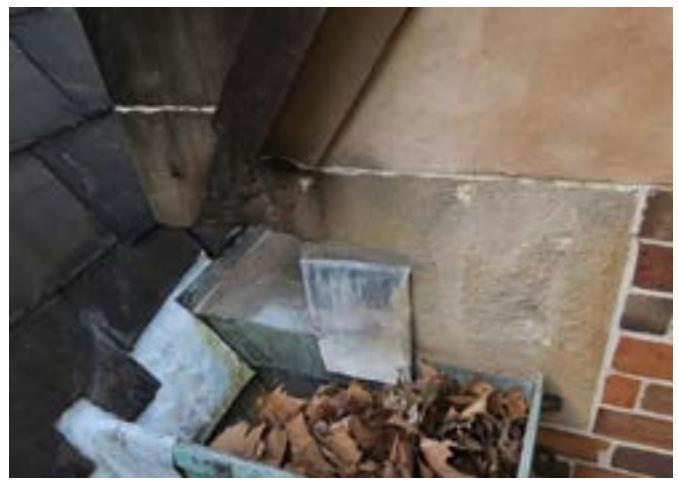
Figure 7 Rainwater head filled with leaves on Victoria street

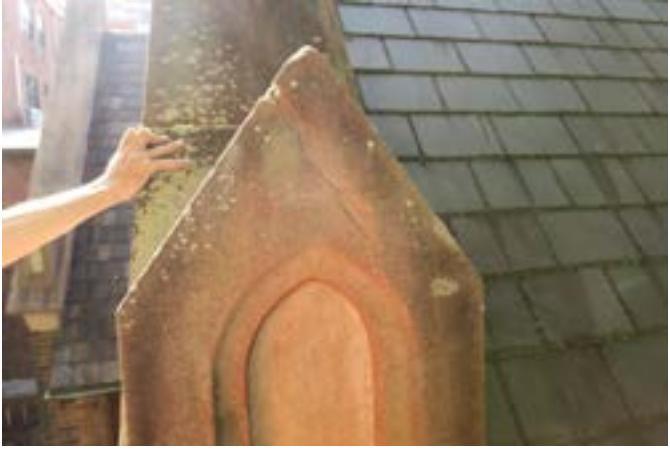
Figure 12 Decay, staining and substantial cracks

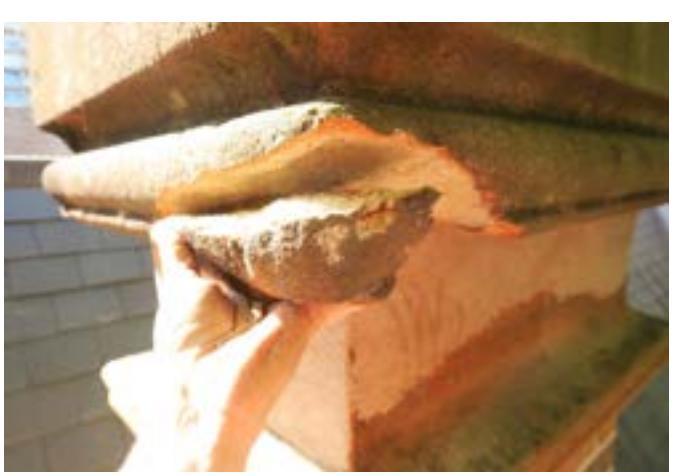
Figure 14 Eremoval of loose stone during safety aidit of stone cap

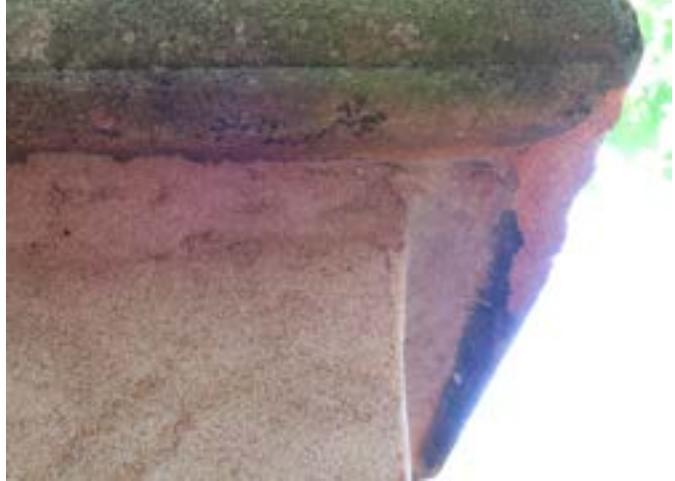
Figure 15 Fretting to underside of stone cap

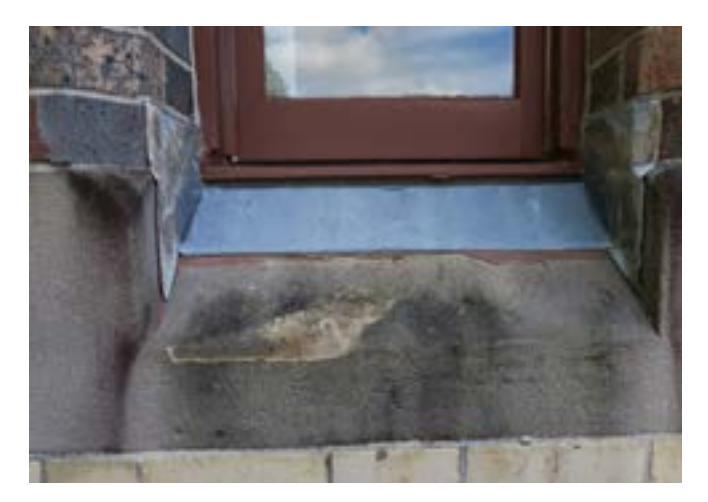
Figure 19 Removal of deacayed stonework from window sill

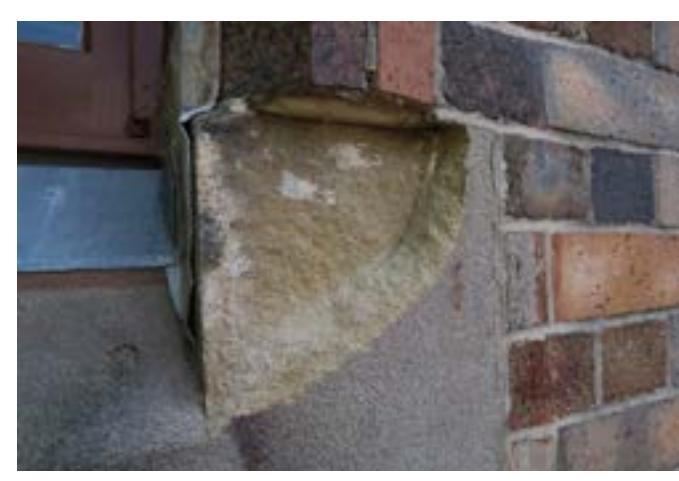
Figure 20 Removal of loose stone

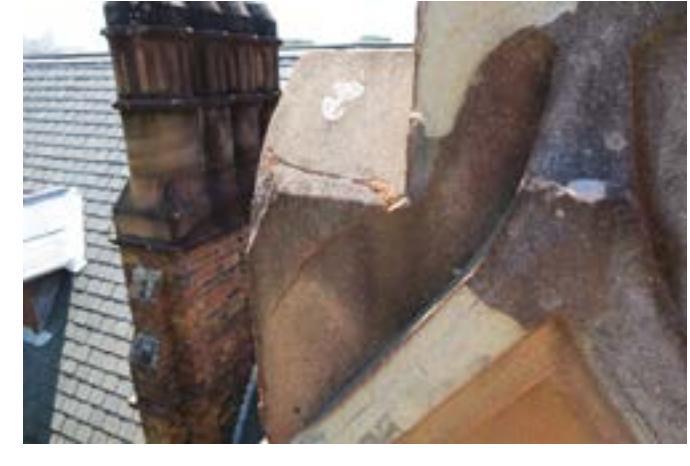
Figure 23 Cracking of Gable 2 Apex stone

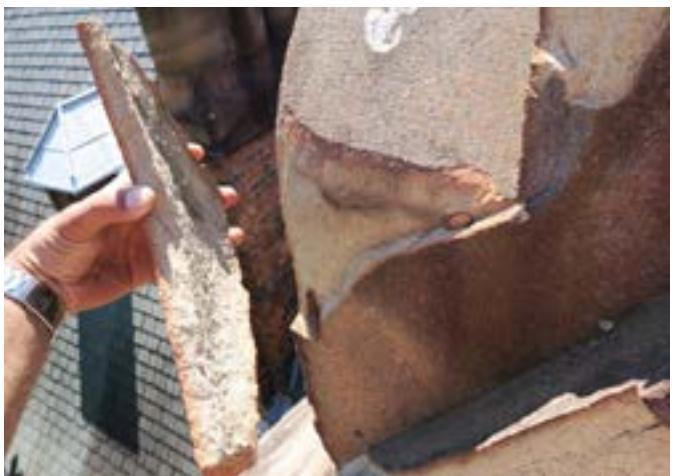
Figure 24 Removal of loose apex stone of Gable 2

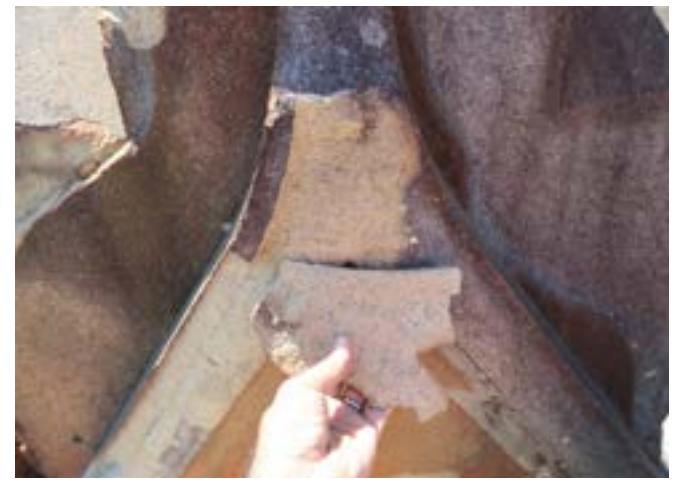
Figure 25 Removal of loose apex stone of Gable 2

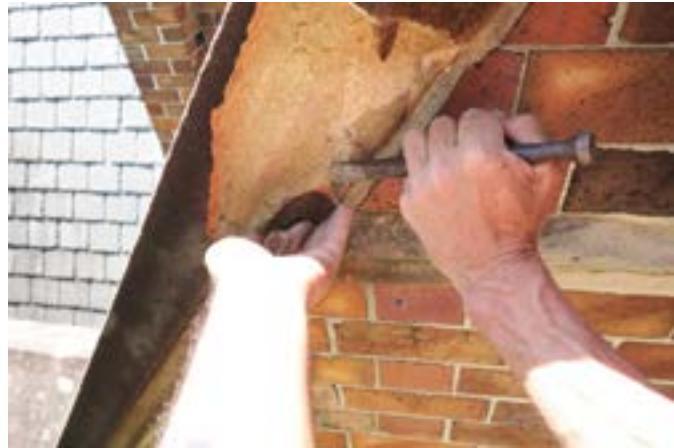
Figure 30 removal of loose stone

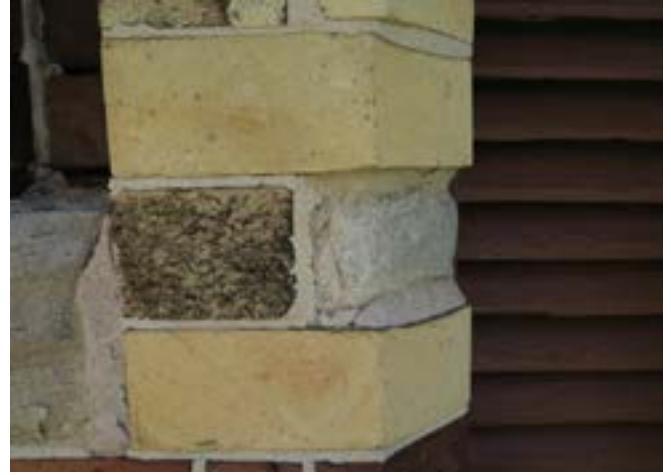
Figure 31 Evidence of defective brickwork to window reveallevel

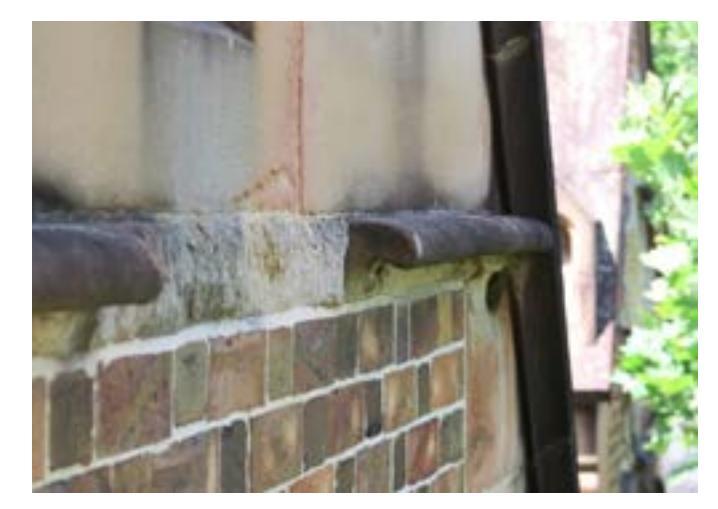
Figure 35 Typical loss of string course

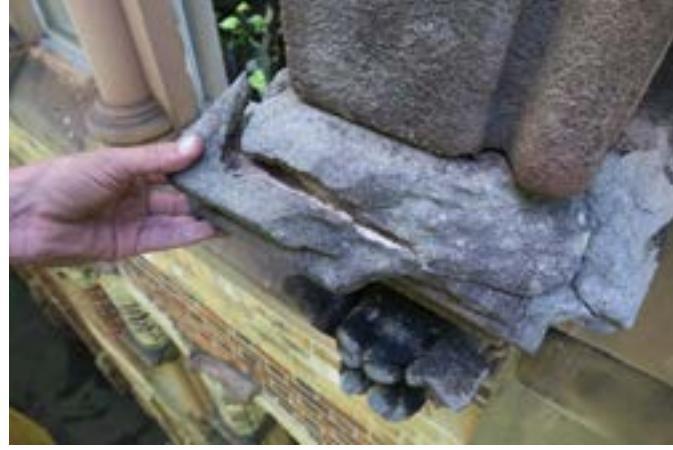
Figure 36 Failing mould detail and drip

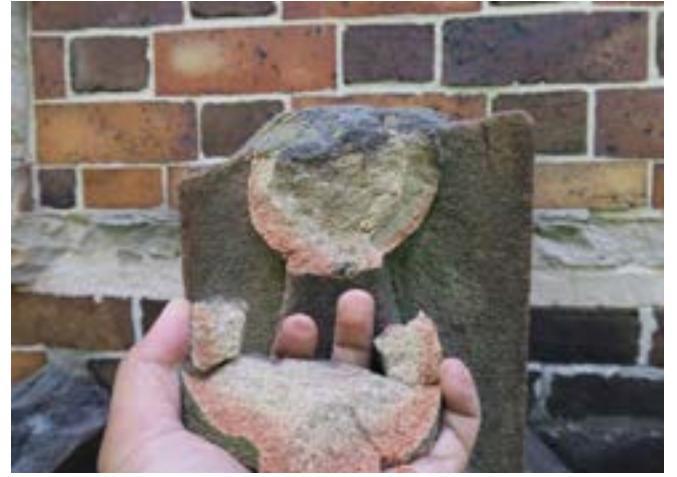
Figure 37 Removal of loose stone

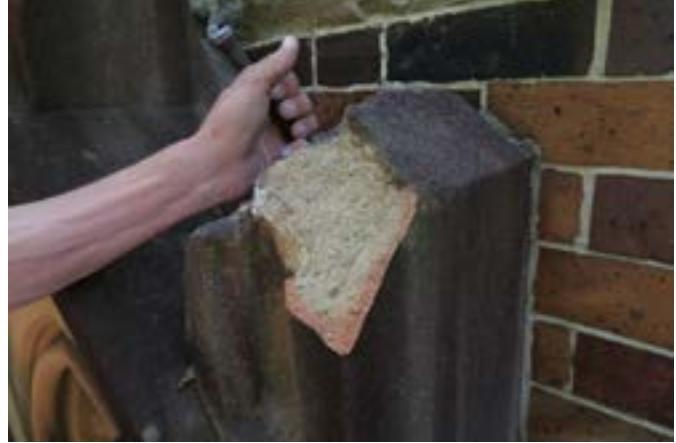
Figure 42 Removal of loose stone

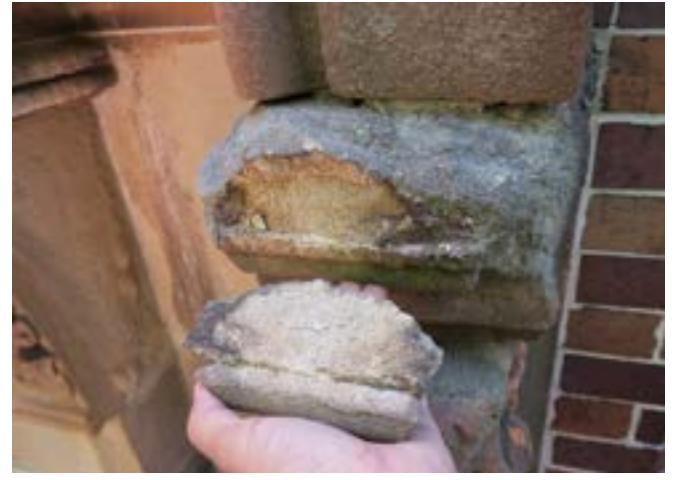
Figure 43 Removal of section of deteriorated stone

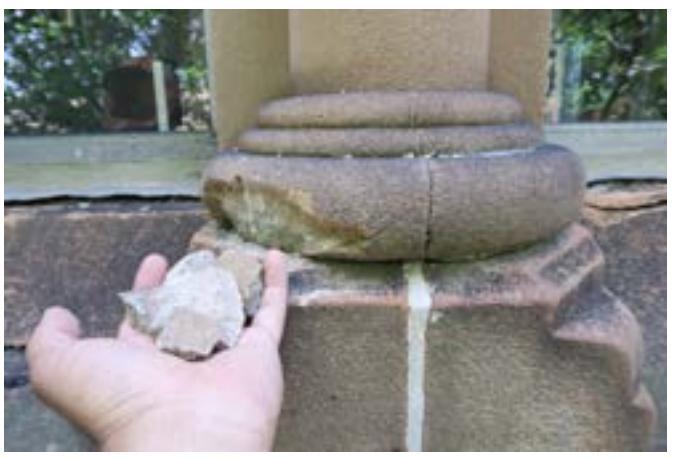
Figure 46 Cracking to base of window mullion

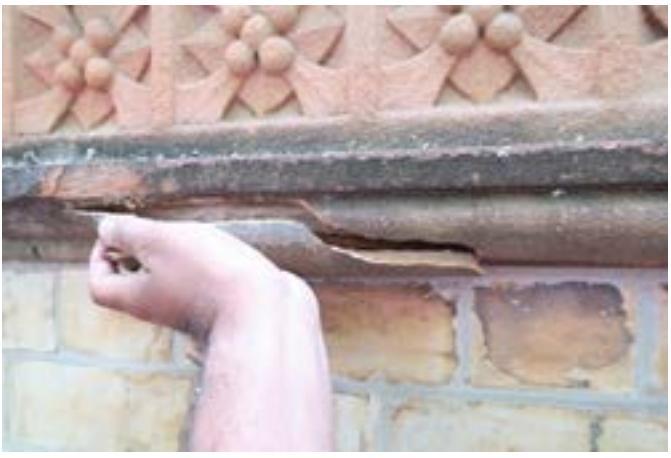
Figure 48 Removal of string course

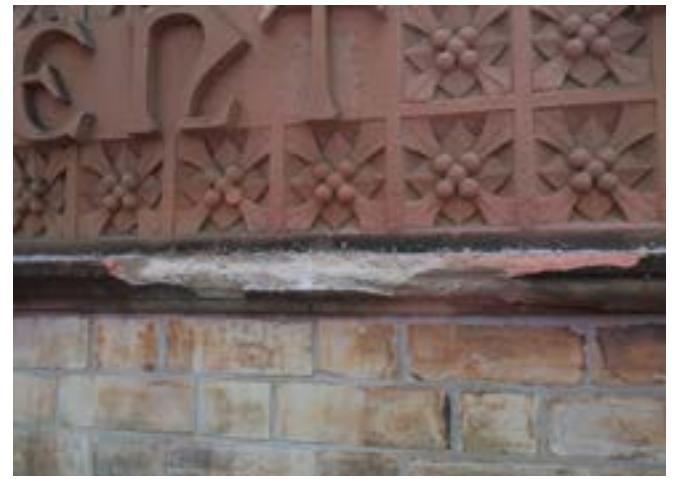
Figure 49 Removal of string course

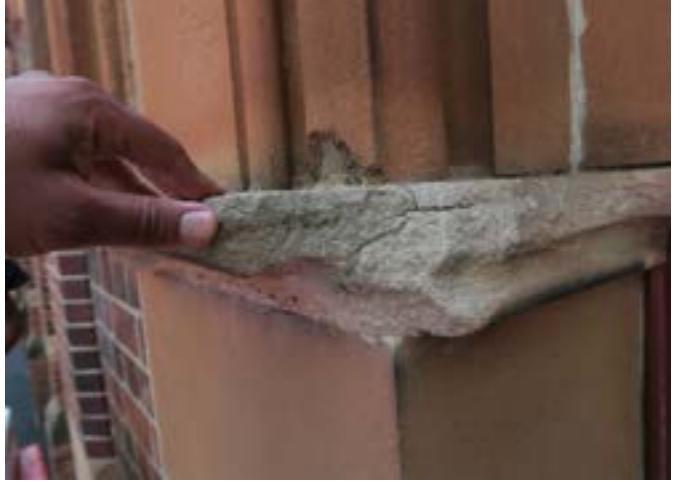
Figure 51 Removalof loose moulding

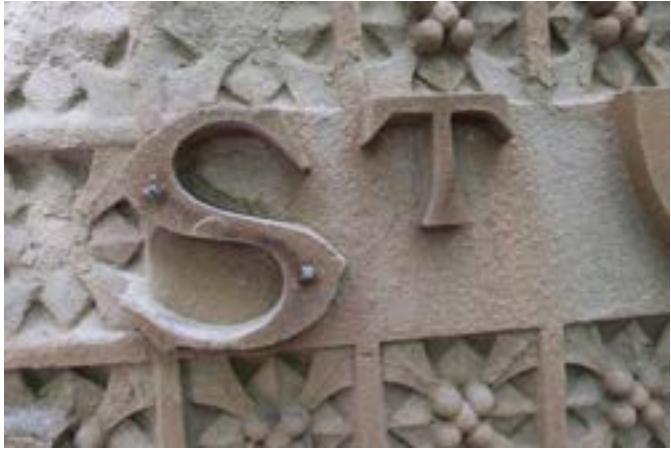
Figure 54 Temporary repairs to "S'

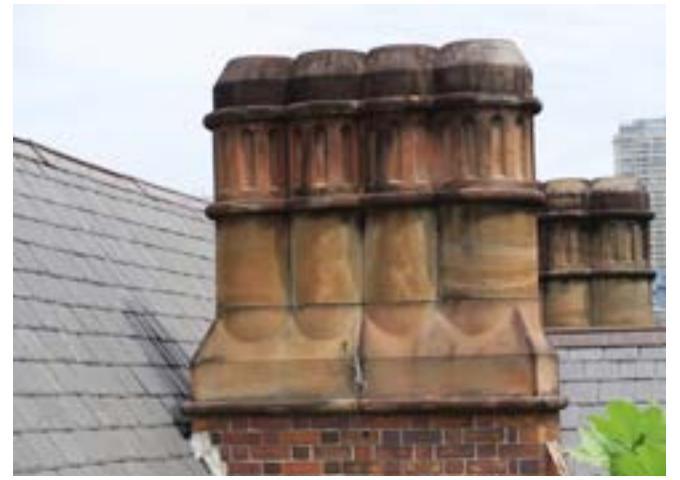
Figure 55 Photographic recording of chimneys

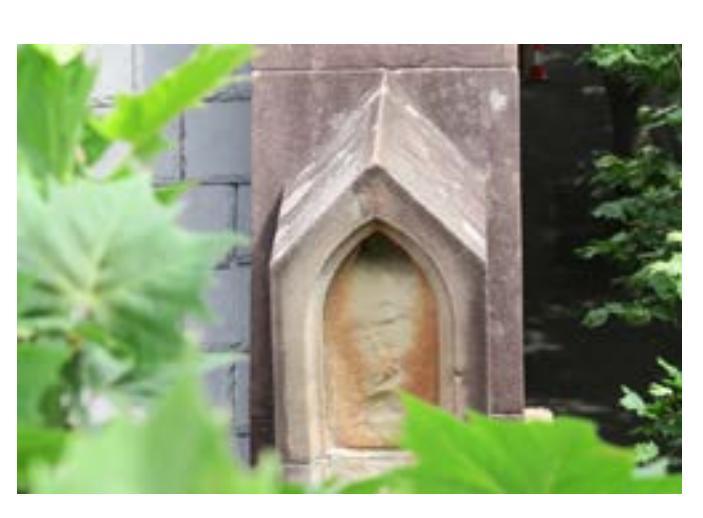
Figure 56 Wind erosion to stone springer

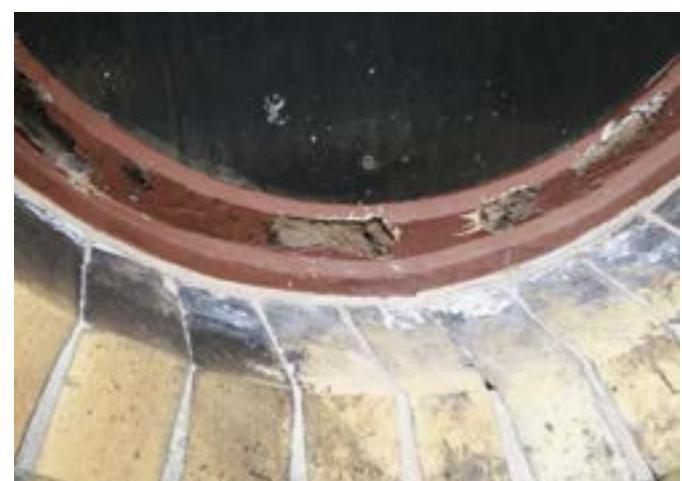
Figure 59 Typical decay to bottom edge of timber sill of Gable 3

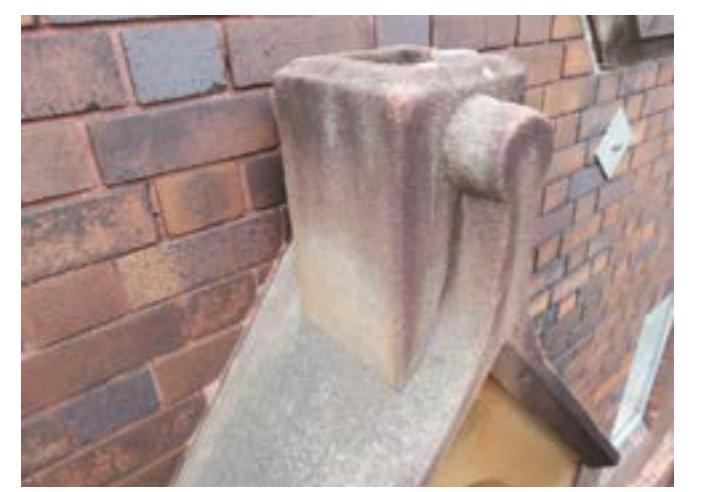
Figure 61 Finial Detail St Dominics Building

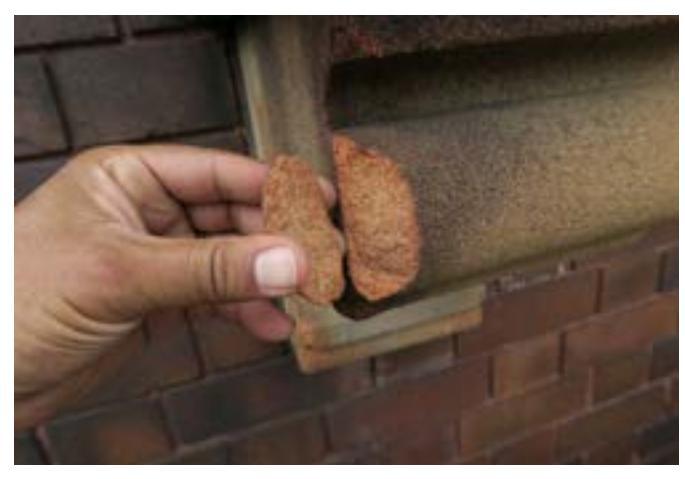
Figure 62 Loose stone removed

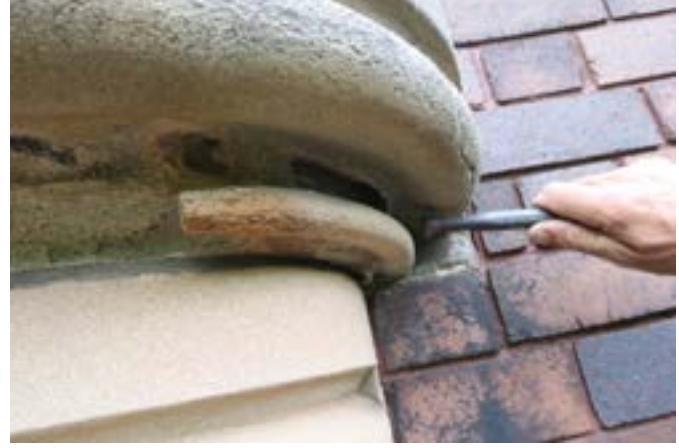
Figure 66 Decay, staining and deteriorated mould

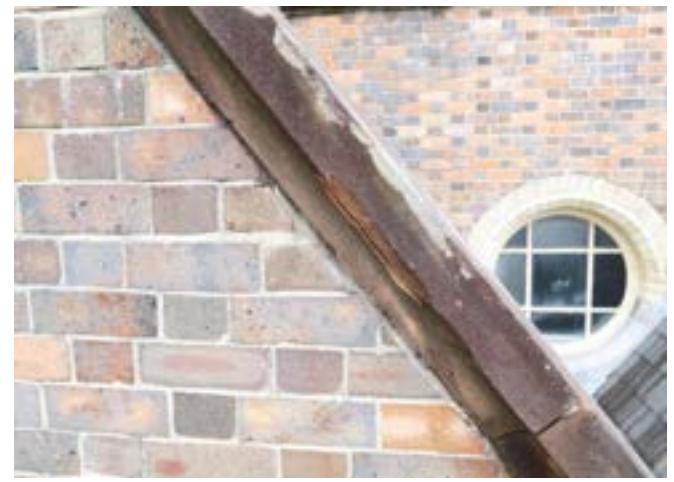
Figure 67 Gable 4 delaminating stone

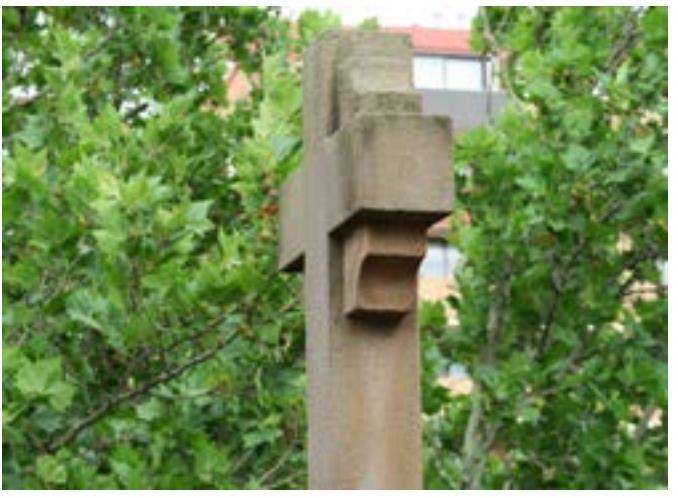
Figure 69 Final detail

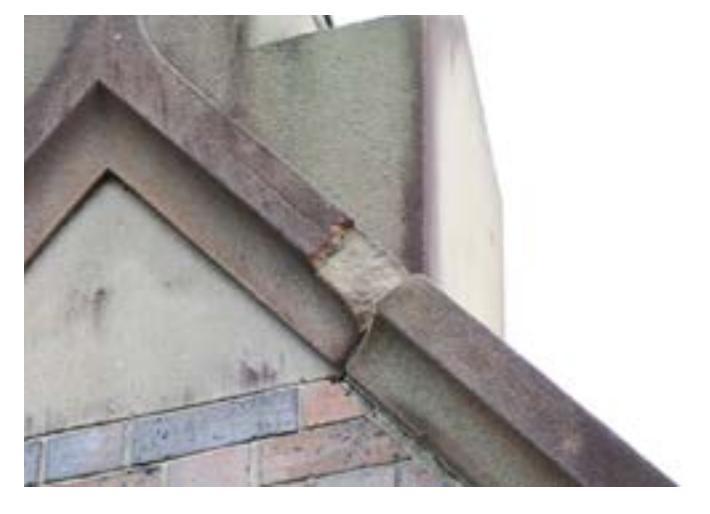
Figure 71 Remoaval of stone moulding

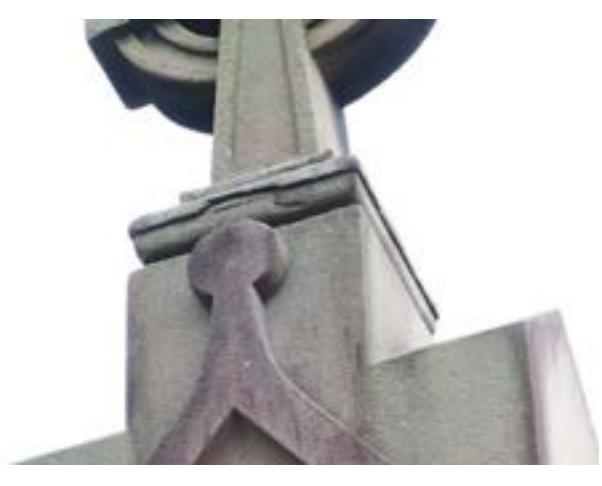
Figure 72 missing mould detail

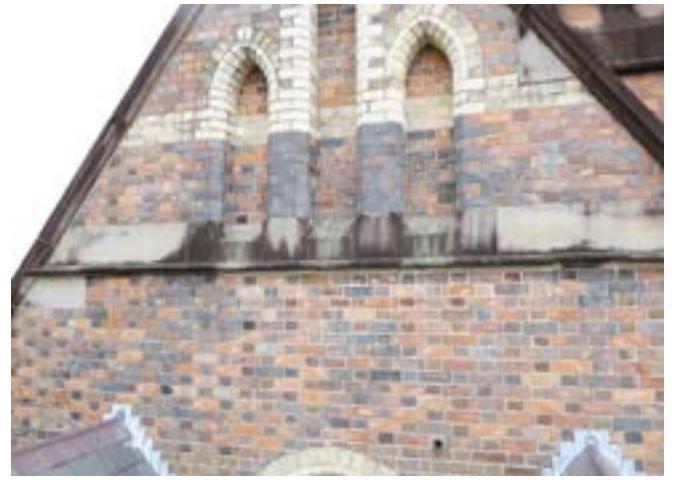
Figure 73 Gable 4 detail

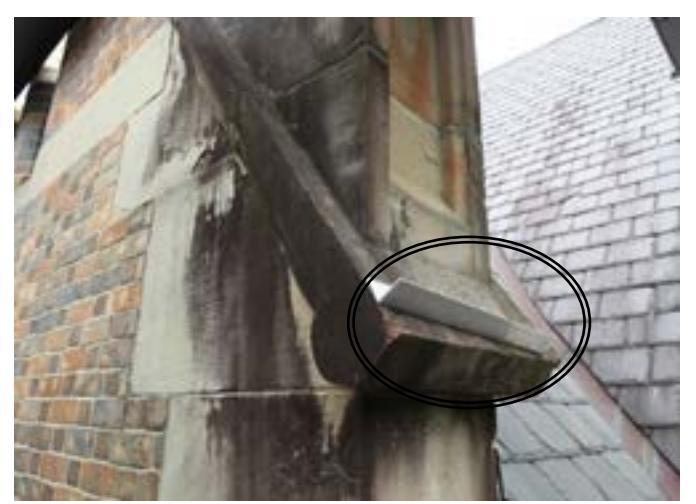
Figure 75 Inappropiate water runoff detail

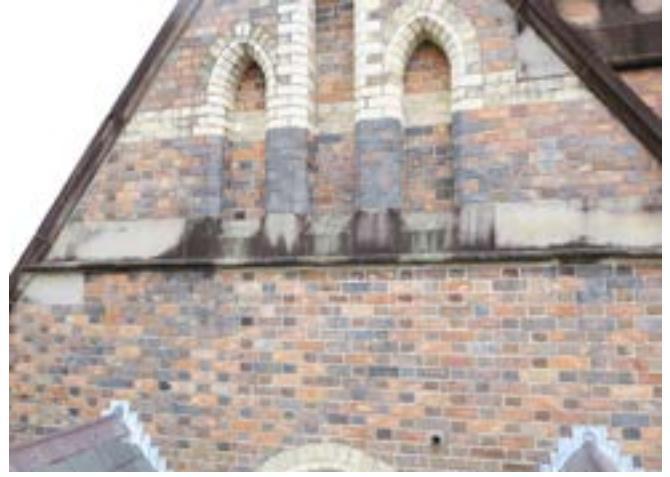
Figure 79

Gable 4 inspection as close as possible from machine access

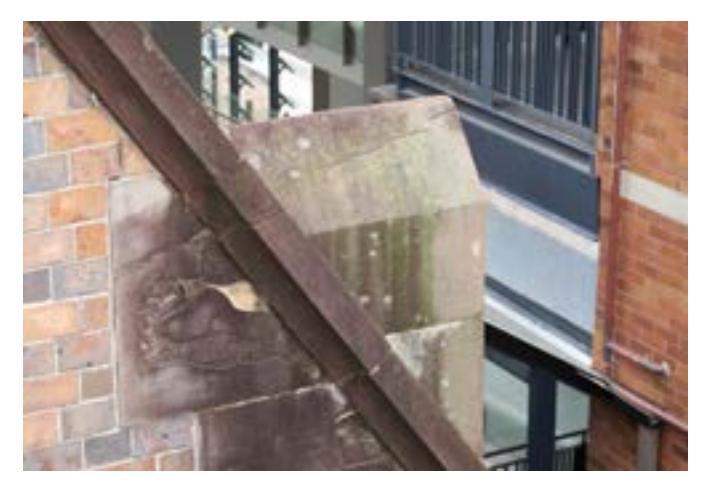
Figure 80 Drummy stone removed

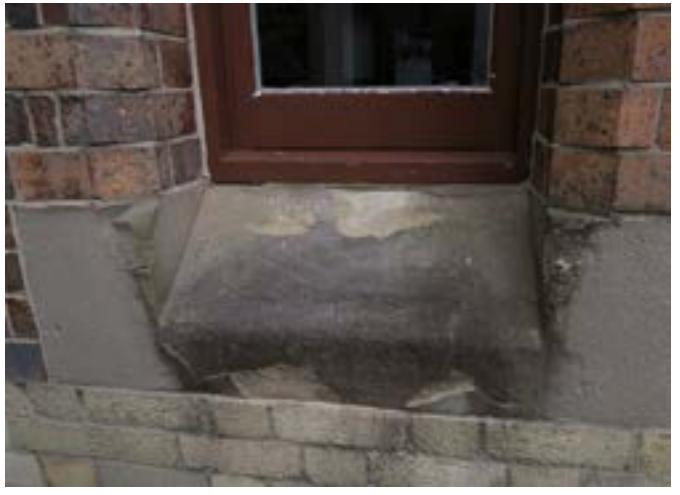
Figure 81 Drummy stone removed

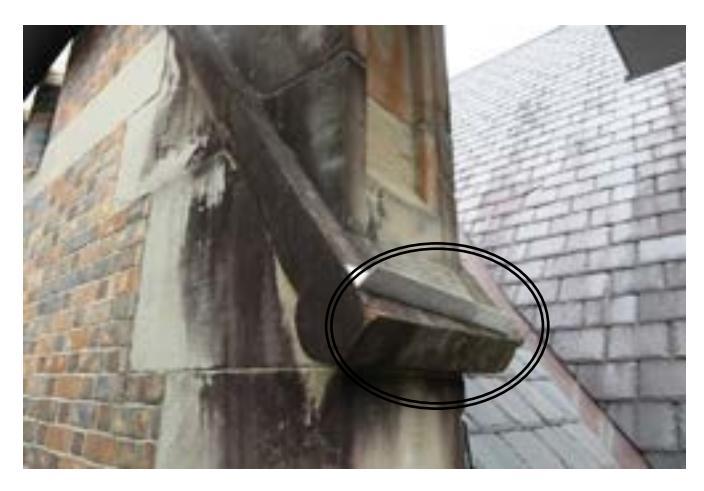
Figure 82 Not effective water shedding detail

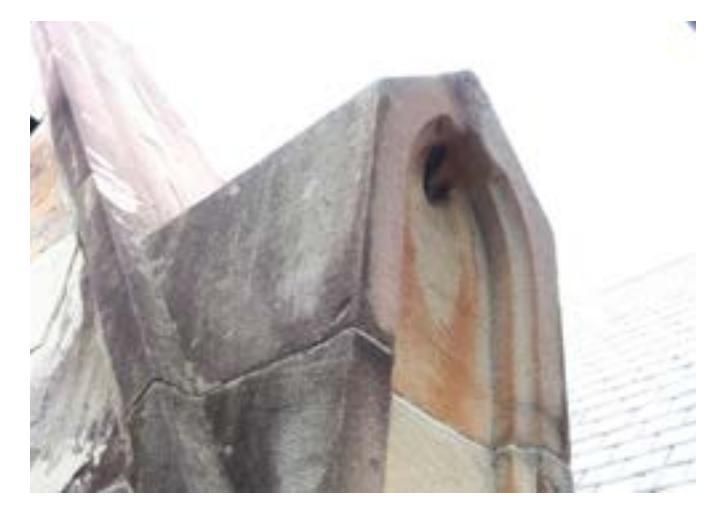
Figure 83 Typical wind erosion to springer stones

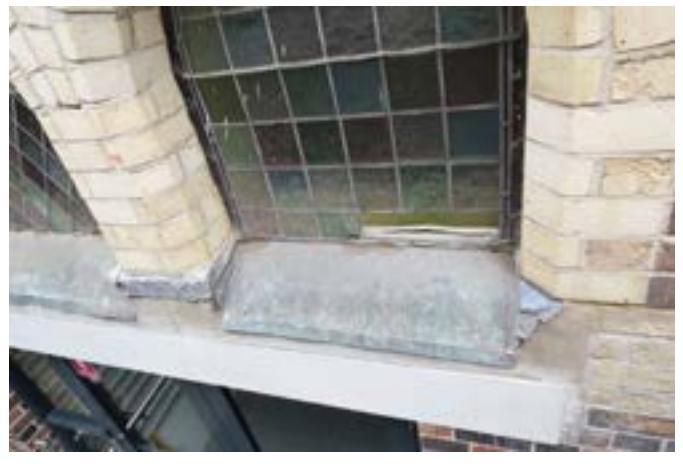
Figure 84 Inappropriate lead weathering detail

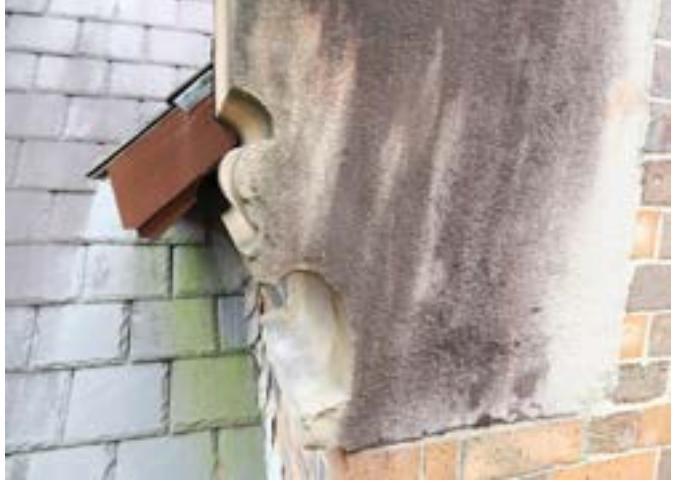
Figure 87 condition of springer

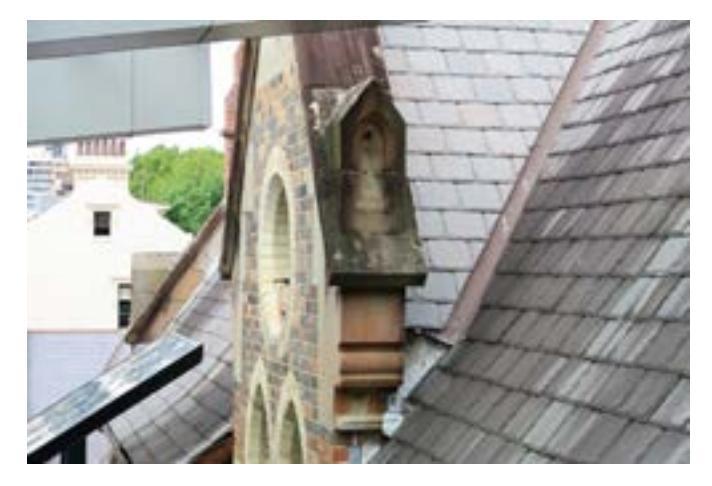
Figure 88 Open stone joints, biological growth

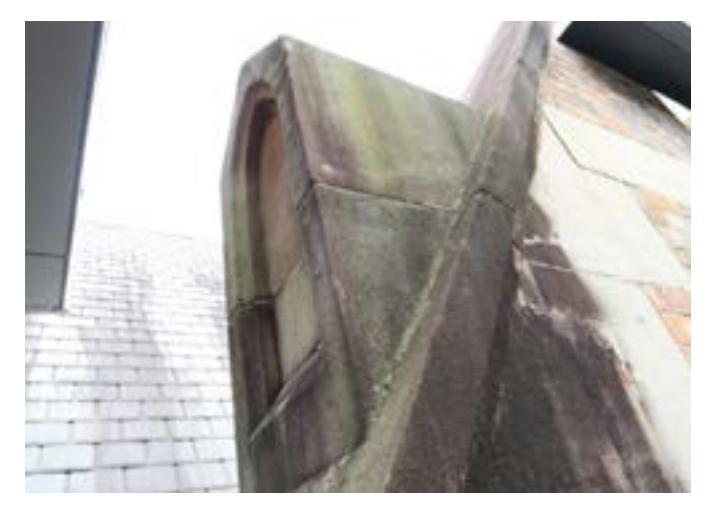
Figure 89 Open stone joints

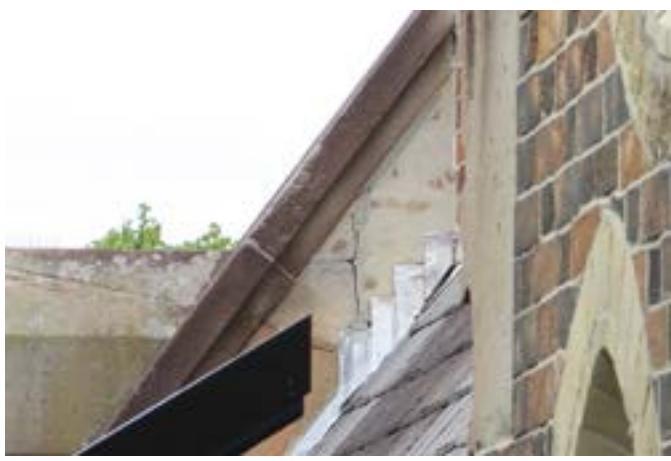
Figure 90 Carcking to back of gable and open joints
