ST VINCENT'S COLLEGE STONEWORK REPAIRS AND SEISMIC STRENGTHENING 2018

REVIEW OF ENVIRONMENTAL FACTORS

November 2018 Final Part 5 EP&A Act Environmental Impact Assessment Prepared for St Vincent's College

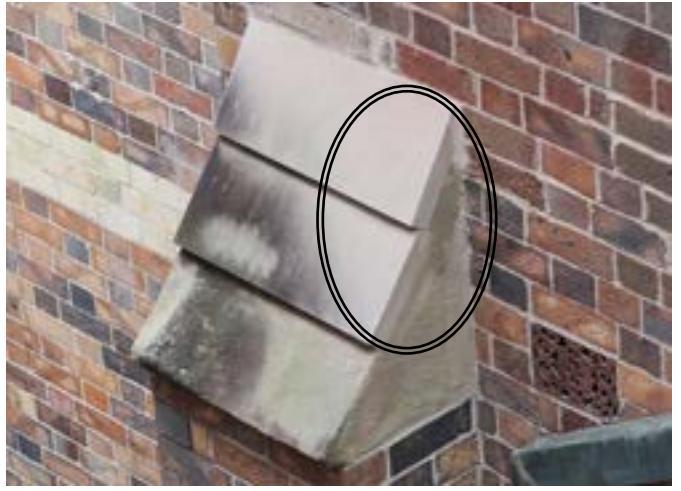
Figure 93 Previous stone repairs

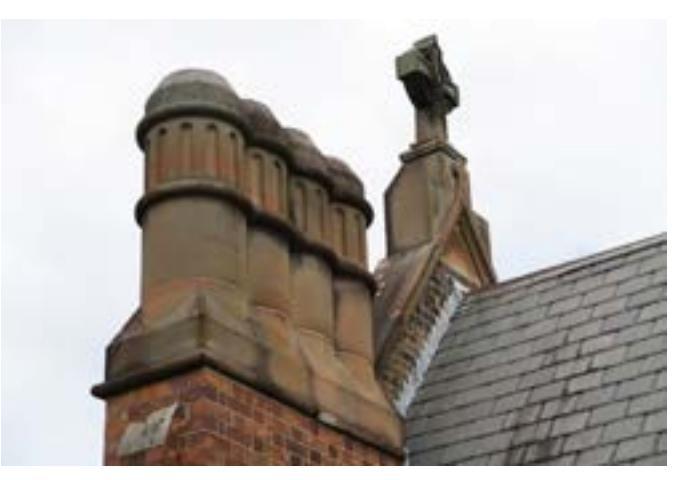
Figure 96 Chimney 3 detail

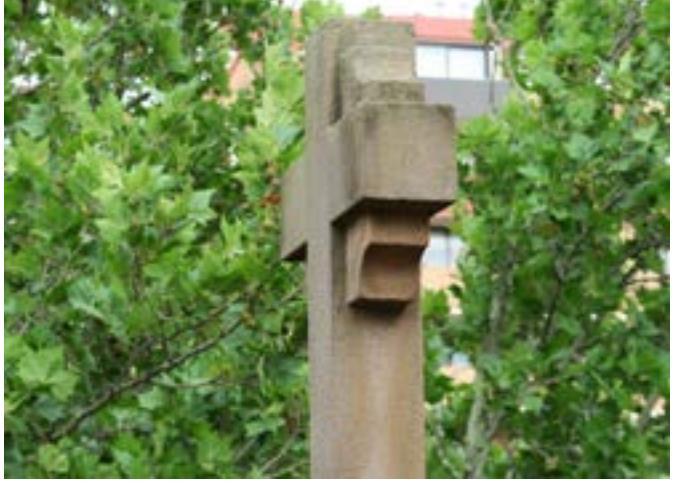
Figure 98 Evidence of cracking stonework

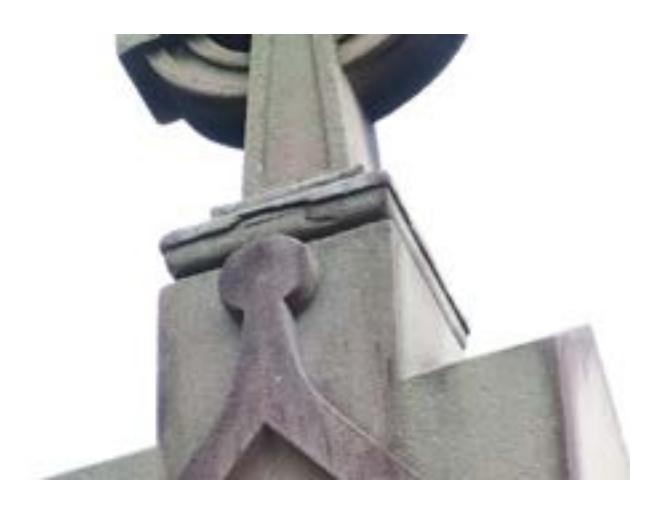
Figure 101 Typical cracking of moulding

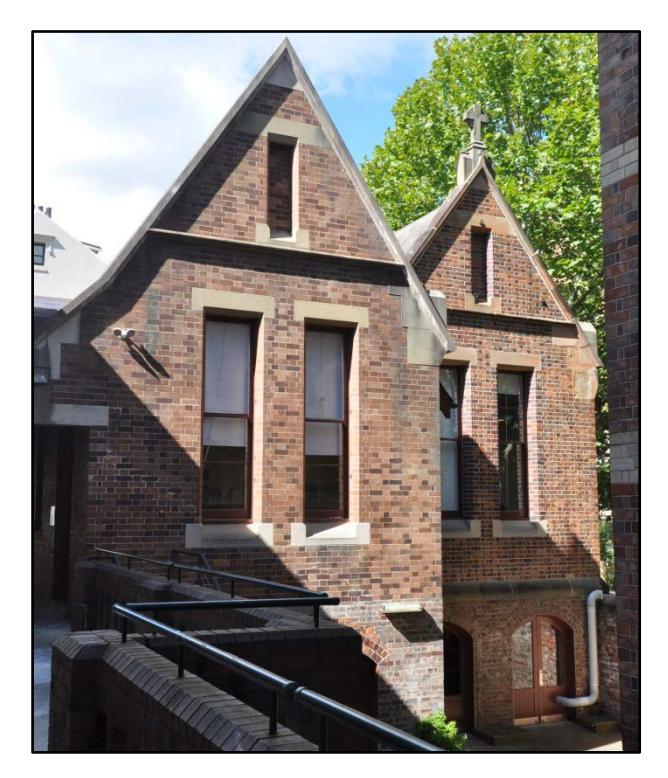
Figure 13. School Hall building, showing the 1950 addition to the left, and the original 1886 building to the right.

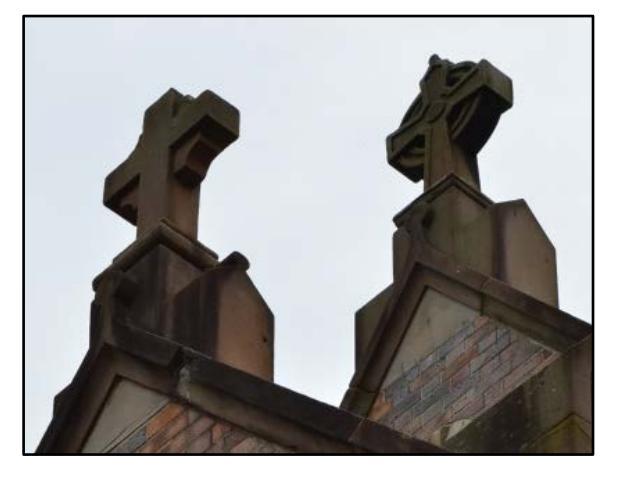
Figure 17. Cruciform finials on the main building southern gables.

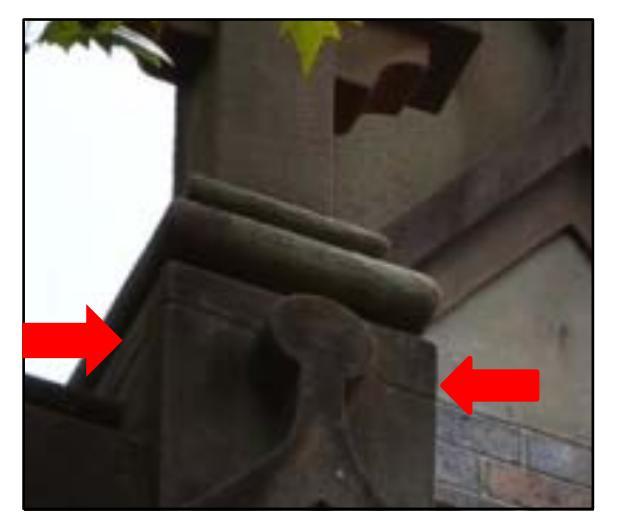
Figure 19. Cruciform finial on the main building southern gable, showing a crack along the sandstone base of the finial.

Element	Cruciform finials	
Location	Roof (gables) of main building and school hallBoundary wall	
Condition	Fair (staining) to very poor (Figure 19)	
Cause	 Staining due to rainwater with pollutants over time Early signs of failing (Figure 18) Crack on base of finial (Figure 19) 	
Heritage significance	High	
Conservation action	 Erect scaffold to complete inspection of all affected stones at close range. Use scaffold to invite tenderers to price the works and carry out the remediation as specified herein. Replace finial base (Figure 19) with new stone to match original profile. Preventative action: seismically brace the finials (bracing rod inserted from above through the finial anchoring it into the underlying stonework in accordance with structural engineer's detail). Follow up with a general cleaning of the façade using the Gommage or Heritage No.1 system and remove scaffold.

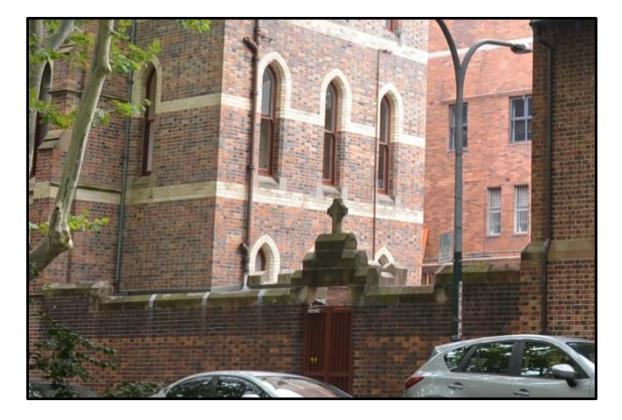
Figure 21. Cruciform finial on the boundary fence between the main school building and the school hall building.

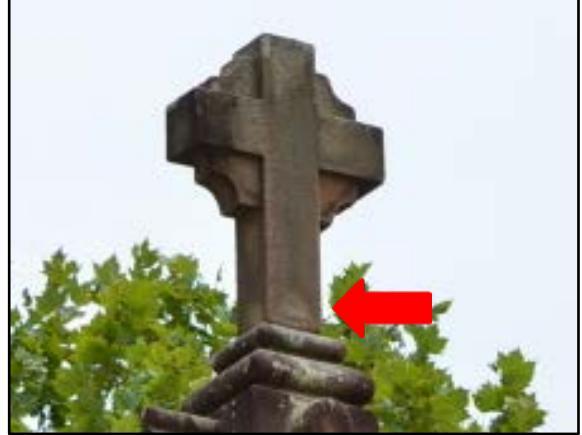
Figure 18. Cruciform finial on the school hall building roof (Early signs of failing at the base of the finial).

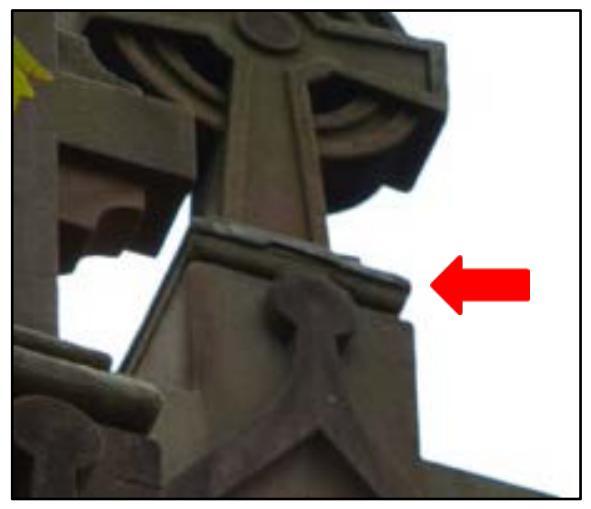
Figure 20. Cruciform finial on the main building southern gable, with delamination of the sandstone base of the finial.

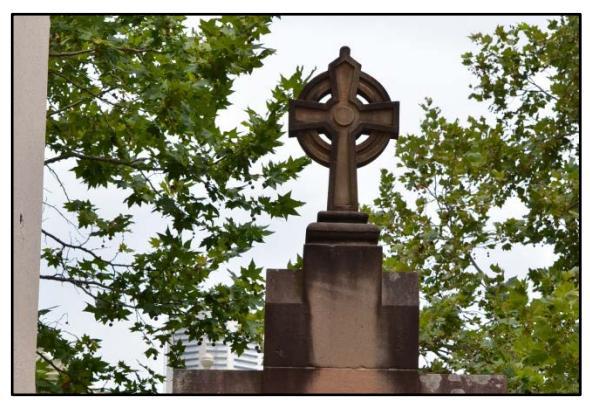
Figure 22. Cruciform finial on the boundary fence to the south of the school hall building.

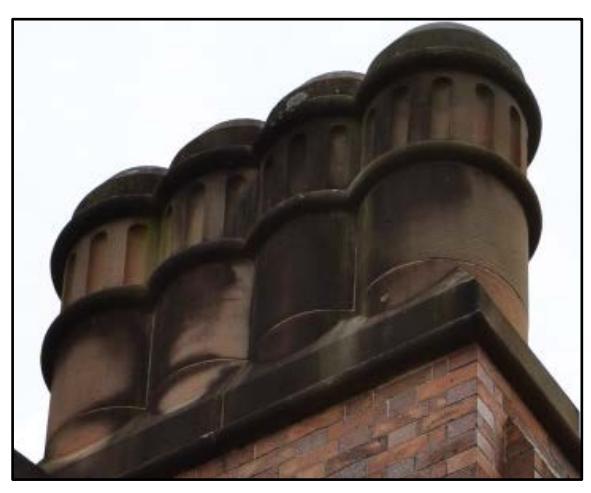
Figure 25. Chimney on the main building's southern end (Staining, lichen growth). A small carbonaceous occlusion can be seen on the bottom of the right chimney pot (does not weaken the stone).

Element	Chimneys	
Location	 Roof of main building Roof of school hall	
Condition	Fair (Staining, lichen growth)	
Cause	Staining due to rainwater with pollutants over timeLichen growth	
Heritage significance	High	
Conservation action	 Erect scaffold to complete inspection of all affected stones at close range. Use scaffold to invite tenderers to price the works and carry out the remediation as specified herein. Preventative action: seismically bracing the chimneys (bracing rod inserted from above through the chimney anchoring it into the underlying stonework in accordance with structural engineer's detail) Follow up with a general cleaning of the façade using the Gommage or Heritage No.1 system and remove scaffold.

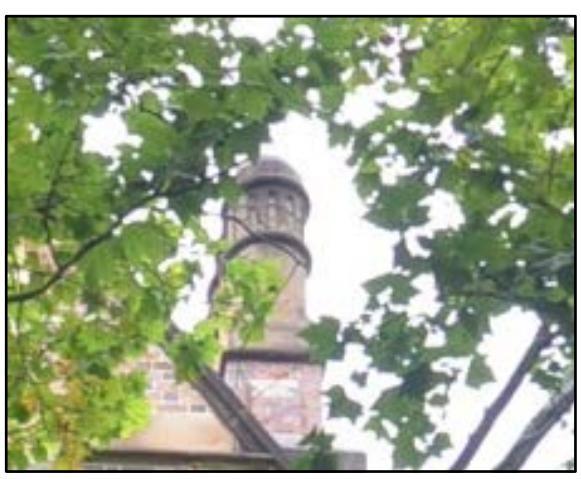
Figure 26. Chimney above the main building's western central gable (Staining).

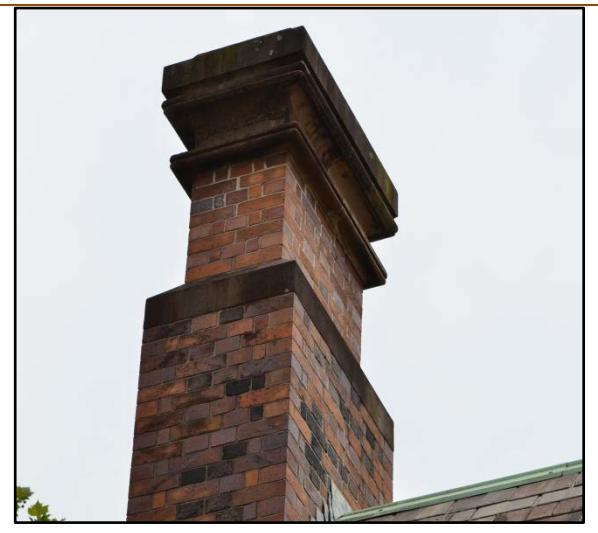
Figure 28. Chimney on the school hall's southern end (Staining, lichen growth).

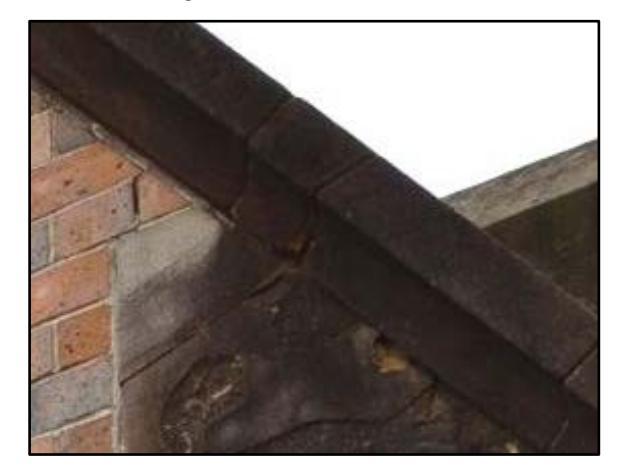
Figure 31. Gable barge on the main building southern gables (exfoliation).

Gable barge	
Gabled roofs of main building and school hall	
Very poor (Exfoliation)	
 Exfoliation due to cementitious/elastomeric mortar causing entrapment of moisture within the sandstone Improper repair of some sections in the past, with indenting of stone not obeying the original joints 	
High	
 Erect scaffold to complete inspection of all affected stones at close range. Use scaffold to invite tenderers to price the works and carry out the remediation as specified herein. Remove affected gable barge stones and indent with new stones to match original profiles. Repoint with appropriately specified mortar (1:2:9⁸). Follow up with a general cleaning of the façade using the Gommage or Heritage No.1 system and remove scaffold.

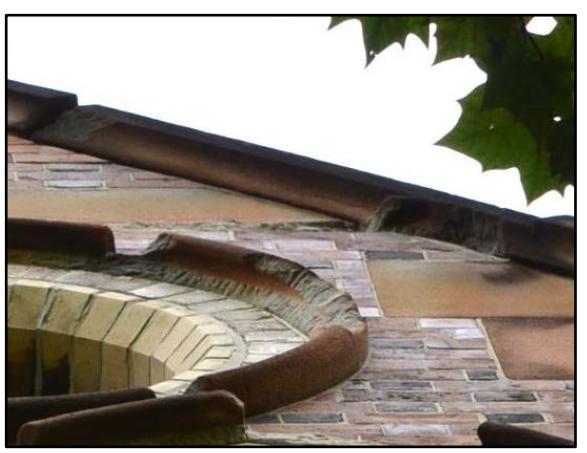
Figure 32. Gable barge on the main building western central gable (exfoliation).

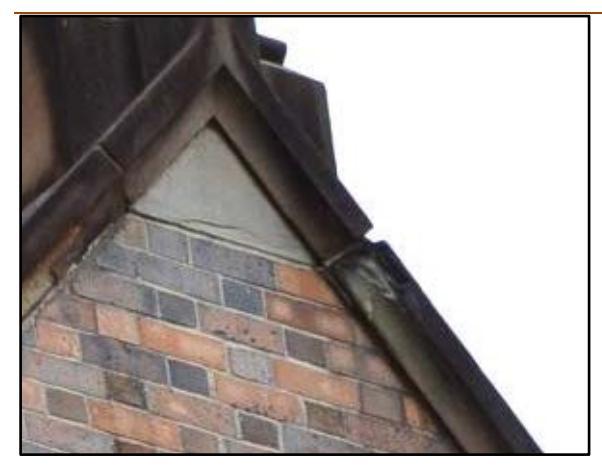
Figure 33. Gable barge on the main building southern façade (exfoliation).

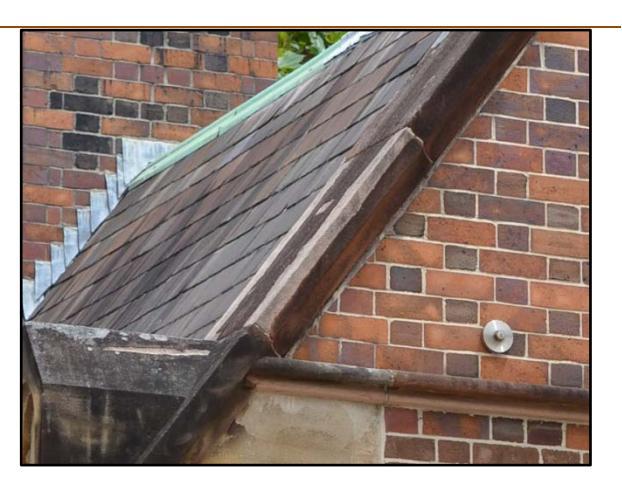
Figure 34. Gable barge on the school hall eastern façade, with evidence of previous repairs (Improperly repaired).

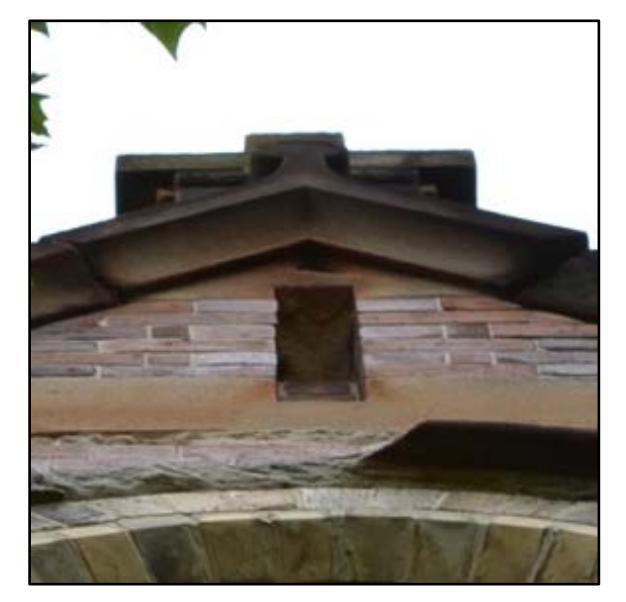
Figure 35. Tympanum of gable face on the projecting part of the most southern gable of the main building (Advanced efflorescence).

Page | 19 of 53 RAPPOPORT PTY LTD
Element	Tympanum stone
Location	Gables of the main building and the school hall.
Condition	Fair to very poor (Exfoliation)
Cause	 Advanced efflorescence due to cementitious/elastomeric mortar causing entrapment of moisture within the sandstone Exfoliation due to failing flashing (Figure 37)
Heritage significance	High
Conservation action	 Erect scaffold to complete inspection of all affected stones at close range. Use scaffold to invite tenderers to price the works and carry out the remediation as specified herein. Remove affected tympanum stones of the gable faces and indent with new stones to match original profiles. Remove failing flashing (Figure 37, back of Victoria Street gable of the school hall) and flash with electrolytically compatible metals. Repoint with appropriately specified mortar (1:2:9⁹). Follow up with a general cleaning of the façade using the Gommage or Heritage No.1 system and remove scaffold.

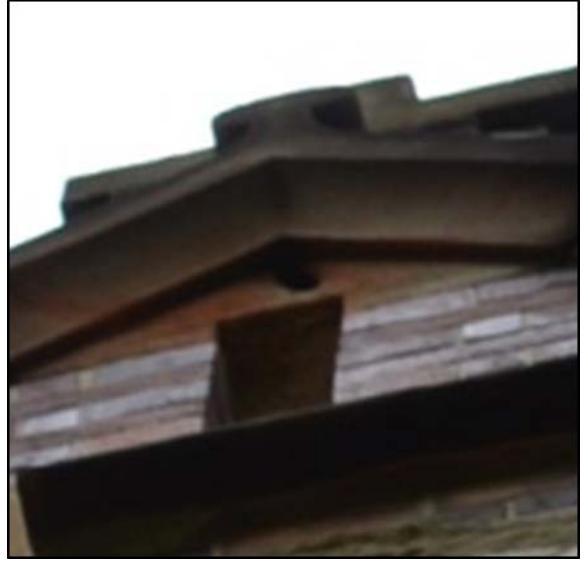
Figure 36. Tympanum of gable face on the projecting part of the most northern gable of the main building (Advanced efflorescence).

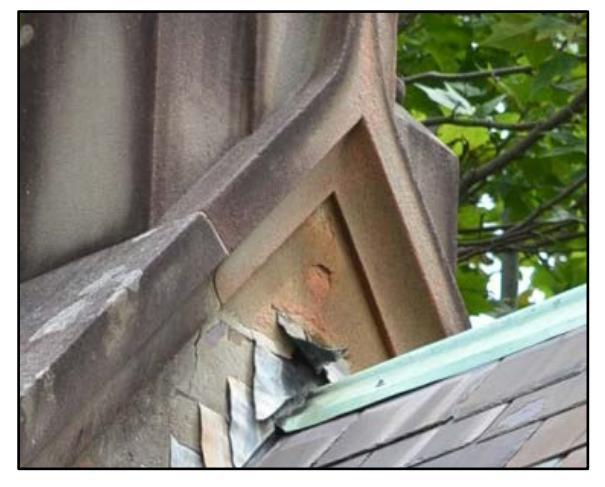
Figure 37. Top stone on the back of the school hall's Victoria Street gable (Exfoliation).

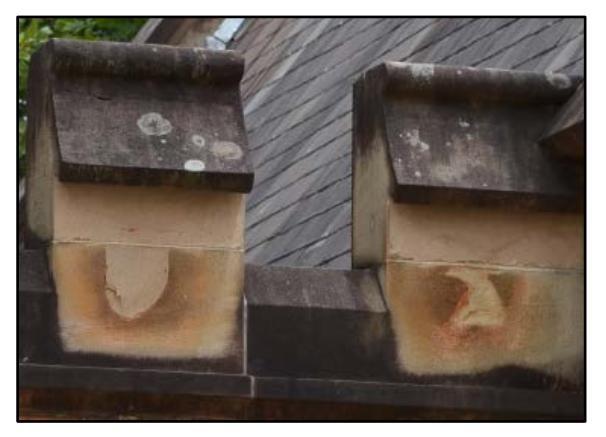
Figure 38. Capping on the eastern façade of the school hall (Delamination causing unstable stone).

Element	Capping
Location	Boundary wall
Condition	Poor (staining, lichen growth, vegetation growth, hairline cracking, delamination, improperly repaired)
Cause	 Staining due to rainwater with pollutants over time Lichen growth Vegetation growth due to moisture issues and the location of the electrical duct Hairline cracking due to cementitious/elastomeric mortar Delamination due to cementitious/elastomeric mortar Improper repair of some sections in the past, with indenting of stone not obeying the original joints
Heritage significance	High
Conservation action	 Erect scaffold to complete inspection of all affected stones at close range. Use scaffold to invite tenderers to price the works and carry out the remediation as specified herein. Remove vegetation. Relocate electricity duct away from the building or if redundant, remove entirely. Remove affected capping and replace with new stones to match original stones. Repoint with appropriately specified mortar (1:2:9¹⁰). Follow up with a general cleaning of the façade using the Gommage or Heritage No.1 system and remove scaffold.

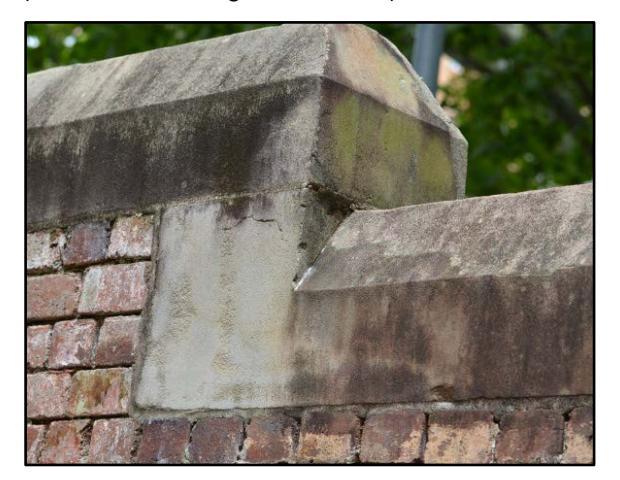
Figure 40. Detail of capping on the boundary wall between the main building and the school hall (Staining, hairline cracking, and cement application at later date).

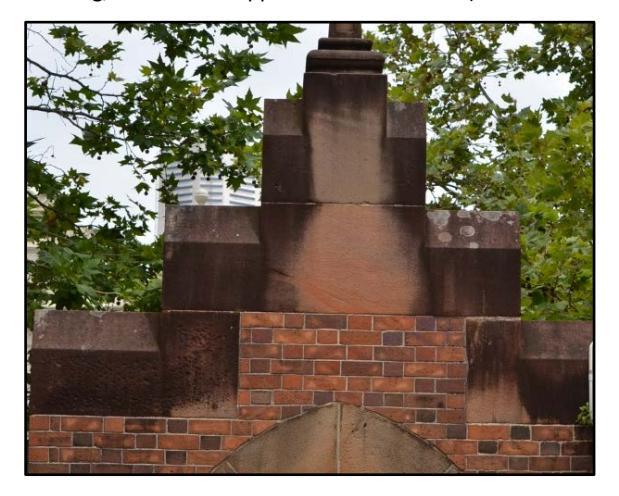
Figure 42. Capping on the boundary wall to the south of the school hall (eastern façade) (Staining, lichen growth, vegetation growth).

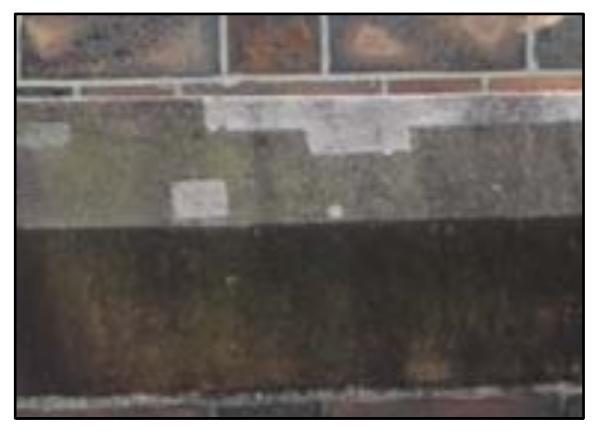
Figure 39. Capping on the boundary wall between the main building and the school hall (Improperly repaired).

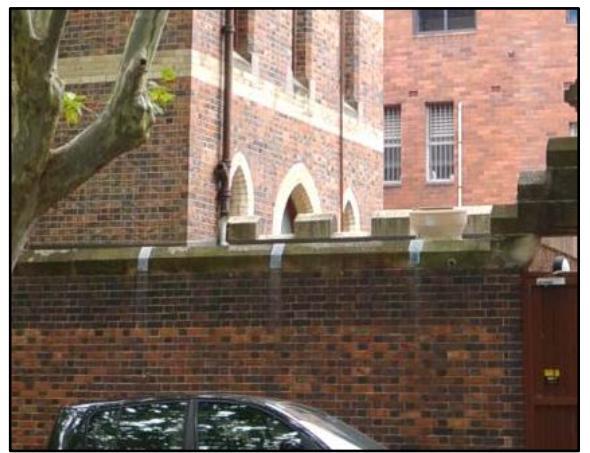
Figure 41. Capping on the boundary wall between the main building and the school hall (Cramps have been added at a later date).

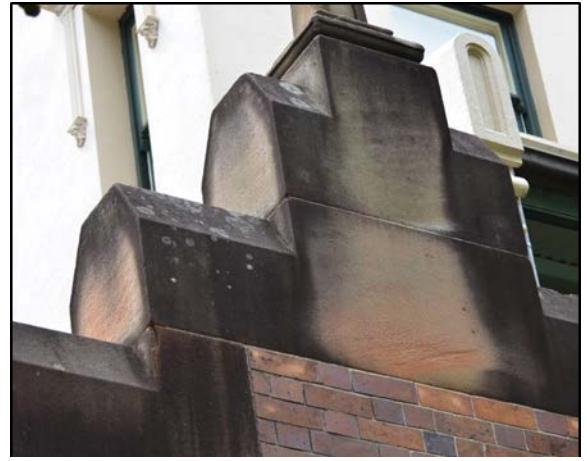
Figure 43. Capping on the boundary wall to the south of the school hall (western façade) (staining, lichen growth, hairline cracking).

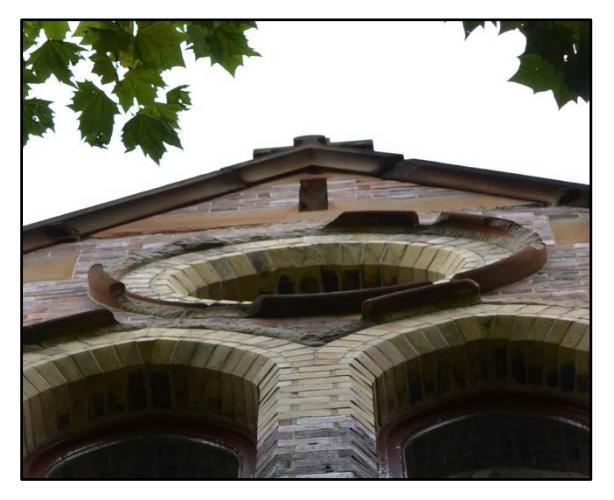
Figure 47. Label moulds around centrally located *oeil de boeuf* window on the main building's most southern gable/right gable (western façade) (Delamination/case hardening and removal of the label mould).

Element	Label moulds
Location	Around all triple gothic windows on the western façade (Victoria Street) of the main school building
Condition	Poor (delamination/case hardening, removal of the label mould)
Cause	 Delamination/case hardening due to cementitious/elastomeric mortar causing entrapment of moisture Removal of the label mould in the past under a make-safe program
Heritage significance	High
Conservation action	 Erect scaffold to complete inspection of all affected stones at close range. Use scaffold to invite tenderers to price the works and carry out the remediation as specified herein. Remove affected label mould stones and indent. Where previously removed, indent to match original profile. Repoint with appropriately specified mortar (1:2:9¹¹). Follow up with a general cleaning of the façade using the Gommage or Heritage No.1 system and remove scaffold.

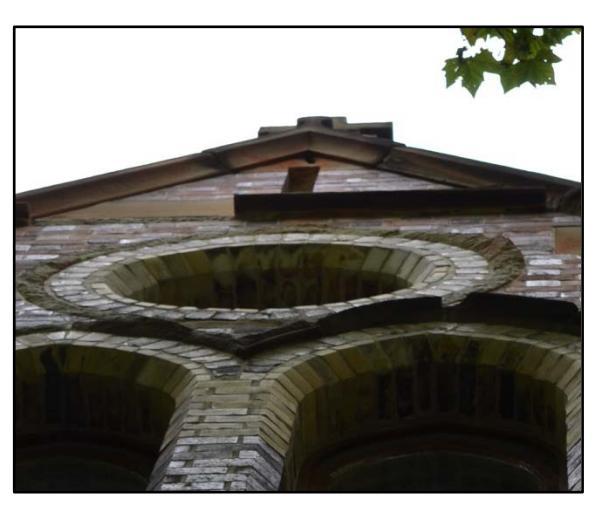
Figure 48. Label moulds around centrally located *oeil de boeuf* window on the main building's most northern gable/left gable (western façade) (Delamination/case hardening and removal of the label mould).

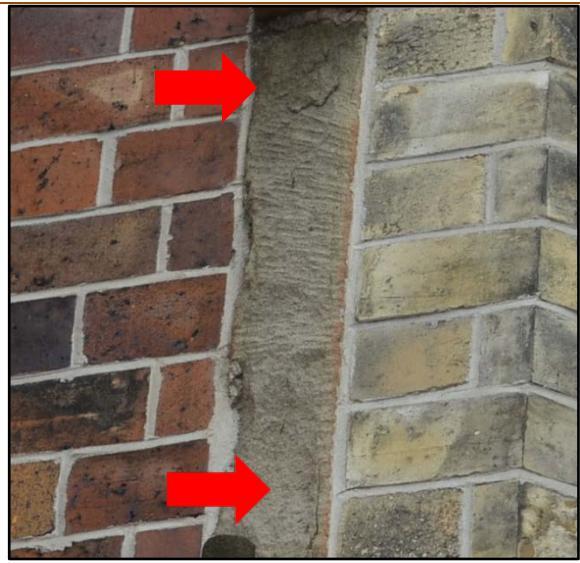
Figure 50. Detail of one of the label moulds, which –even though the section has been removed in the past, it continues to degrade as a result of the cementitious/ elastomeric mortar in the joints.

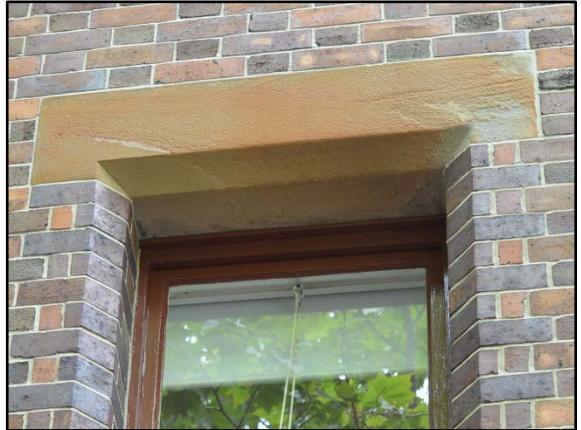
Figure 52. Lintel on western façade (Victoria Street) of the school hall building (Exfoliation).

Element	Lintels
Location	Above windowsAbove doors
Condition	Fair (Exfoliation)
Cause	Exfoliation due to cementitious/elastomeric mortar causing entrapment of moisture
Heritage significance	High
Conservation action	 Erect scaffold to complete inspection of all affected stones at close range. Use scaffold to invite tenderers to price the works and carry out the remediation as specified herein. Indent affected stones ('Voussoir indent') to match original profiles. ¹² Repoint with appropriately specified mortar (1:2:9¹³). Follow up with a general cleaning of the façade using the Gommage or Heritage No.1 system and remove scaffold.

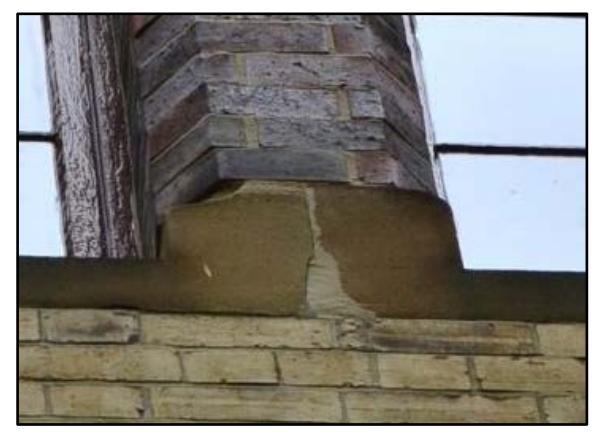
Figure 55. Sills on the western façade of the main building (Cementitious/elastomeric mortar used to fill up gap).

Element	Sills
Location	Windows of main school building and school hall.
Condition	Fair (Staining, lichen growth, exfoliation)
Cause	 Staining due to rainwater with pollutants over time Lichen growth Exfoliation due to cementitious/elastomeric mortar causing entrapment of moisture
Heritage significance	High
Conservation action	 Erect scaffold to complete inspection of all affected stones at close range. Use scaffold to invite tenderers to price the works and carry out the remediation as specified herein. Indent affected stones ('Inverted voussoir indent') to match original profiles.¹⁴ Repoint with appropriately specified mortar (1:2:9¹⁵). Follow up with a general cleaning of the façade using the Gommage or Heritage No.1 system and remove scaffold.

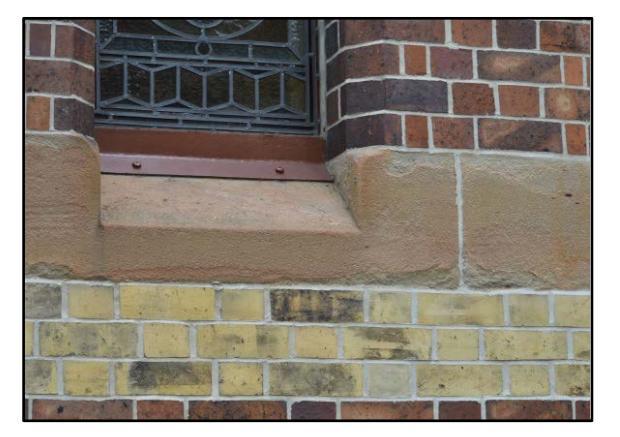
Figure 57. Sill on the western façade of the main building (Exfoliation).

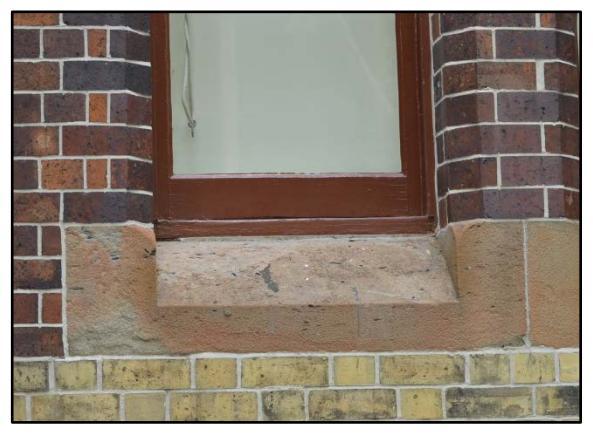
Figure 56. Sills on the western façade of the main building (Carbonaceous material).

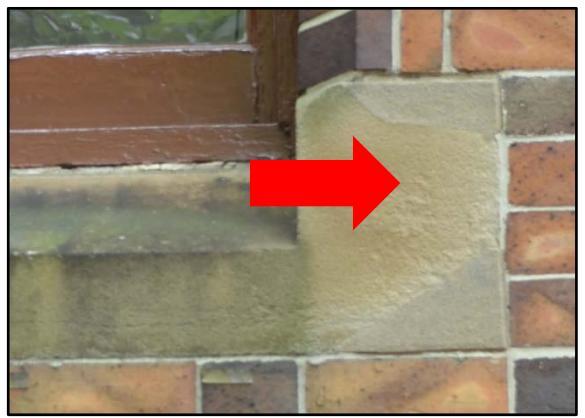
Figure 58. Sill on the western façade of the school hall (Exfoliation). The red arrow shows where the cementitious/elastomeric mortar has caused moisture entrapment which has caused exfoliation of the stone.

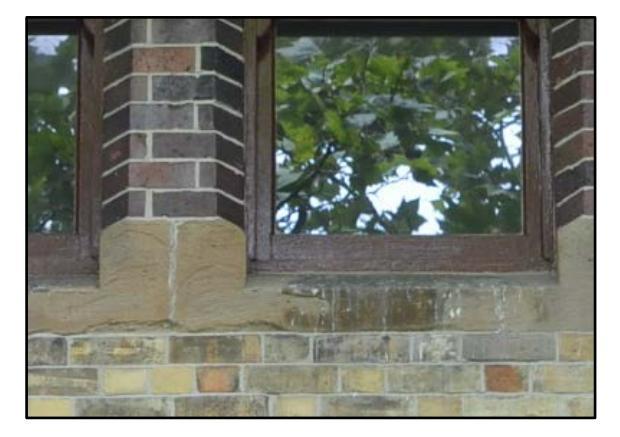
Figure 59. Sills on the western façade of the main building (Exfoliation).

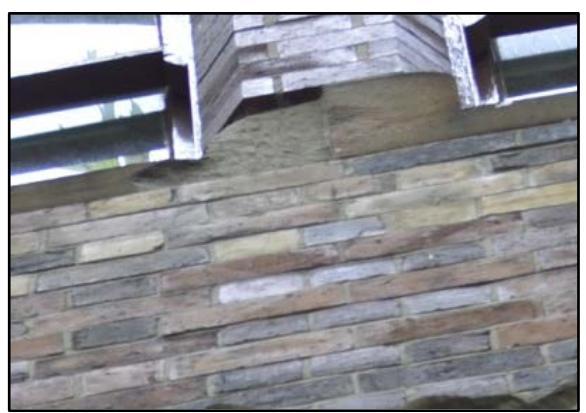
Figure 60. Sills on the western façade of the main building (Delamination, case hardening).

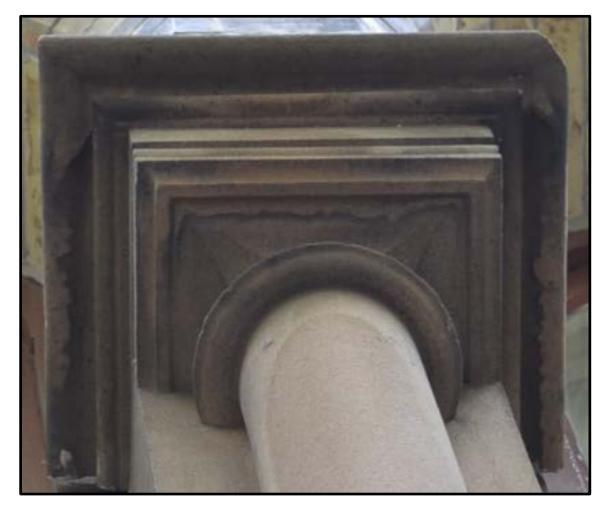
Figure 63. Detail of column capital (Staining, corner cracked off)

Element	Columns
Location	Between central windows on the western façade (Victoria Street) of the main school building.
Condition	Fair (Staining, corner of capital cracked off)
Cause	Staining due to rainwater with pollutants over time.Corner of capital cracked off due to delamination
Heritage significance	High
Conservation action	 Erect scaffold to complete inspection of all affected stones at close range. Use scaffold to invite tenderers to price the works and carry out the remediation as specified herein.¹⁶ Remove affected capital stones and replace with new stones to match original profiles. Follow up with a general cleaning of the façade using the Gommage or Heritage No.1 system and remove scaffold.

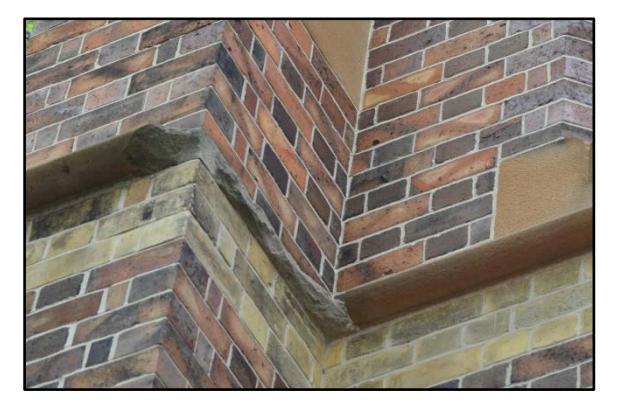
Figure 64. String course on the western façade of the main building (Delamination/case hardening).

Element	String course
Location	 Western façade (Victoria Street) of the main school building Eastern façade of the school hall (1886 part of the L-shaped building, perpendicular to Victoria Street)
Condition	Poor (delamination/case hardening, removal of the string course)
Cause	 Delamination/case hardening due to cementitious/elastomeric mortar causing entrapment of moisture Removal of the string course in the past under a make-safe program
Heritage significance	High
Conservation action	 Erect scaffold to complete inspection of all affected stones at close range. Use scaffold to invite tenderers to price the works and carry out the remediation as specified herein. Remove affected string course stones and indent. Where previously removed, indent to match original profile. Repoint with appropriately specified mortar (1:2:9¹⁷). Follow up with a general cleaning of the façade using the Gommage or Heritage No.1 system and remove scaffold.

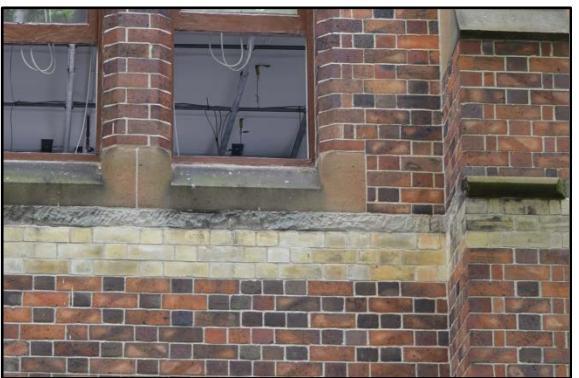
Figure 65. String course on the western façade of the main building (Removal of the string course).

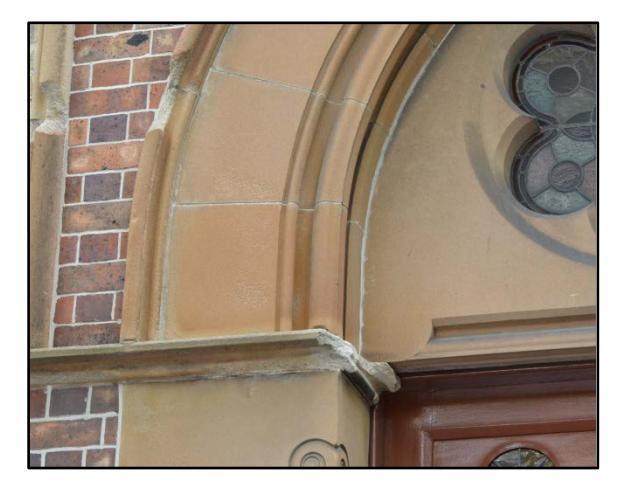
Figure 66. Label moulds around central entry door to the main building (Delamination/case hardening).

Element	Label moulds
Location	 Around the central entry door to the main school building (Victoria Street) Around the entry door located within the boundary wall section to the south of the school hall
Condition	Fair (staining, delamination)
Cause	 Staining due to rainwater with pollutants over time. Delamination/case hardening due to cementitious/elastomeric mortar causing entrapment of moisture
Heritage significance	High
Conservation action	 Erect scaffold to complete inspection of all affected stones at close range. Use scaffold to invite tenderers to price the works and carry out the remediation as specified herein. Remove affected label mould stones and indent with new stones to match original profiles. Repoint with appropriately specified mortar (1:2:9¹⁸). Follow up with a general cleaning of the façade using the Gommage or Heritage No.1 system and remove scaffold.

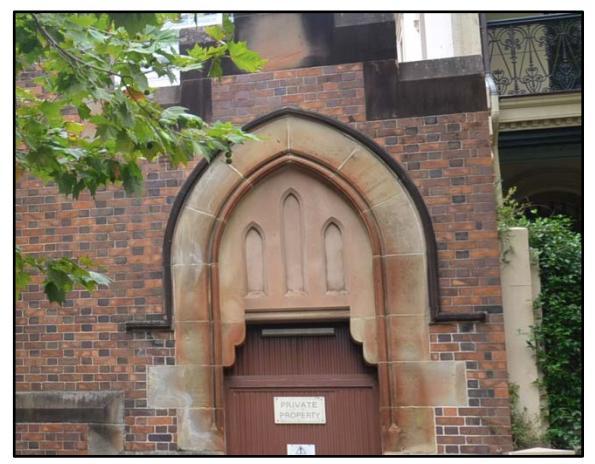
Figure 67. Label moulds around entry in boundary wall section to the south of the school hall (Staining).

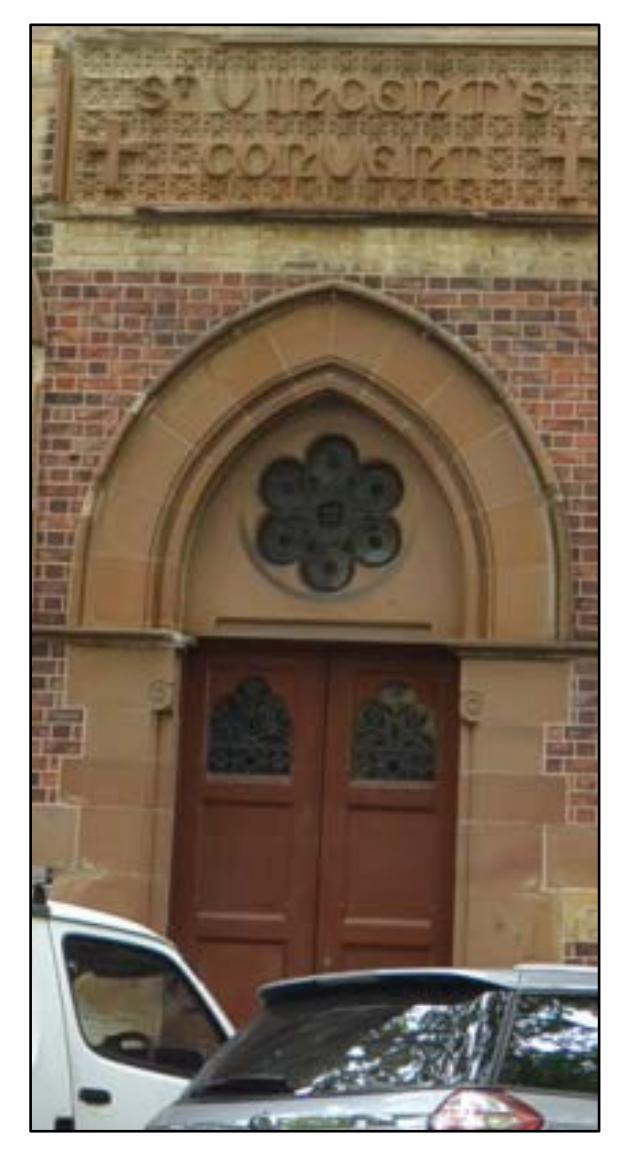
Figure 68. Arch above main building central entry door. The fielded panel above this door includes a six-lobed foil glazed oculus.

Element	Voussoirs/arch and fielded panels
Location	 Above the central entry door to the main school building (Victoria Street) Above the entry door located within the boundary wall section to the south of the school hall
Condition	Fair (efflorescence)
Cause	Efflorescence due to cementitious/elastomeric mortar
Heritage significance	High
Conservation action	 Erect scaffold to complete inspection of all affected stones at close range. Use scaffold to invite tenderers to price the works and carry out the remediation as specified herein. Remove affected voussoir/arch stones and indent with new stones to match original profiles. Repoint with appropriately specified mortar (1:2:9¹⁹). Follow up with a general cleaning of the façade using the Gommage or Heritage No.1 system and remove scaffold.

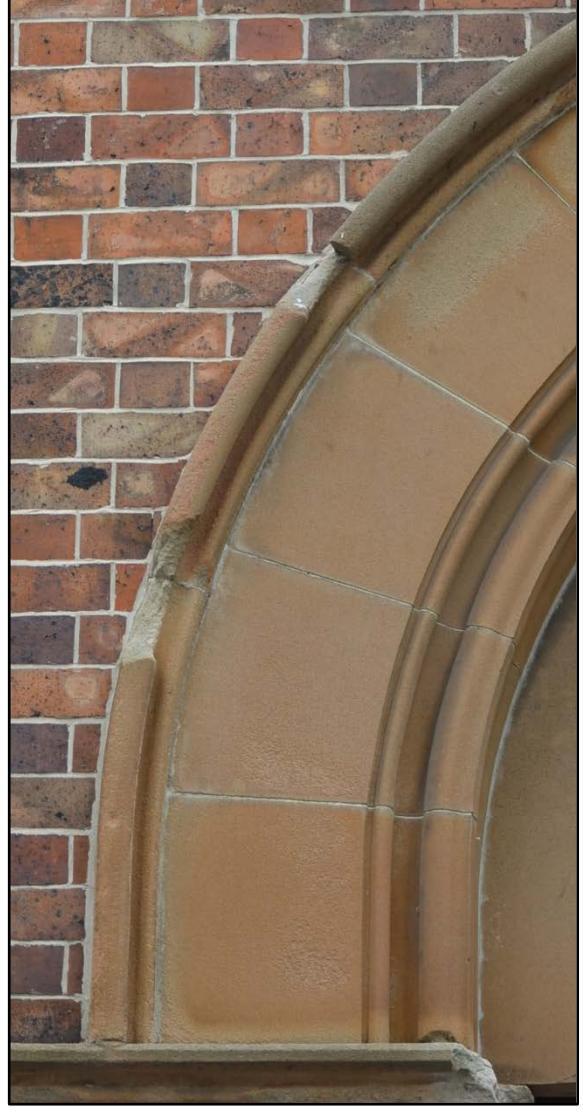
Figure 69. Detail of arch above main building central entry door (Efflorescence).

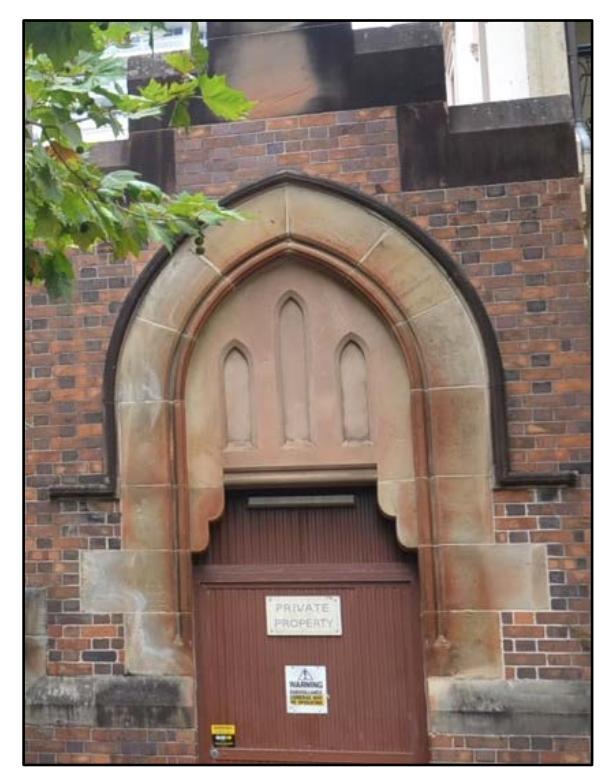
Figure 72. Arch above doorway through boundary wall section to the south of the school hall (Efflorescence). The fielded panel above this door includes three pointed arched recesses.

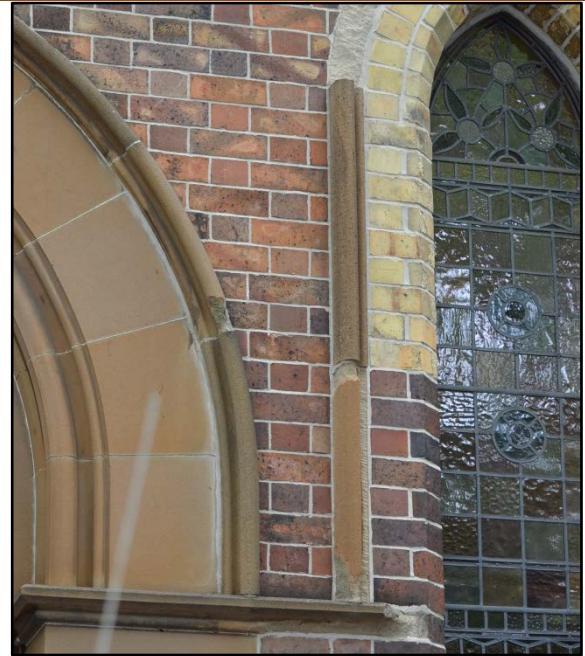
Figure 71. Detail of arch above main building central entry door.

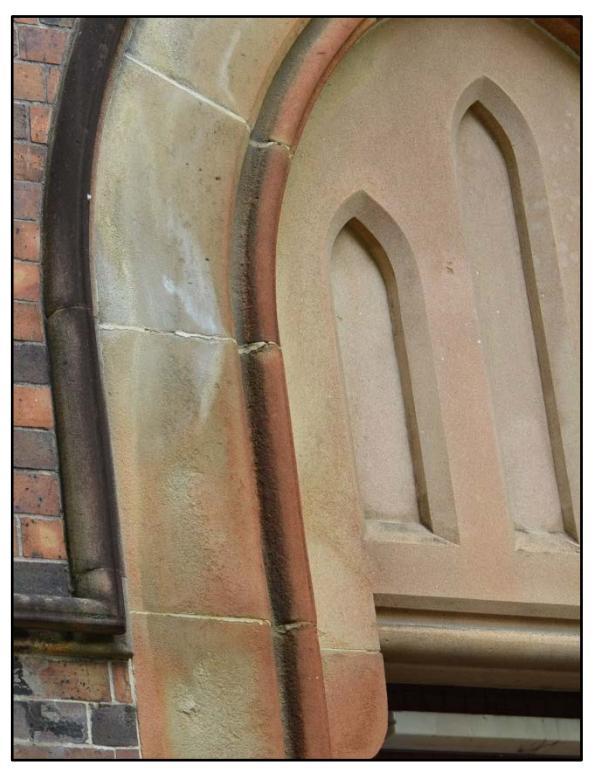
Figure 73. Detail of arch above doorway through southern boundary wall section (Efflorescence).

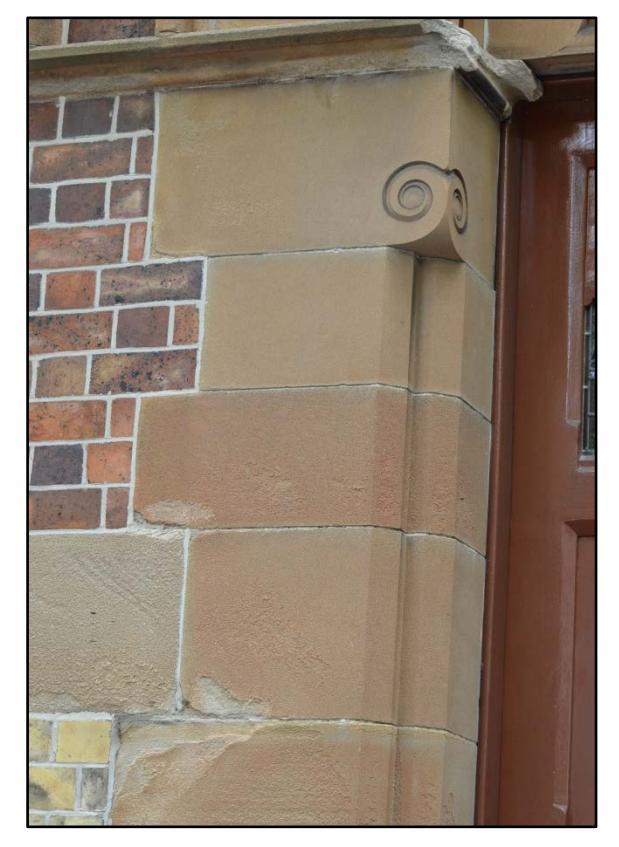
Figure 74. Door jambs of the main building's central entry (Efflorescence, delamination).

Element	Door jambs
Location	 Around the central entry door to the main school building (Victoria Street) Around the entry door located within the boundary wall section to the south of the school hall
Condition	Poor (efflorescence, delamination)
Cause	 Efflorescence due to cementitious/elastomeric mortar Delamination due to cementitious/elastomeric mortar
Heritage significance	High
Conservation action	 Erect scaffold to complete inspection of all affected stones at close range. Use scaffold to invite tenderers to price the works and carry out the remediation as specified herein. Remove affected jamb stones and indent with new stones to match original profiles. Repoint with appropriately specified mortar (1:2:9²⁰). Follow up with a general cleaning of the façade using the Gommage or Heritage No.1 system and remove scaffold.

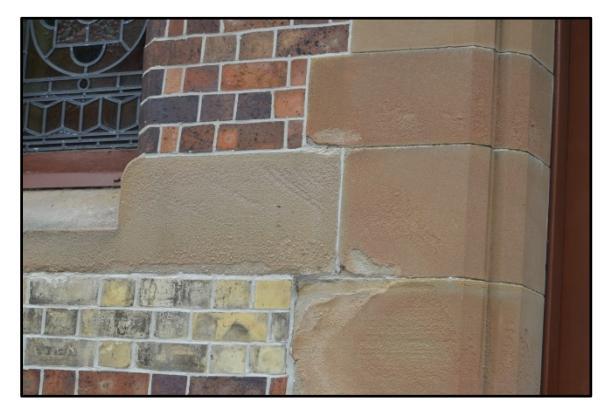
Figure 76. Door jambs of the main building's central entry (Efflorescence, delamination).

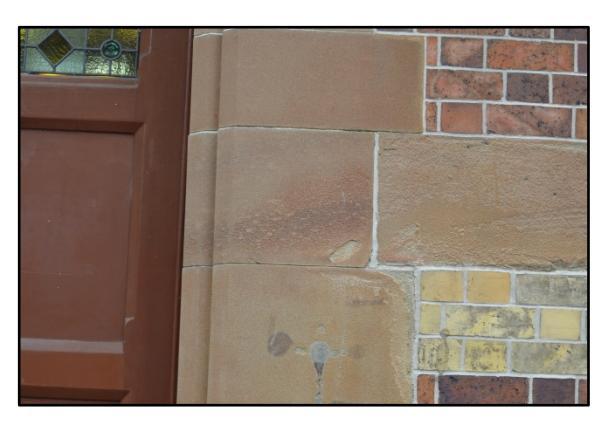
Figure 77. Door jambs of the main building's central entry (Efflorescence, delamination and filled up holes probably relating to original signage/doorbell).

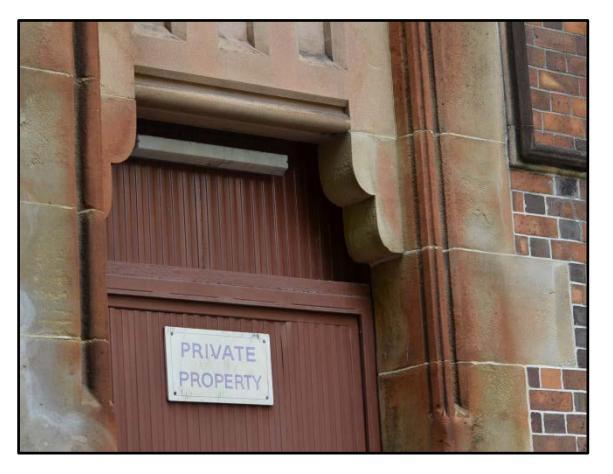
Figure 80. Door jambs of the entry door immediately south to the school hall building (Efflorescence, discolouration).

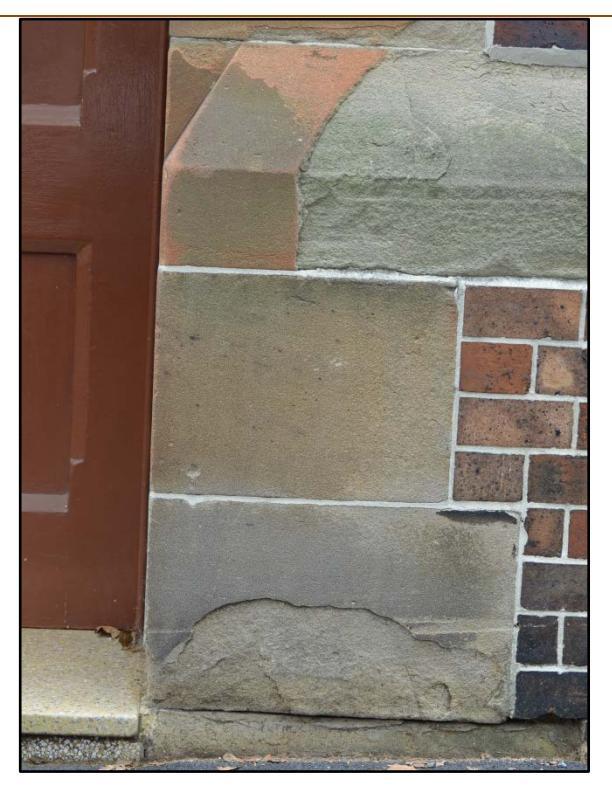
Figure 79. Door jambs of the main building's central entry (Delamination).

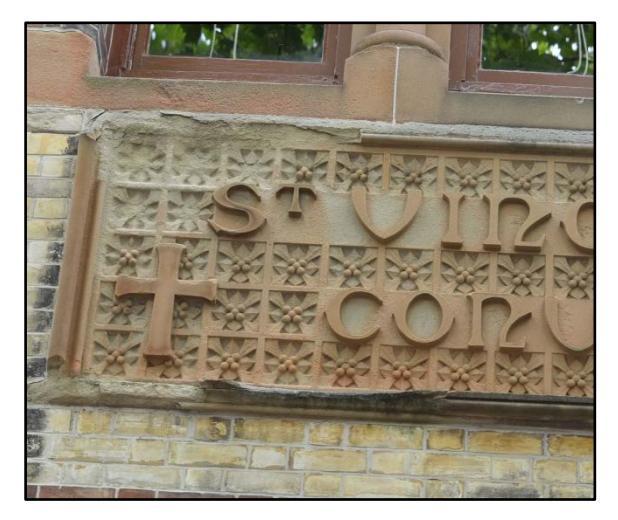
Figure 81. 'St Vincent's Convent' sign above the central entry to the main building (Delamination, salt crystallization).

Element	Heraldry 'St Vincent's Convent'
Location	Above the central entry door to the main school building (Victoria Street)
Condition	Poor (efflorescence, delamination)
Cause	 Salt crystallization due to cementitious/elastomeric mortar Delamination due to cementitious/elastomeric mortar
Heritage significance	High
Conservation action	 Erect scaffold to complete inspection of all affected stones at close range. Use scaffold to invite tenderers to price the works and carry out the remediation as specified herein. Indent entire stone. Otherwise consider replacing entire stone with cast bronze facsimile. Repoint with appropriately specified mortar (1:2:9²¹). Follow up with a general cleaning of the façade using the Gommage or Heritage No.1 system and remove scaffold.

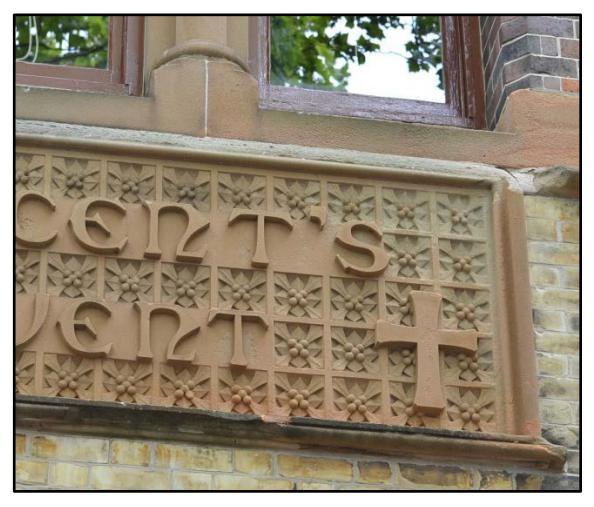
Figure 82. 'St Vincent's Convent' sign above the central entry to the main building (Delamination, salt crystallization).
