ST VINCENT'S COLLEGE STONEWORK REPAIRS AND SEISMIC STRENGTHENING 2018

REVIEW OF ENVIRONMENTAL FACTORS

November 2018 Final Part 5 EP&A Act Environmental Impact Assessment Prepared for St Vincent's College

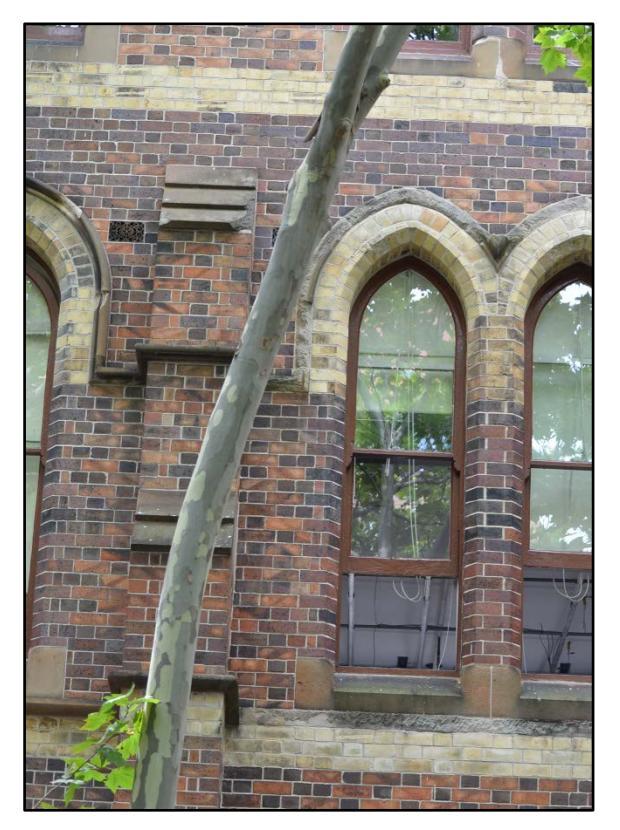
Figure 83. Saddle stones and capping on buttress on the western façade of the main building (Delamination).

Element	Saddle stones and capping
Location	Buttresses (western and eastern façade of the main school building)
Condition	Poor (delamination)
Cause	Delamination
Heritage significance	High
Conservation action	 Erect scaffold to complete inspection of all affected stones at close range. Use scaffold to invite tenderers to price the works and carry out the remediation as specified herein. Remove affected capping stones and indent with new stones to match original profiles Repoint with appropriately specified mortar (1:2:9²²). Follow up with a general cleaning of the façade using the Gommage or Heritage No.1 system and remove scaffold.

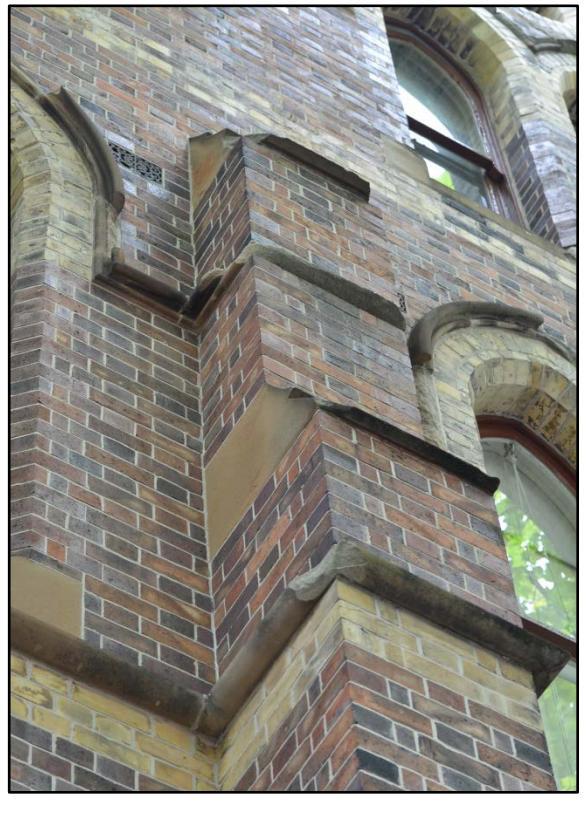
Figure 84. Saddle stones and capping on buttress on the western façade of the main building (Delamination).

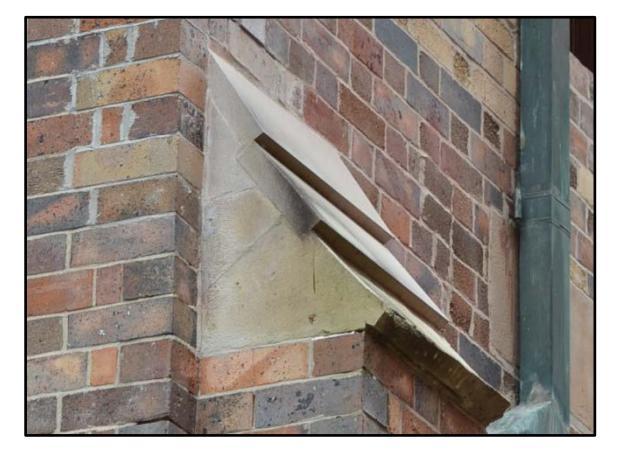
Figure 85. Saddle stones and capping on buttress on the eastern façade of the main building (Replaced in the past).

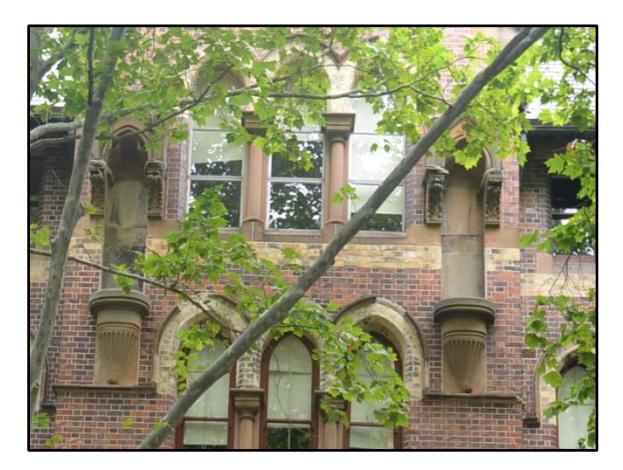
Figure 86. Niches on either side of the central gable on the western façade of the main building.

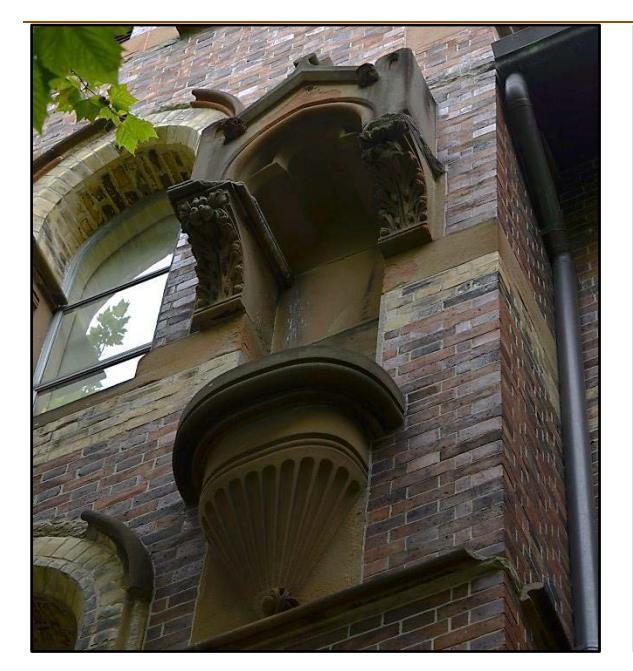
Figure 89. Most southern niche on the central gable of the

main building (Staining, delamination).

Element	Niches and 'gablets'
Location	 On either side of the central gable on the western façade (Victoria Street) of the main building On the end of the gables of the main building and the school hall building
Condition	Fair to very poor (staining, lichen growth, efflorescence -past and present-, delamination)
Cause	 Staining due to rainwater with pollutants over time Lichen growth Delamination due to inappropriate mortar used in the past Previous salt attack (which has exposed the striations of the stone) of niche on southern façade of main building (Figure 91)
Heritage significance	High
Conservation action	 Erect scaffold to complete inspection of all affected stones at close range. Use scaffold to invite tenderers to price the works and carry out the remediation as specified herein. Remove affected niche stones and indent with new stones to match original profiles. Repoint with appropriately specified mortar (1:2:9²³). Follow up with a general cleaning of the façade using the Gommage or Heritage No.1 system and remove scaffold.

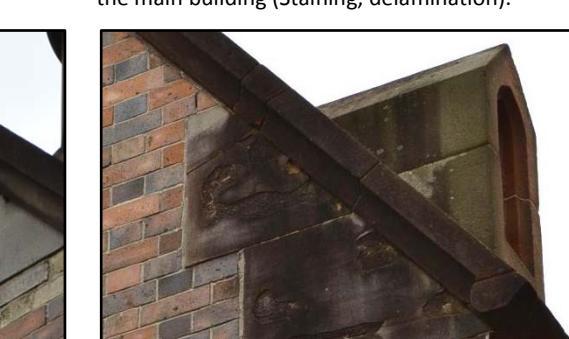
Figure 91. Gablet on gable on southern façade (front gable) of main building (Previous salt attack).

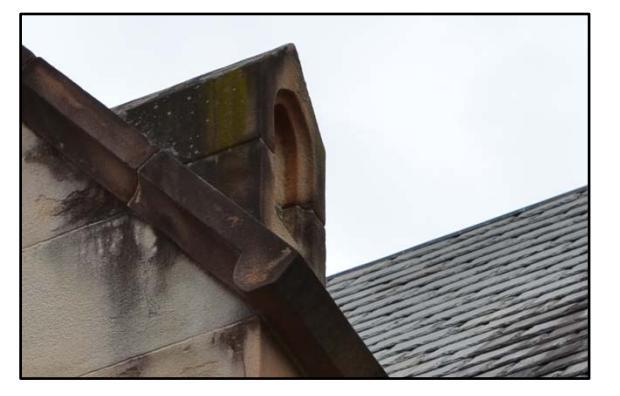
Figure 93. Gablet on gable on the eastern façade of main building (Staining, lichen growth).

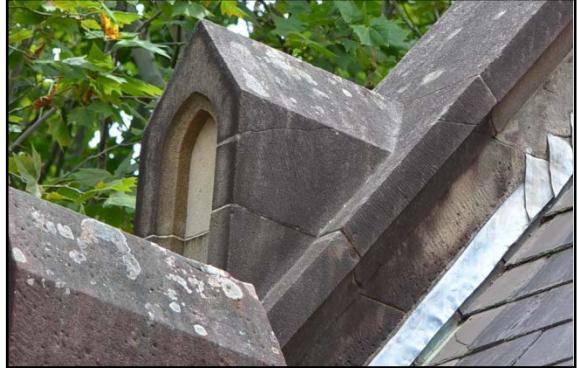
Figure 94. Gablet on the Victoria Street gable of the school hall building (Crack which has been patched with mortar in the past).

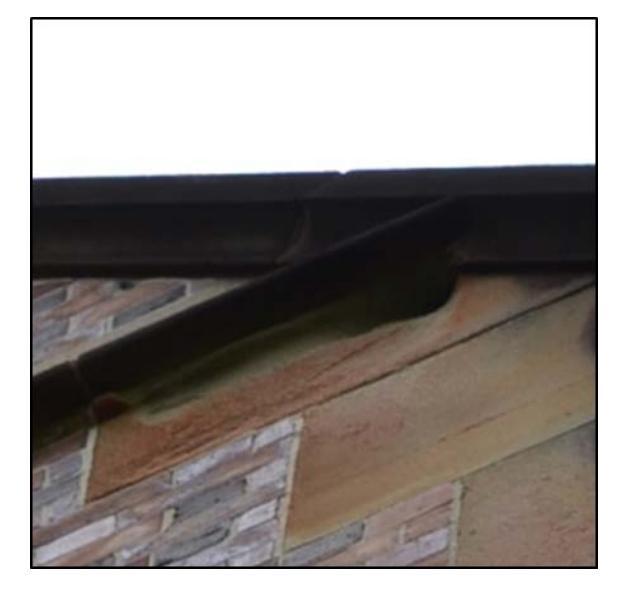
Figure 95. Quoin (under string course) on the central gable of western façade of the main building (Advanced efflorescence). This problem is mirrored on the other end of this central gable.

Element	Quoins
Location	On the end of the gables of the main building and the school hall building.
Condition	Fair to very poor (staining, efflorescence, delamination)
Cause	 Staining due to rainwater with pollutants over time Efflorescence due to cementitious/elastomeric mortar Delamination due to cementitious/elastomeric mortar
Heritage significance	High
Conservation action	 Erect scaffold to complete inspection of all affected stones at close range. Use scaffold to invite tenderers to price the works and carry out the remediation as specified herein. Remove affected quoins stones and indent with new stones to match original profiles. Repoint with appropriately specified mortar (1:2:9²⁴). Follow up with a general cleaning of the façade using the Gommage or Heritage No.1 system and remove scaffold.

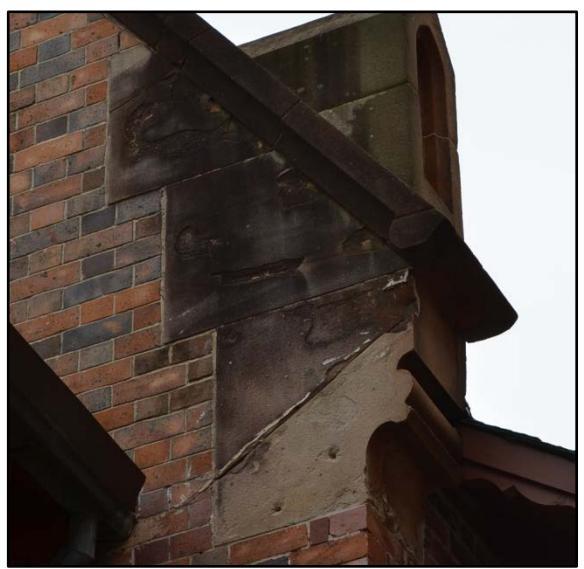
Figure 96. Quoin on the southern façade of the main building (Staining, delamination).

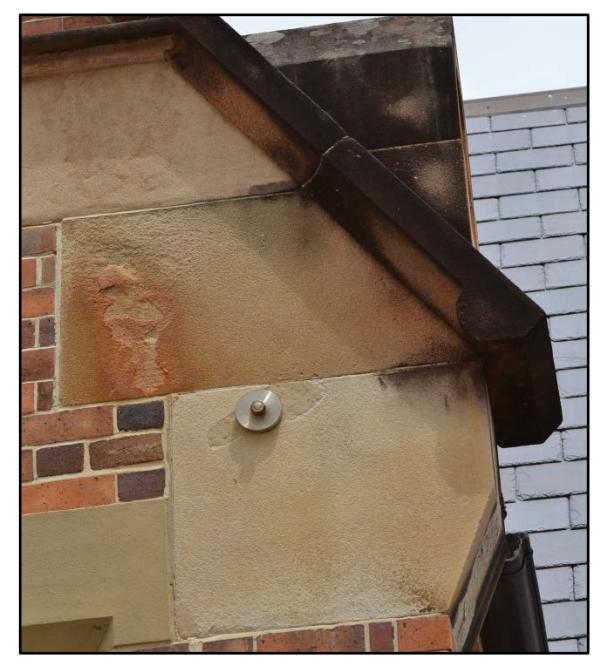
Figure 98. Quoins on the eastern façade of the school hall (Efflorescence, delamination).

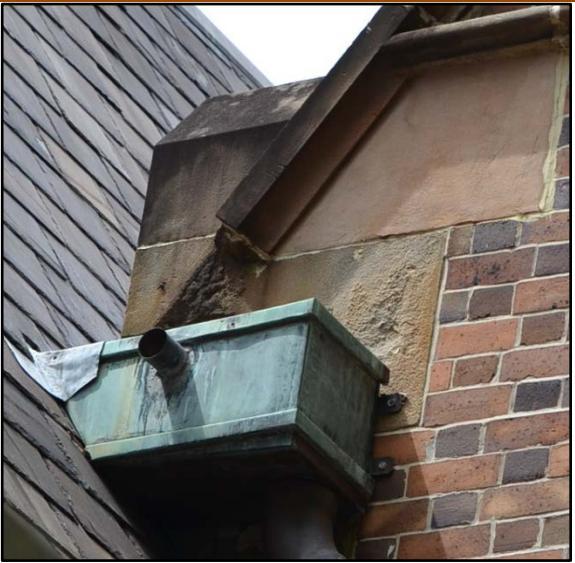
Figure 100. Quoins on the northern façade of the school hall (Efflorescence). This is where the 1950 addition was joined into the 1886 building.

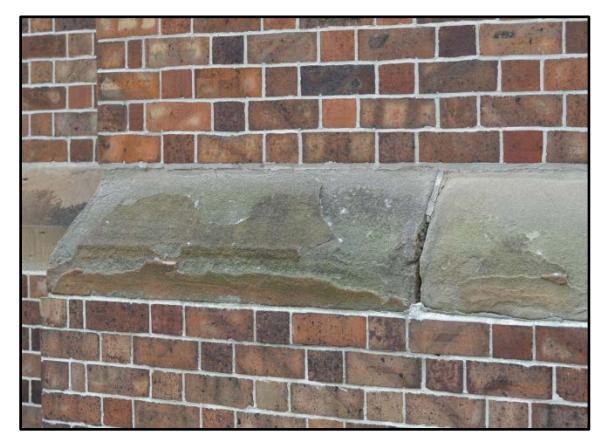
Figure 101. Plinth on western façade of main building (Staining, case hardening, missing mortar).

Element	Plinth
Location	Main school building and school hall.
Condition	Poor (staining, delamination/case hardening, missing mortar, incorrectly rendered in the past)
Cause	 Staining due to rainwater with pollutants over time Delamination/case hardening due to inappropriate mortar use in the past Mortar missing due to sections breaking away with the stone due to case hardening and due to inappropriate mortar in the vicinity Incorrectly rendered in the past
Heritage significance	High
Conservation action	 Erect scaffold to complete inspection of all affected stones at close range. Use scaffold to invite tenderers to price the works and carry out the remediation as specified herein. Remove affected plinth stones and indent with new stones to match original profiles. Where stone has been inappropriately rendered over in the past, remove render and indent the stone to match original profile. Repoint with appropriately specified mortar (1:2:9²⁵). Follow up with a general cleaning of the façade using the Gommage or Heritage No.1 system and remove scaffold.

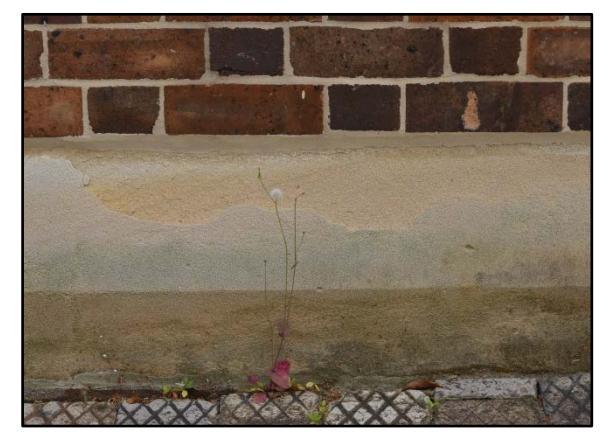
Figure 103. Plinth on southern façade of school hall (Delamination).

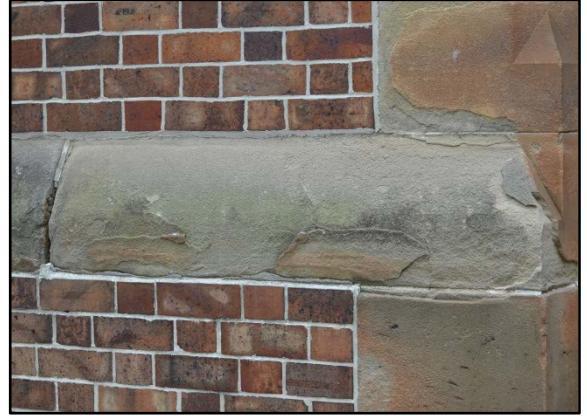
Figure 102. Plinth on western façade of main building (Staining, case hardening, missing mortar).

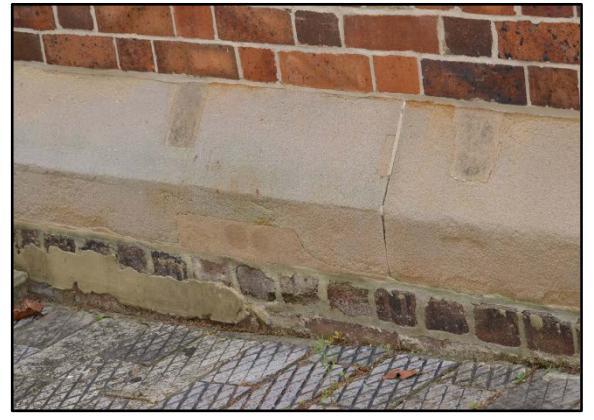
Figure 104. Plinth on southern façade of school hall (Incorrectly rendered in the past).

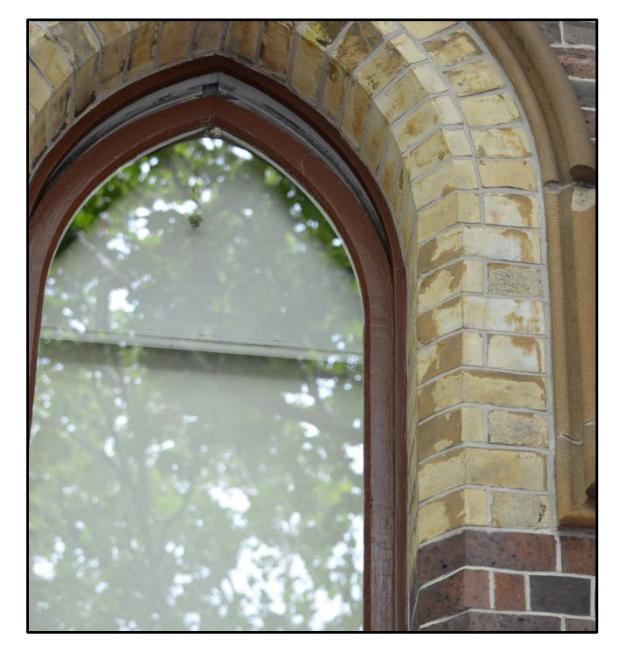
Figure 105. Bricks on western façade of main building (Efflorescence).

Element	Bricks
Location	Main school building and school hall.
Condition	Good to poor (efflorescence, case hardening, missing mortar, cracking)
Cause	Efflorescence due to the elastomeric sealant which has been applied in the past and which has caused the glazing to come off the bricks
Heritage significance	High
Conservation action	 Erect scaffold to complete inspection of all affected brick at close range. Use scaffold to invite tenderers to price the works and carry out the remediation as specified herein. Repoint with appropriately specified mortar (1:2:9²⁶). Follow up with a general cleaning of the façade using the Gommage or Heritage No.1 system and remove scaffold.

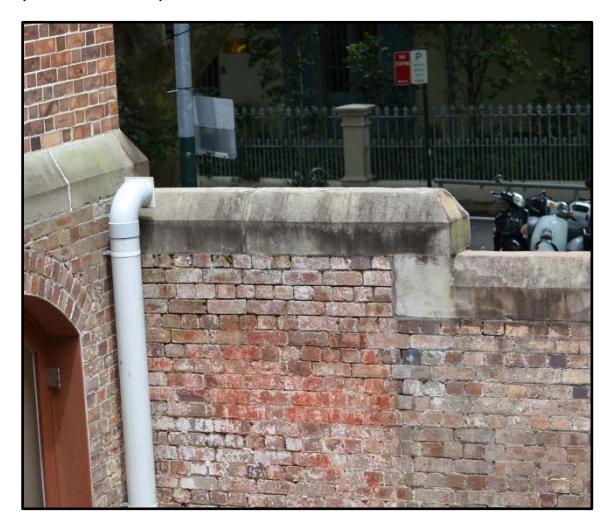
Figure 107. Bricks on the eastern side of the boundary wall between the main building and the school hall (missing mortar, cracking).
